Rehabilitation Procedures for Faulted Rigid Pavement

LUIS JULIAN BENDAÑA AND WEI-SHIH YANG

Engineering Research and Development Bureau, New York State Department of Transportation, State Campus, Albany, N.Y. 12232.

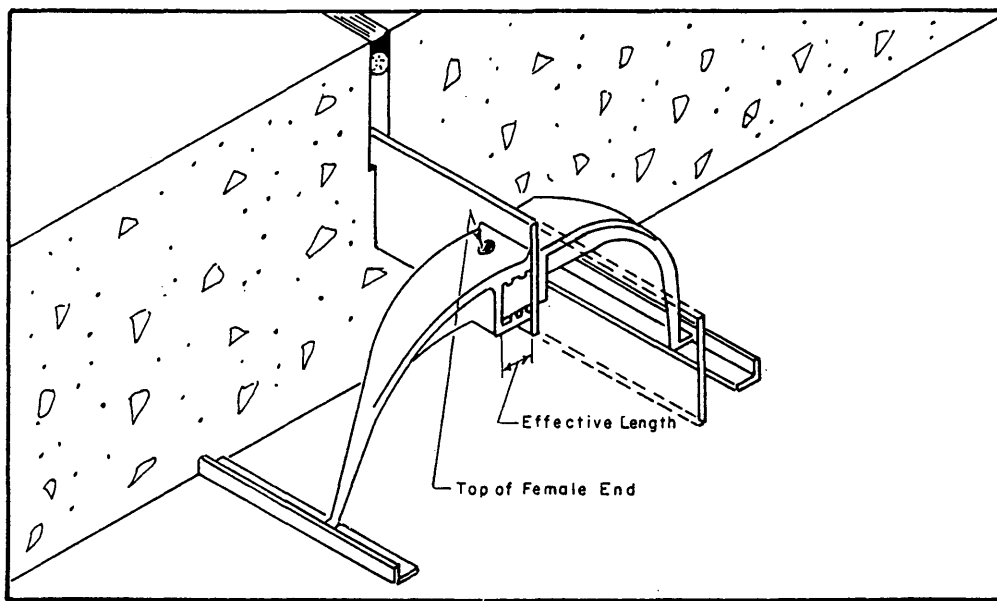
FIGURE 1 Configuration of two-component load-transfer device.

Inadequate horizontal slab movement, joint lockup, concrete cracking, and loss of load transfer experienced with steel dowels led in 1960 to introduction of two-component, malleable-iron devices (Figure 1). However, these new devices proved to be less efficient than the dowels, eventually losing metal because of corrosion and wear and thus failing

in load-transfer capability. As these problems became apparent, use of these devices was discontinued and plastic-coated or epoxy-coated dowels and I-beams were substituted. The problem now was how to restore load-transfer capability to the two-component devices that were reaching the stage at which they became ineffective, resulting in severe faulting and related distress.

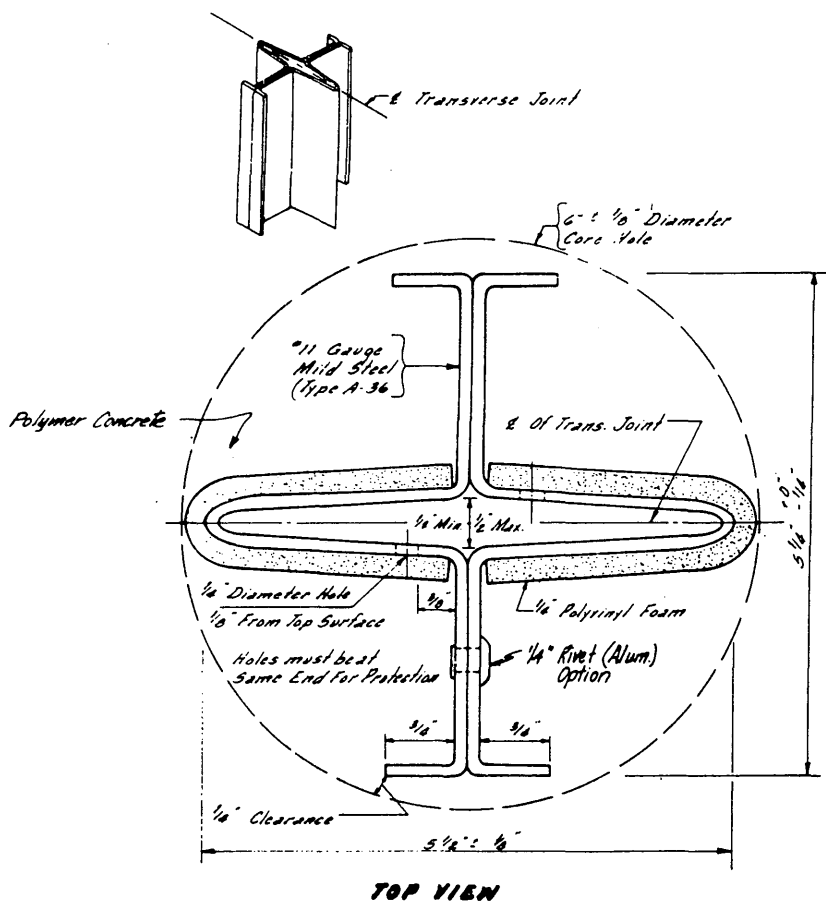
FIGURE 3 Configuration of University of Illinois double-V retrofit LTD (1 mm = 0.04 in.).

Retrofitted LTDs In the second part of the study, two devices were installed and evaluated: University of Illinois (IU) LTDs [epoxy-coated (E), stainless steel (S), and pre-compressed (C)] and epoxy-coated I-beam dowel bars. The Illinois devices (Figure 3) were placed either three or four per joint. The retrofitted I-beam dowel bars (Figure 4) were in two configurations, four or eight per joint. Installation of the Illinois devices involved drilling a 15.25-cm core hole across the joint, applying polymer primer, inserting the device, and backfilling the hole with polymer concrete; the transverse joints were sawcut to remove the fiberboard bond breaker and form a sealer reservoir. The procedure for the I-beams consisted of making longitudinal grooves (slots) at least 7.6 cm wide and 46 cm long, preparing the slots using the same procedures as for the Illinois devices, installing the I-beams,
