Field Investigations of Selected Strategies To Reduce Reflective Cracking in Asphalt Concrete Overlays Constructed over Existing Jointed Concrete Pavements

ERIC D. MOODY

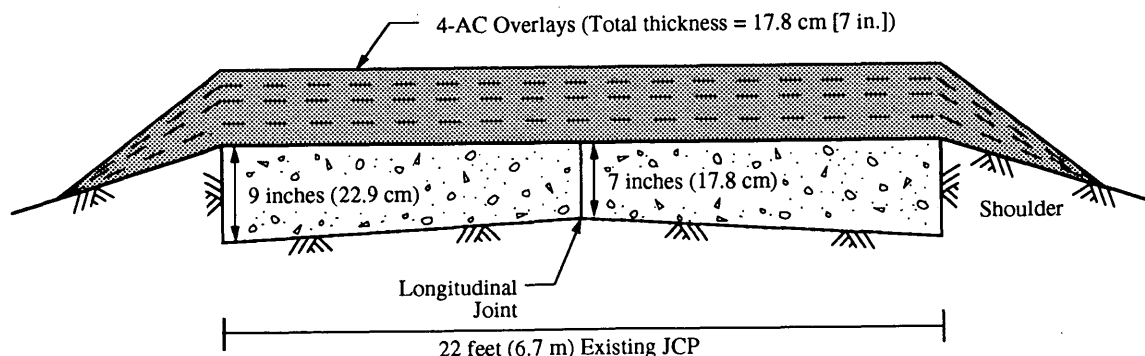
FIGURE 2 Typical cross section of existing 9-7-9 JCP.

technique described above has been implemented numerous times throughout the history of the highway, and as a result the original JCP is now covered with four AC overlays totaling 17.8 cm (7.0 in.) in thickness. Figure 2 shows the typical cross section of the existing pavement structure.
