Compacted Clay Embankment Failures

ZENON G. KYFOR AND RAYMOND L. GEMME

Embankment instability that occurred along several completed sections of a major interstate highway located in the western part of New York State is described. The affected embankments ranged in height from 4.6 m (15 ft) to 9.15 m (30 ft) and were constructed of silty clay over a silty clay foundation. Field investigations revealed that movements were taking place within the embankments and were not a result of the foundation soil. These movements were consistent with an undrained mode of failure. The embankment material was obtained from borrow excavations made outside the project limits and classified as a medium to highly plastic clay. The moisture contents of the borrow ranged from 25 to 55 percent and the plasticity index ranged from 15 to 32 percent. Drill holes progressed through the affected fills indicated that the embankment moisture contents at the time of distress exceeded the optimum moisture content (20 percent) by 5 to 10 percent based on a standard Proctor compactive effort. The undrained shear strengths at these moisture contents were not sufficient to provide for internal stability of the emb

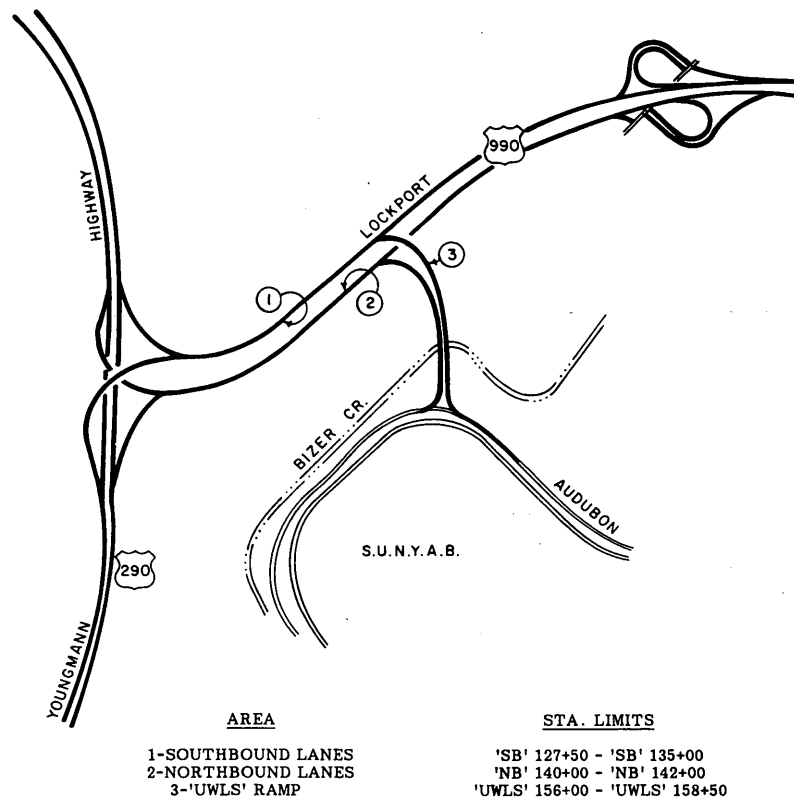
FIGURE 2 Project plan and location of problem areas.

The project is located in Erie County just northeast of Buffalo (Figure 1). A closeup of the location of the problem areas is shown in Figure 2.

Several months after project embankments were completed and pavements were in place, three embankment areas (Figure 2) began experiencing unexplained movements (Figure 3). Eventually all embankments greater than 4.6 m (15 ft) in height would experience similar movements. The southbound (Area 1) and northbound (Area 2) lanes of the project mainline were paved with concrete, whereas the third, designated the UWLS ramp (Area 3), was paved with asphalt. The fill heights of the southbound lanes, northbound lanes, and UWLS ramp were 7.6 m (25 ft), 6.1 m (20 ft), and 9.2 m (30 ft),

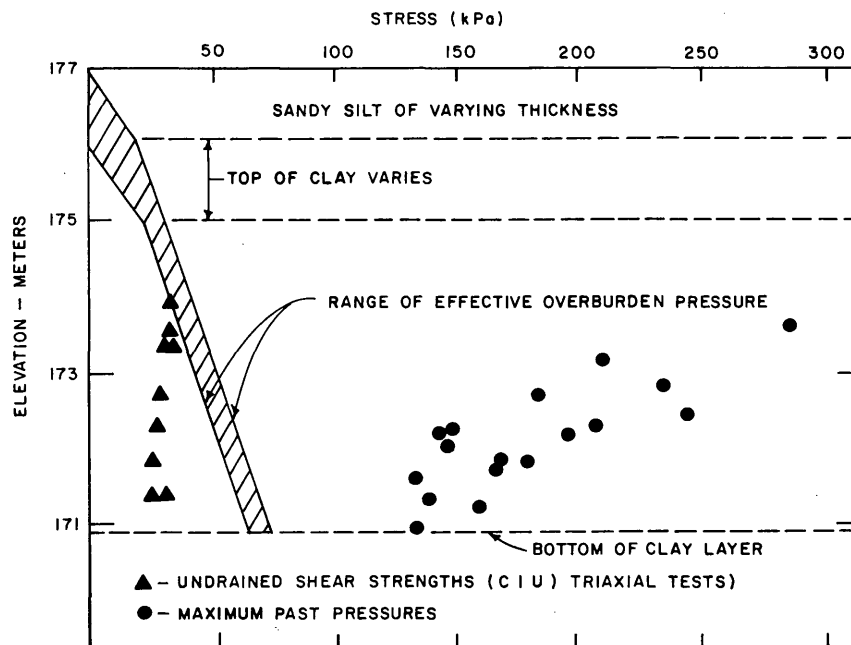
FIGURE 4 Stress history and undrained shear strengths of foundation soils.

The general foundation conditions in the project area consist of up to 1.5 m (5 ft) of sandy silt, underlain by 1.5 m (5 ft) of stiff red/brown clay over 3.1 m (10 ft) of soft red/brown clay. The soft clay is underlain by compact glacial till extending to rock. Figure 3 diagrams the embankment geometry showing embankment distress. Figure 4 shows the stress history and undrained shear strengths of the foundation soils.

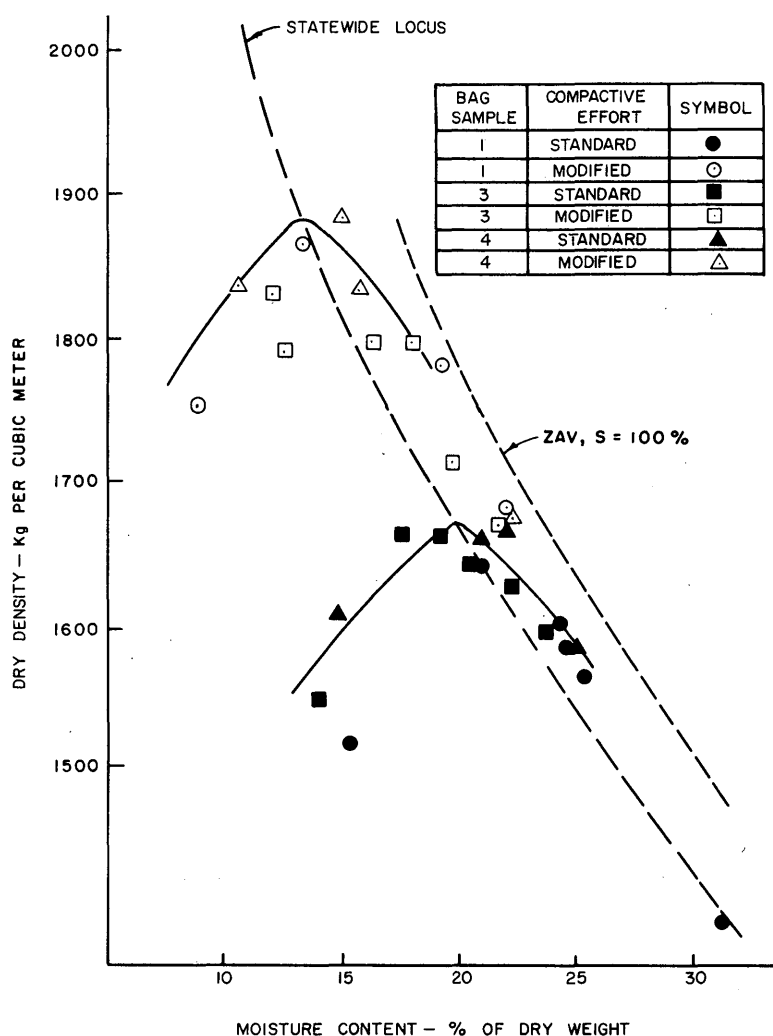
FIGURE 5 Dry density versus moisture content for bag samples.

The moisture content of the borrow ranged from 25 to 55 percent and the plasticity index ranged from 15 to 32 percent. The optimum moisture content at the standard Proctor compactive effort was determined to be ± 20 percent (Figure 5). As indicated, the natural moisture content of the material from these excavations was wetter than optimum.

Bag samples of the clay material used to construct the embankments were obtained to perform laboratory compaction and strength tests. The samples were compacted under both standard and modified compactive efforts, and the results are shown in Figure 5. At the standard compactive effort, the optimum moisture content was 20 percent and the maximum dry density was $1\,681\text{ kg/m}^3$ (105 pcf). An optimum moisture content of 13 percent and a maximum dry density of $1\,874\text{ kg/m}^3$ (117 pcf) was obtained for this material compacted at the modified effort.

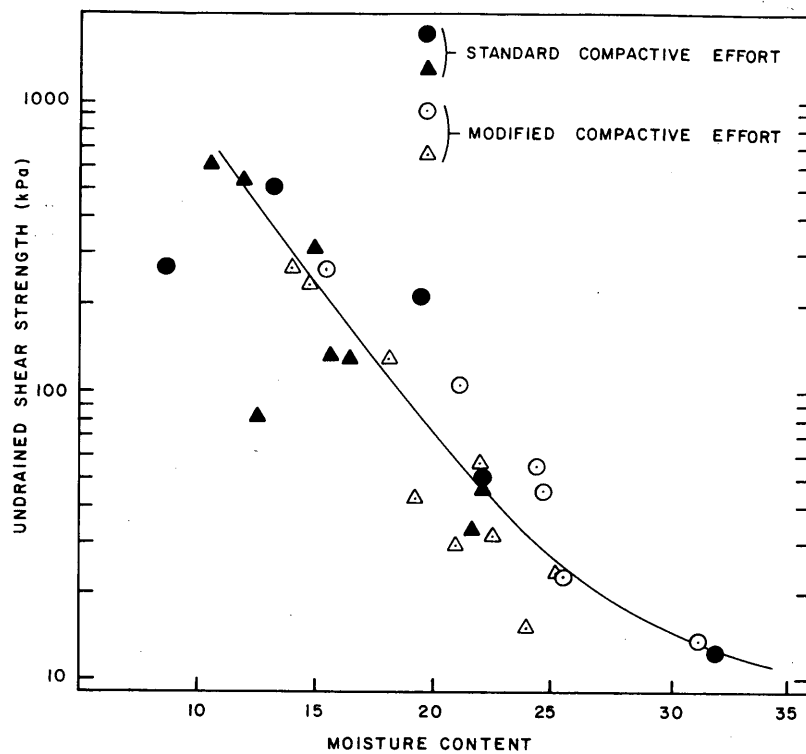
FIGURE 9 Undrained shear strength versus moisture content for bag samples.

On completion of the compaction tests, each sample was taken out of the compaction mold and full-diameter unconsolidated-undrained triaxial compression tests were performed at 100 percent saturation. A confining pressure of 172.5 kPa (25 psi) was applied to each sample. A relationship between moisture content and undrained shear strength was developed and is shown in Figure 9.

As can be seen, strengths as low as 14.4 kPa (300 psf) were obtained at a ± 30 percent moisture content. It made no significant difference whether the samples were compacted at the standard or the modified effort.

and compactive effort. Of all these factors, moisture content appears to play the most important role in the strength of the soil, as indicated from the plot of moisture content versus shear strength shown in Figure 9.

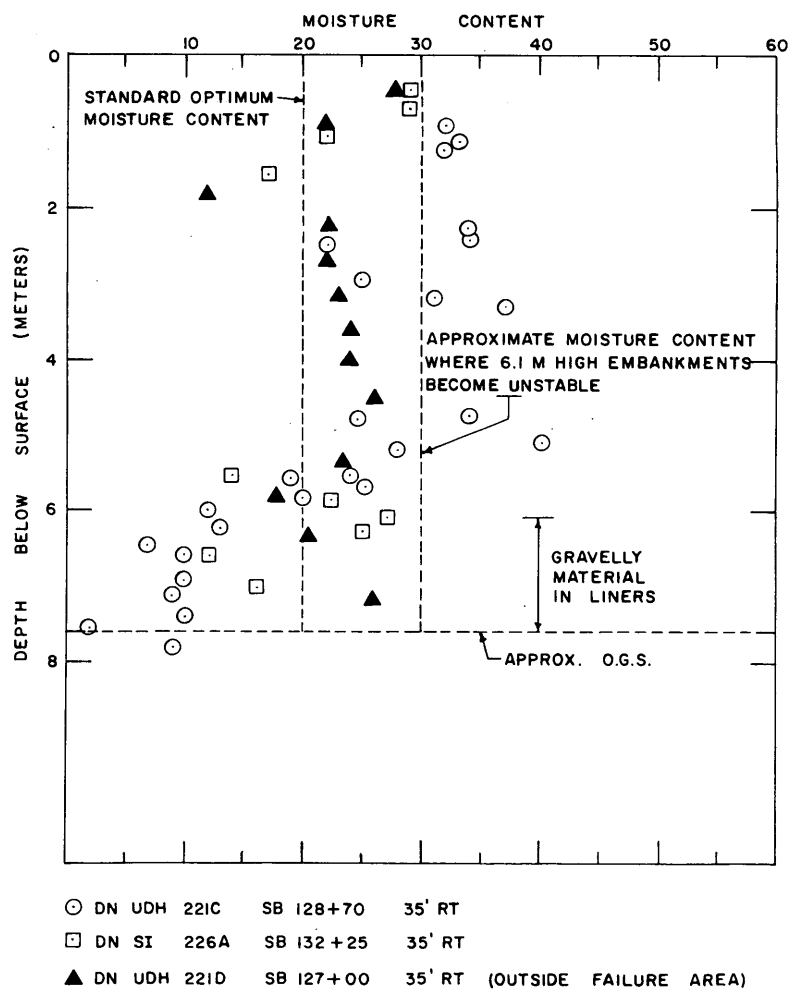
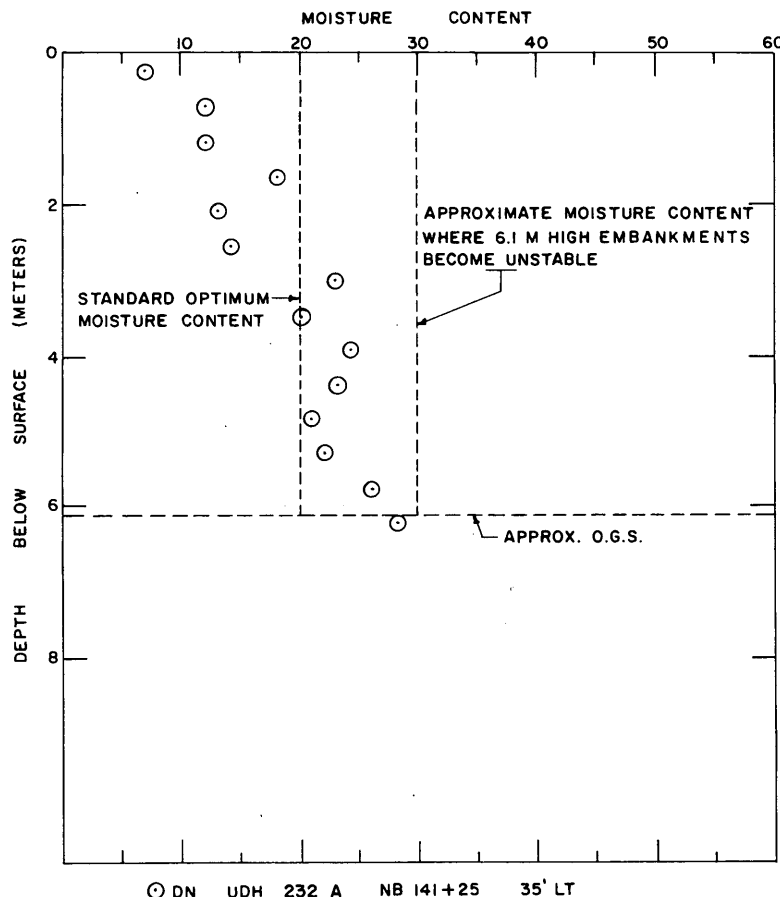
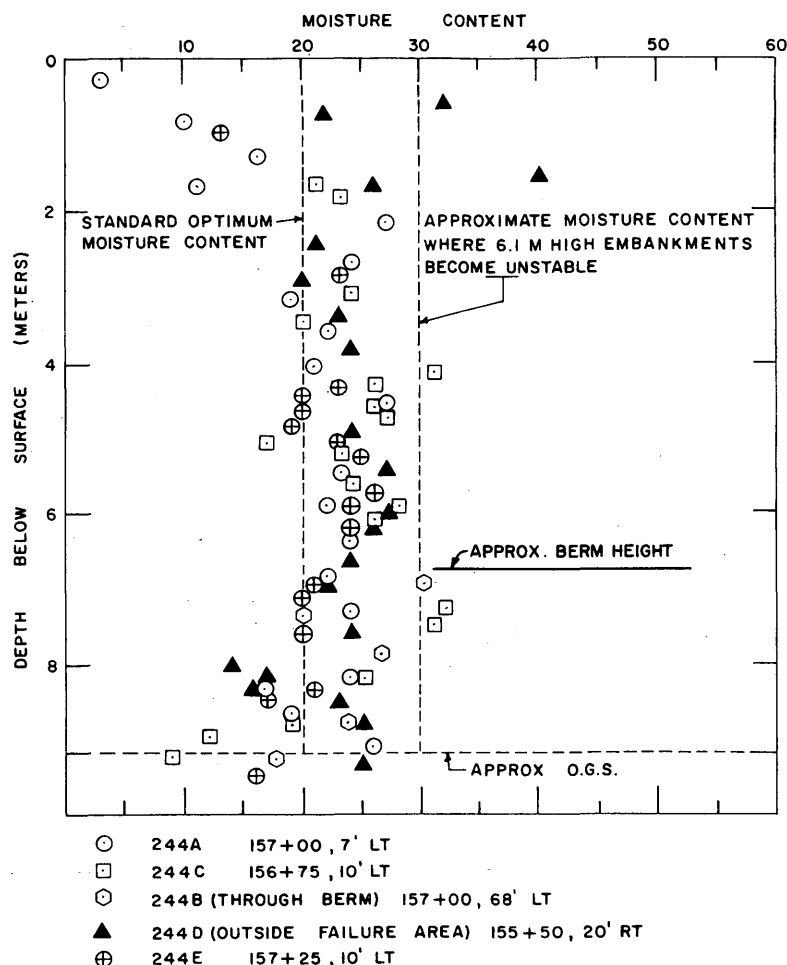
FIGURE 10 Depth versus moisture content for southbound lanes.

Density, moisture content, and strength determinations were made on the brass liner samples of the embankment material obtained from borings progressed through the problem embankments. Moisture content profiles are shown in Figures 10–12. Density versus moisture content relationships are shown in Figure 13. As can be seen, the densities of the embankment samples were determined to be above the minimum required 90 percent standard Proctor density and the moisture contents were considerably wetter than optimum. The relationship between moisture content and undrained shear strength is shown in Figure 14. As indicated, the shear strengths obtained from tests performed on the brass liner samples of the embankments were generally higher than those for the bag samples. An explanation for this is that most of the material in the embankments had a chance to gain strength after placement. The sampling procedure may also have had an effect on the strengths obtained. The bag samples, on the other hand, were tested soon after they were compacted and thus were not allowed to gain strength with time (i.e., no thixotropic strength gain). The bag sample shear strengths are more typical of the shear strengths of embankments experiencing movement. This is true because along the active plane of movement, within the embankment, the soil has not had a chance to gain strength because of its constant movement and remolding action. This view is in agreement with other investiga-

FIGURE 11 Depth versus moisture content for northbound lanes.

FIGURE 12 Depth versus moisture content for UWLS ramp.

Figures 10–12 show the moisture content profiles found to exist in borings progressed through the roadway embankments. These figures indicate that moisture contents approached or exceeded 30 percent at the time of failure in these embankments. Using these moisture content profiles, undrained shear strengths were selected for analysis from the relationship of moisture content versus shear strength obtained from Figure 9. From this relationship a shear strength of 14.4 kPa (300 psf) was used for analysis in the lower portions of the compacted embankments.

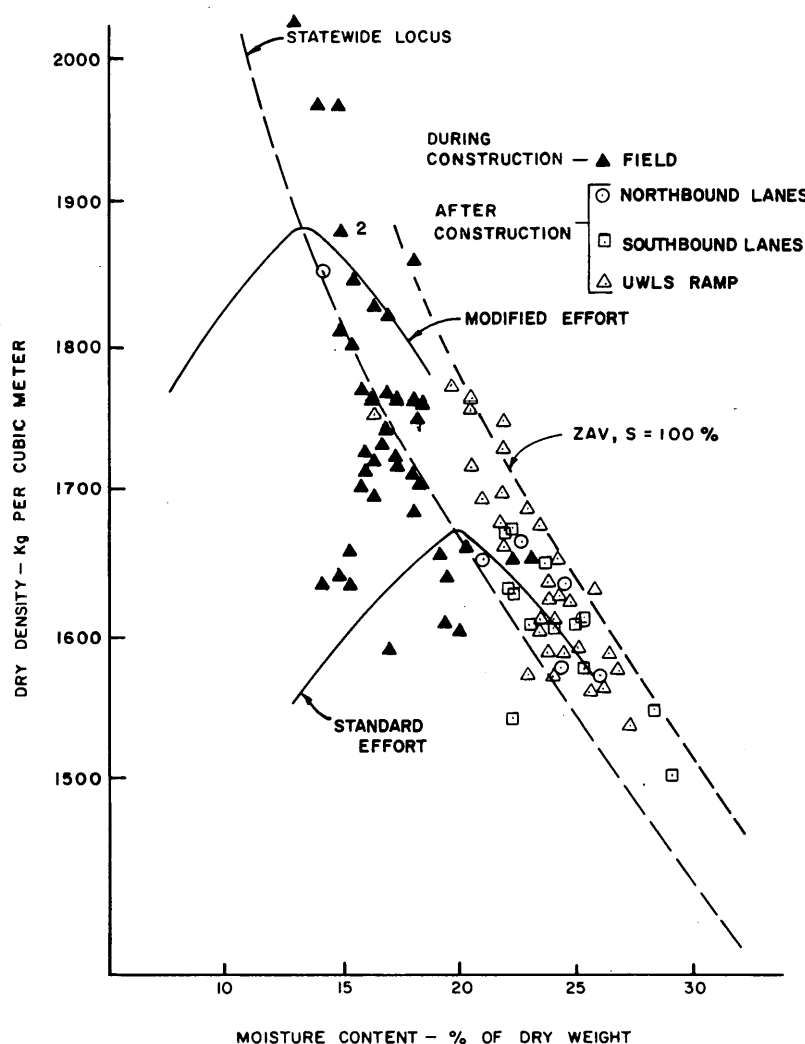
FIGURE 13 Dry density versus moisture content for field and laboratory testing.

The results of recorded field density tests in which moisture contents were obtained during construction are shown in Figure 13. The densities obtained were all above the minimum required 90 percent standard density, and the majority of the moisture contents were at or below the optimum moisture content of 20 percent as determined in the laboratory. The moisture contents determined during construction of the embankments are considerably lower than the moisture contents determined after construction. Some possible reasons for this are
