Retrofit Techniques for Floating Slab Track

HOMER M. CHEN

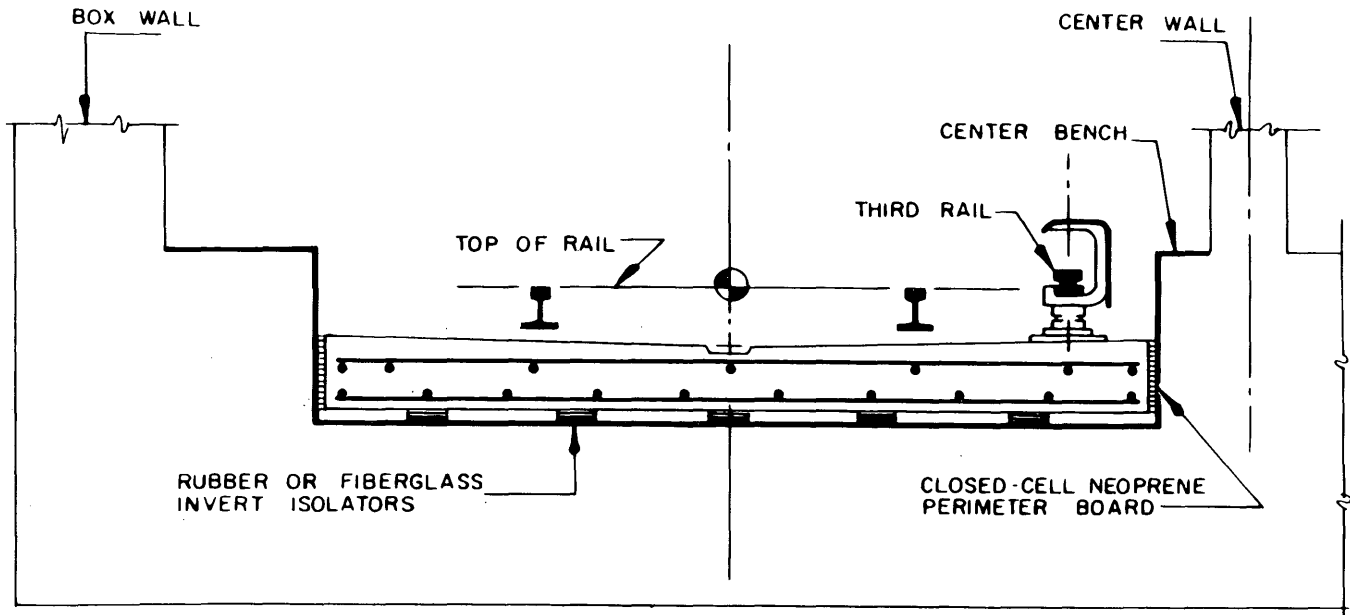
Floating slabs have been designed and installed in Washington Metrorail tunnels to reduce ground-borne vibration and noise transmitted to adjacent buildings. The concrete floating slabs rest on fiberglass, natural rubber, or polyurethane pads. Each pad is 6 in. in diameter or 6 in. square by 3 in. thick, spaced 2 ft on center. These pads serve as cushions to isolate structurally the floating slabs from the adjacent invert slabs (Figure 1).

FIGURE 1 Typical floating slab section in subway box.

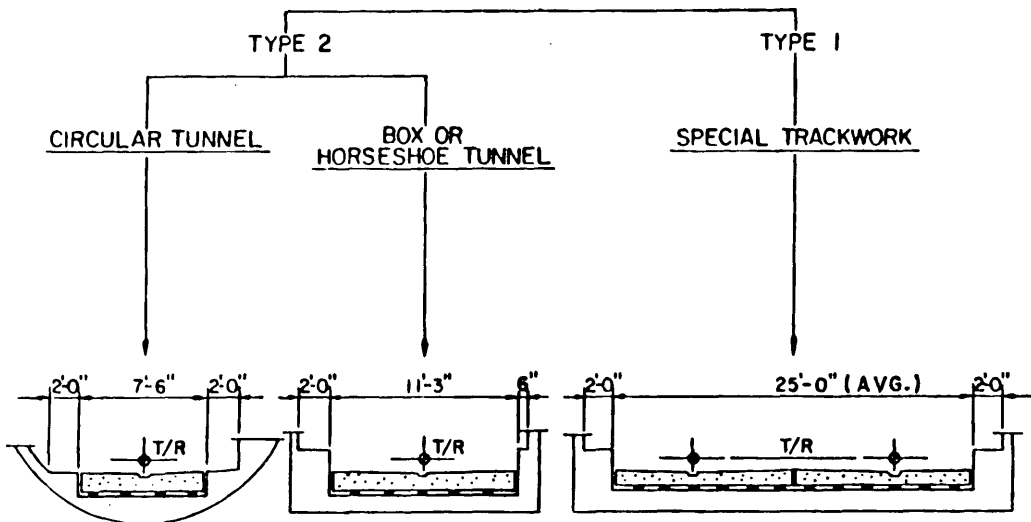
There are two basic types of floating slabs, as shown on Figure 2. Type 1 is used in special trackwork (crossovers and turnouts) areas; Type 2, with two variations, is used in tunnel sections. The box section version of Type 2 has the contact rail sharing the same support with the running rail on the floating slab. The circular section version of Type 2 has the contact rail sitting on the adjacent invert slab.

FIGURE 2 WMATA existing floating slab configurations.
