# **Toyota's ETCS-i System and Latch-up as a Cause of SUA**

**Presentation to the  
National Academy of Sciences Committee  
on Electronic Vehicle Controls and  
Unintended Acceleration**

**Ronald A. Belt  
24 January 2011**

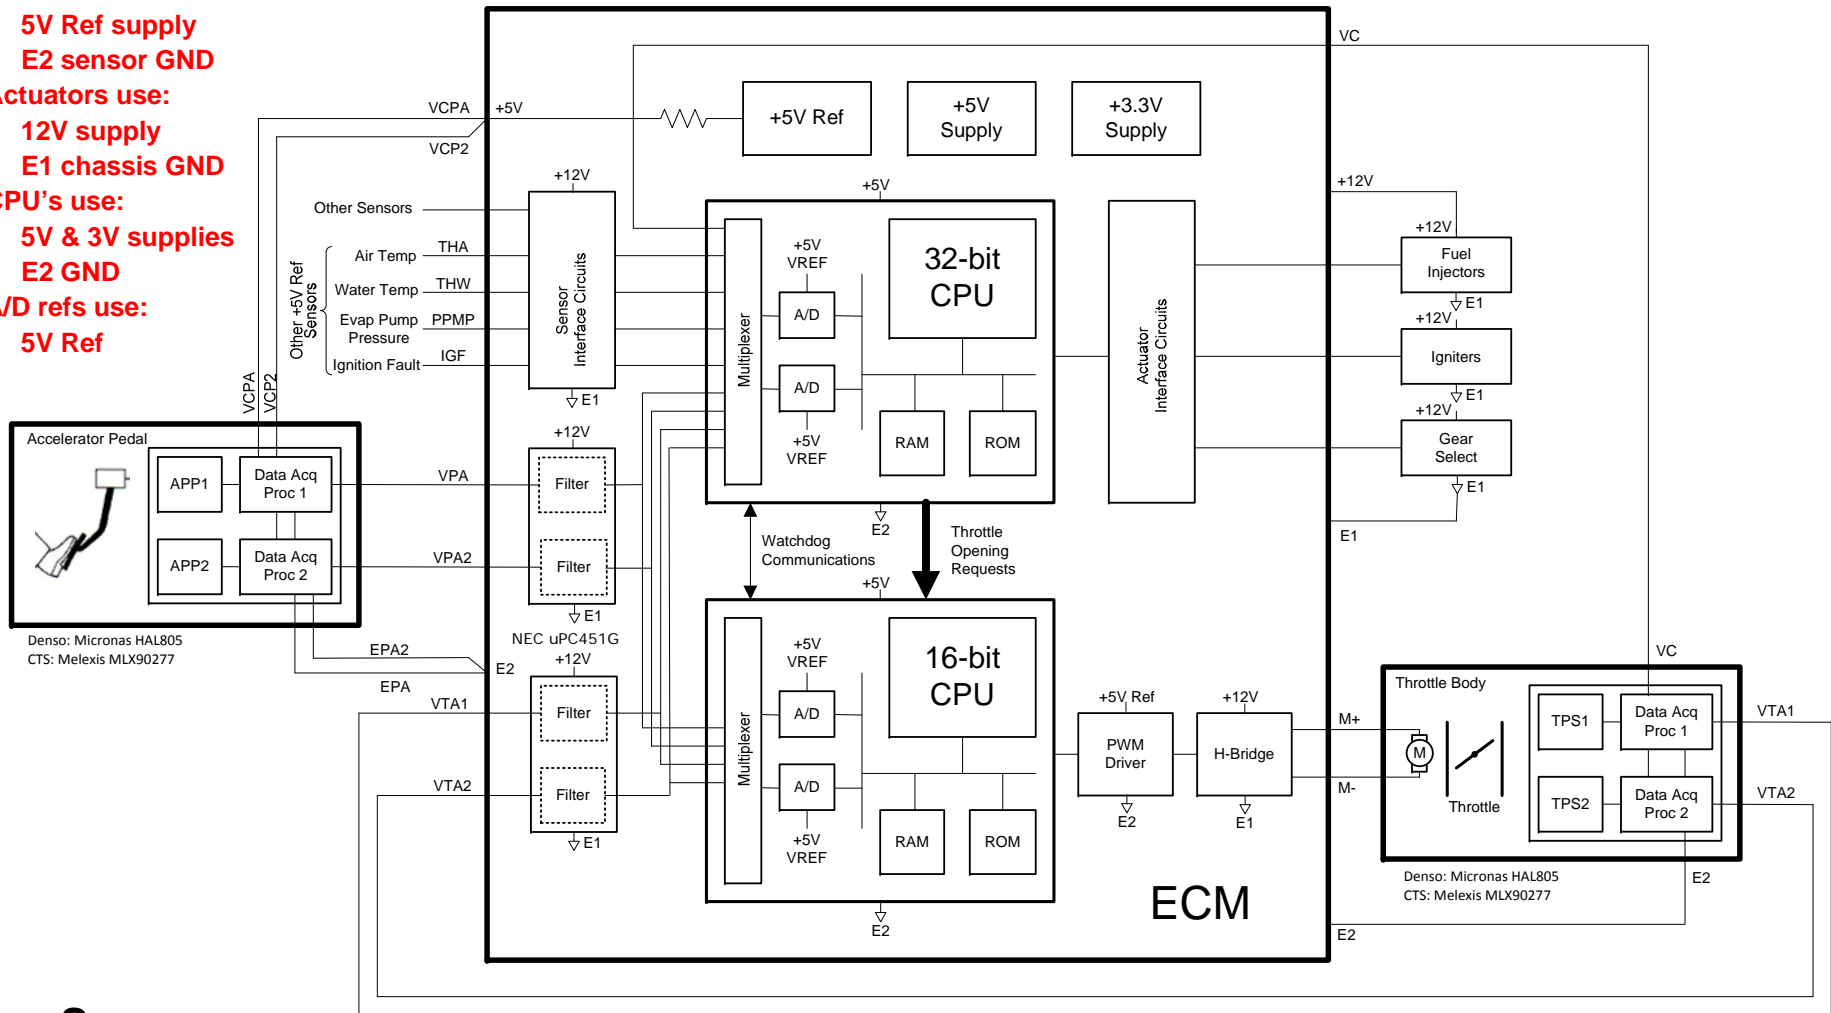
# Toyota's ETCS-i Electronic Throttle System

- Sensors use:
  - 5V Ref supply
  - E2 sensor GND
- Actuators use:
  - 12V supply
  - E1 chassis GND
- CPU's use:
  - 5V & 3V supplies
  - E2 GND
- A/D refs use:
  - 5V Ref

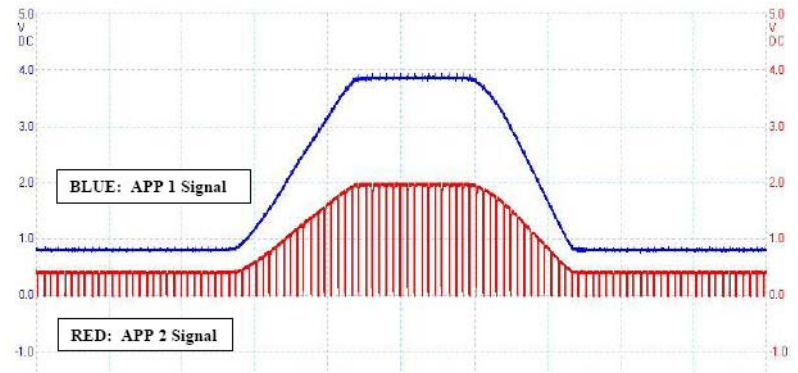
## GM APP sensors (2)

The APP2 signal is periodically pulled to ground to check for opens and shorts.

GM also uses different 5V supplies for each sensor

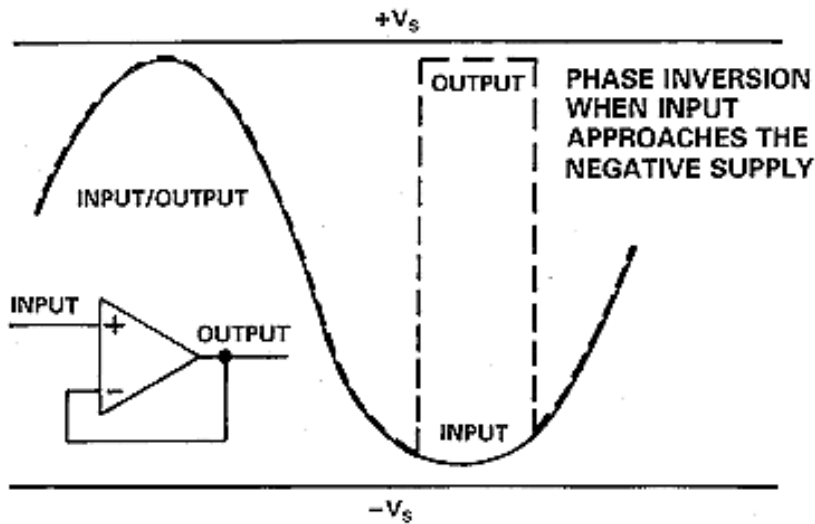
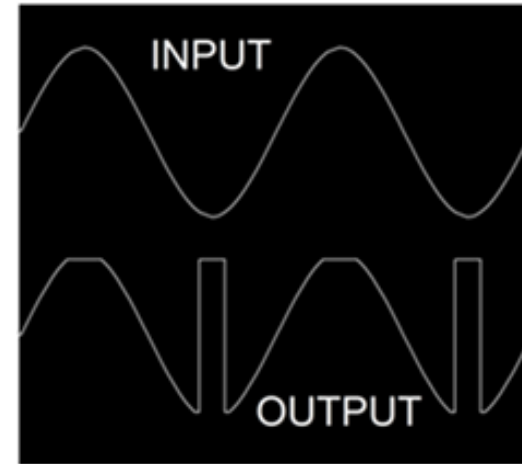
# Phase Inversion

- When an op amp input gets too close to the power rail, the output may switch to the opposite rail
- Occurs in JFET and bipolar op amps, but not CMOS
- Occurs more often when the op amp is used as a unity gain amplifier

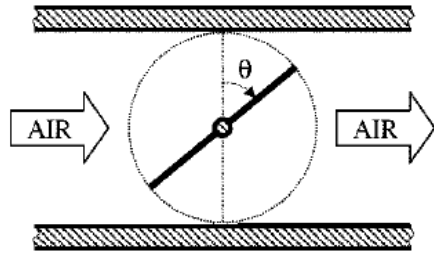
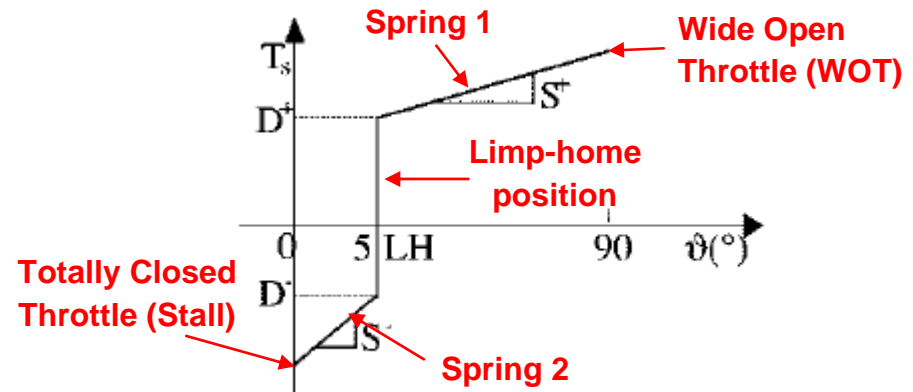
# Limp-Home Position

- **Prevents throttle from sticking in a closed position**
- **Achieved by two opposing springs**
- **Approximately 8° open provides 1500 RPM**
- **Vehicle acceleration  $\Rightarrow$  throttle opening increases  $>$  limp-home position**
- **Vehicle idling  $\Rightarrow$  throttle opening decreases  $<$  limp-home pos (~800 RPM)**
- **Limp-home position causes non-linearity in cruise control PID algorithm**
