The Rehabilitation of Steel Bridge Girders Using Advanced Composite Materials

Final Report for NCHRP-IDEA Project 51

Dennis R. Mertz, John W. Gillespie, Jr.,
Michael J. Chajes, and Scott A. Sabol,
University of Delaware

February 2002

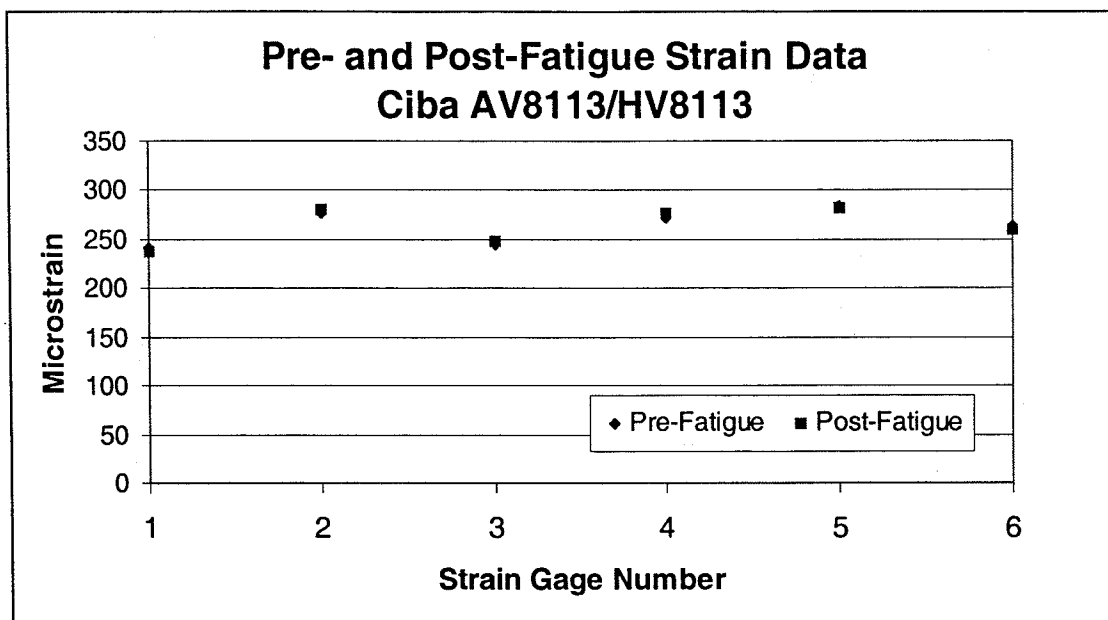
FIGURE 12 Pre- and post-fatigue strain data (Ciba-Geigy AV8113/HV8113).

continue to progressively detach or “unzip” during the fatigue testing. The beveled edges of the CFRP plates aided in reducing adhesive shear and peel stresses at the ends of the plate. Comparison of pre- and post-fatigue data indicates no sign of debonding of the CFRP plates in either adhesive test group. Figures 12 and 13 show representative strain data for the Ciba and Plexus test specimens.

Visual inspections along the edges of the CFRP plates showed no sign of bond failure or initiation of debonding. Similarly, tapping the CFRP plates with a hammer indicated no areas of plate detachment. Table 3 provides a summary of the test specimens including maximum% variation in strain data. Decreases in the recorded strain data are relatively small. It must be noted that the first Ciba specimen was released from the test machine grips and reattached during a

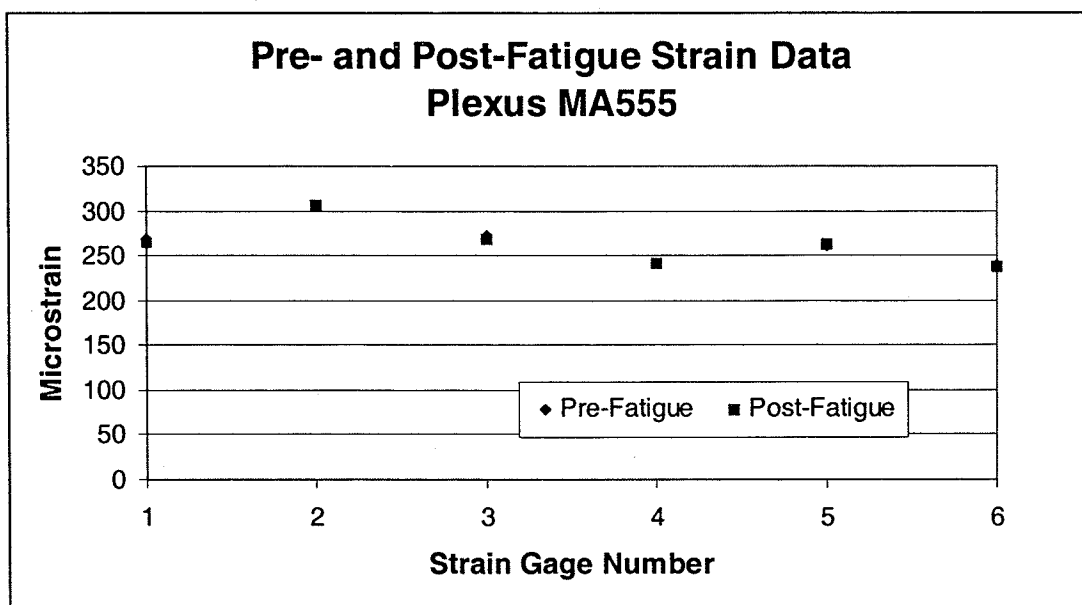
FIGURE 13 Pre- and post-fatigue strain data (Plexus MA555).

static test. The adjustment may have altered the initial boundary conditions and have contributed to the 8.4% variation in strain data. Other factors such as background noise and differences in the applied load during gage zeroing are also attributed to the observed variation in recorded strains.

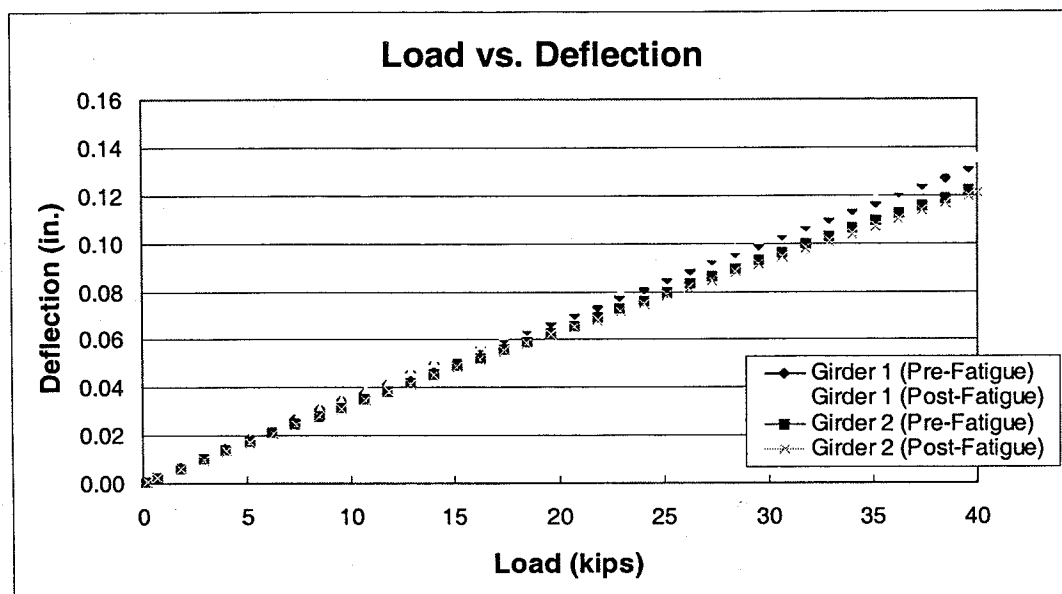
FIGURE 16 Pre- and post-fatigue load vs. deflection data.

Comparisons of strain and deflection data, recorded during static testing, were used to monitor bond durability. Stiffness changes, evident through strain changes and increased deflection, would indicate a significant detachment of the CFRP plates. Virtually no change in deflection or strain data was observed during the fatigue test (Figure 16).

CFRP plate inspections were used to detect localized areas of debonding not apparent from an observable change in girder stiffness. Visual inspections of the CFRP plates indicated no sign of CFRP plate debonding. Initial tapping inspections yielded no signs of pre-existing adhesive voids, confirming that the adhesive spread evenly and thoroughly during the CFRP plate installation. This is an important observation because the flange surface was severely pitted and irregular from corrosion. Subsequent inspections also yielded no sign of stress-induced delamination growth occurring during the fatigue test.
