Research on Bolt Failures in Wolf Creek Structural Plate Pipe

JOHN N. MACADAM, Research Engineer, Research Center, Armco Steel Corporation, Middletown, Ohio

An investigation of high strength bolts in $\frac{3}{8}$ -in. thick structural plate was undertaken following discovery of an 18 $\frac{1}{2}$ -ft diameter pipe failure at Wolf Creek, Montana, in July 1964. Fractured A 490 bolts were found to meet ASTM hardness and chemistry requirements. Static load seam strength tests on $\frac{3}{4}$ -in. diameter A 325 and A 490 bolts in $\frac{3}{8}$ -in. corrugated structural plate were made to determine effects of initial bolt torque, reduced temperatures, freezing water, and prying action from plate bending. No evidence of bolt or joint weakness was observed.

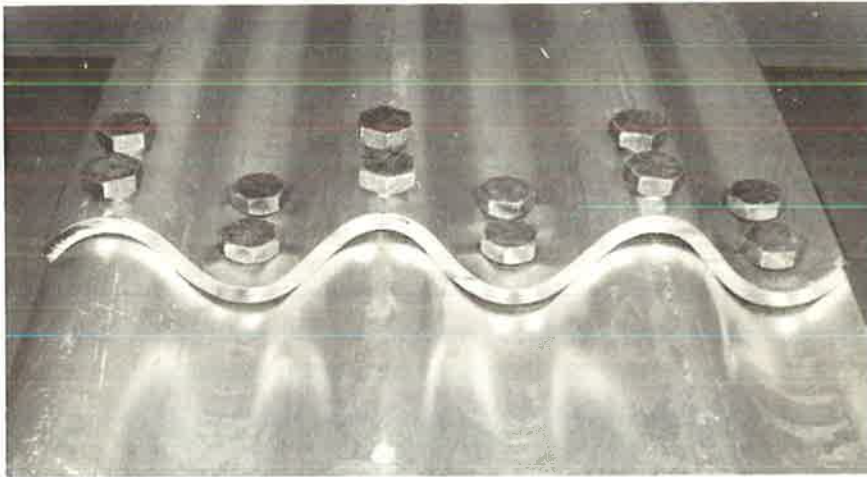
Figure 5. Fit between $\frac{3}{8}$ -in. plates with bolts torqued to 200 ft-lb.

When structural plate sections are connected by the single lap joint, the corrugations do not nest in intimate contact. Inherent gaps between plates at crests and valleys of the corrugations will depend on the plate thickness. The greater the thickness, the greater the gap distance. Figure 5 illustrates the gaps present in $\frac{3}{8}$ -in. thick plate

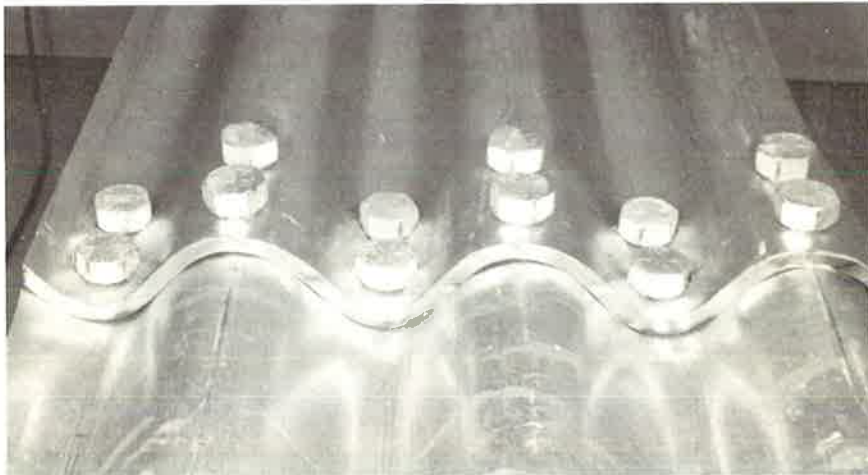
Figure 6. Fit between $\frac{3}{8}$ -in. plates with bolts torqued to 910 ft-lb.

with the bolts tightened to 200 ft-lb torque. A torque of approximately 800 ft-lb was required to essentially close the gaps in 6-in. wide joints. In a wide plate joint complete yielding of the cross section would be required to close the gaps. Figure 6 shows the fit between plates with A 490 bolts tightened to 910 ft-lb.

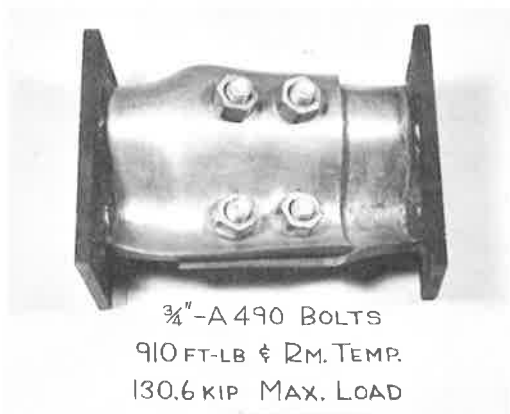
All A 490 bolted joint compression specimens failed by plastic buckling and yielding of the plate material away from the bolted lap (Fig. 9). In some tests at reduced temperatures the "Multi-Plate" material cracked under high local stresses between the bolt holes (Fig. 10). A 325 bolted specimens failed in either of two modes—plate failure (Fig. 10) or bolt shear (Fig. 11).

Figure 9. Typical plate failure.

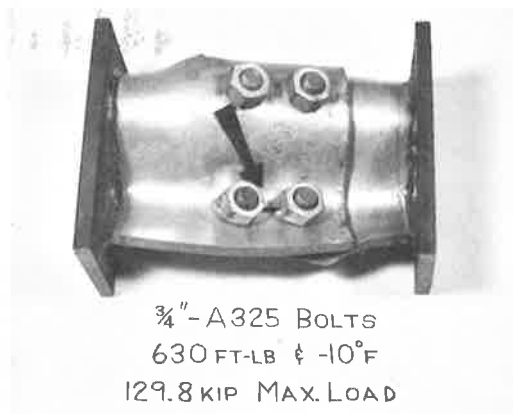
Figure 10. Typical plate failure with crack in plate between bolt holes in lower row.

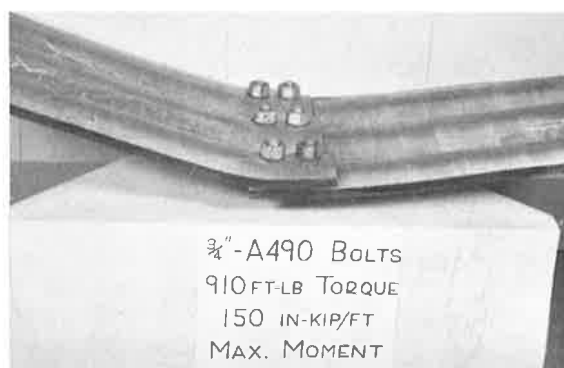
Ultimate loads were governed by plastic bending of the structural plate along a cross section at a row of bolts without any bolt tensile failures. The bending strength or rigidity of the $\frac{3}{8}$ -in. plate was lower than that required to cause prying forces equal to the tensile strength of the bolts. A typical beam test specimen after testing is shown in Figure 13.

Figure 13. Typical beam test specimen after testing showing plastic bending failure of plate material.

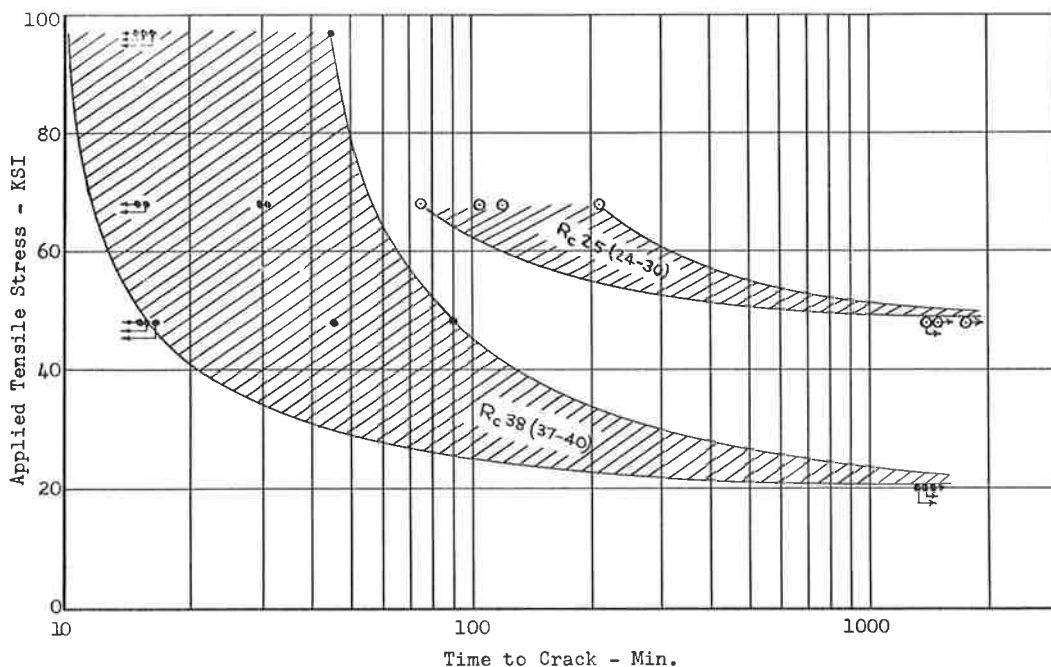
Time-to-fracture or first crack is used as a measure of hydrogen embrittlement susceptibility. Figure 18 shows time to crack and applied stress for both hardness levels. These data are in reasonable agreement with other investigations (5).

The threshold stress for R_C 38 bolts was found to be approximately 20,000 psi, while the value for R_C 25 bolts was approximately 48,000 psi. Actual cathodic charging

Figure 18. Hydrogen-stress cracking experiments.

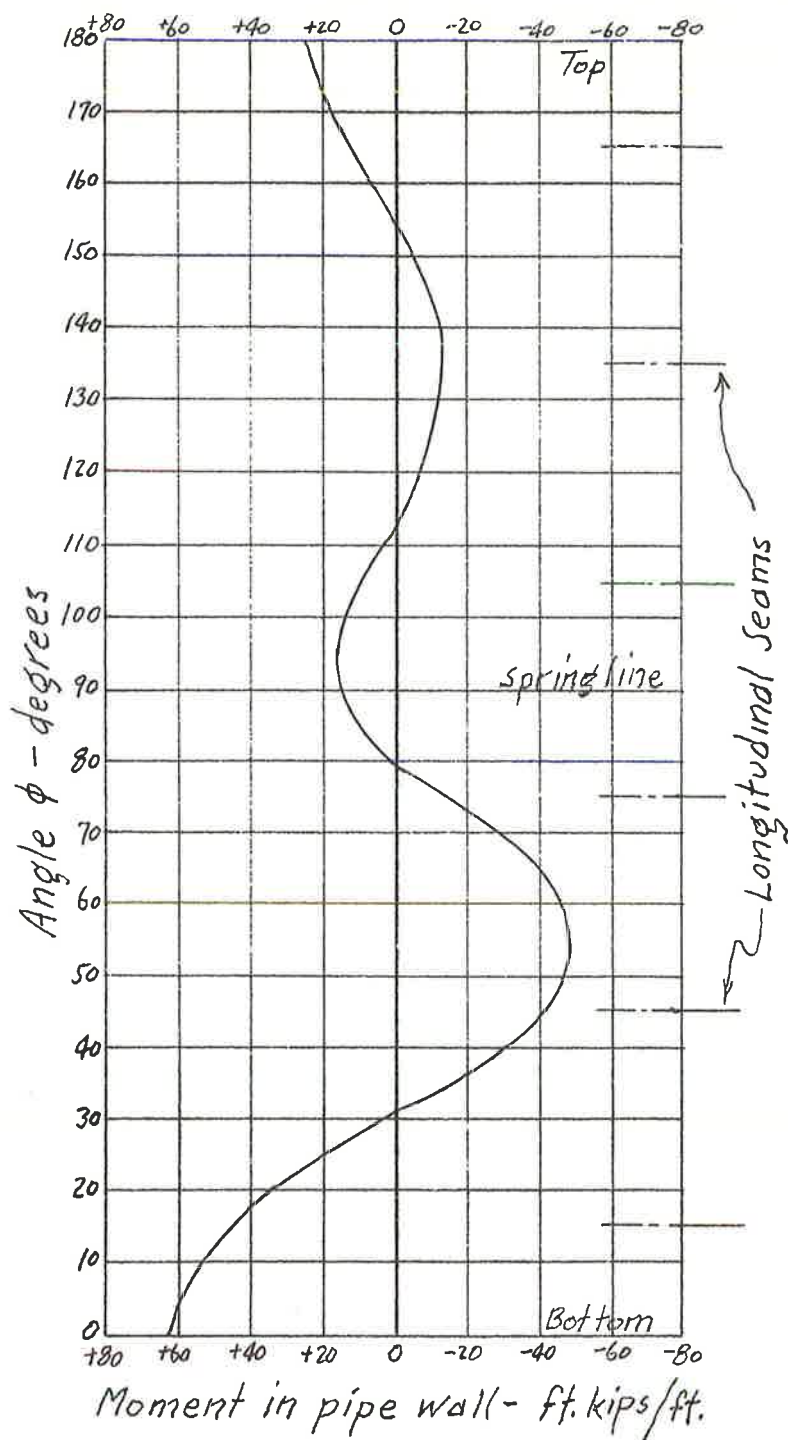
Evaluation and combination of these equations yield the moment diagram shown in Figure 2, and the tangential thrust diagram of Figure 3. The maximum moment in the pipe wall is 63 ft-kips per foot at the bottom. The moment at the longitudinal seam near the lower quarter point ($\phi = 45^\circ$) is approximately 40 ft-kips. A section through the seam is shown in Figure 4. Since the seam must transmit moment from one plate to another, we may determine the tension in the bolts by writing moments about the point of rotation of the seam and setting this equation equal to the moment in the wall.

Figure 2. Moment diagram—Wolf Creek culvert.

An important result of this analysis is the demonstration that the maximum stressed longitudinal seams are located in the quadrants below the springline (Figs. 2, 3). This is the region of extensive bolt failures as shown in Figure 2 of the Macadam paper.

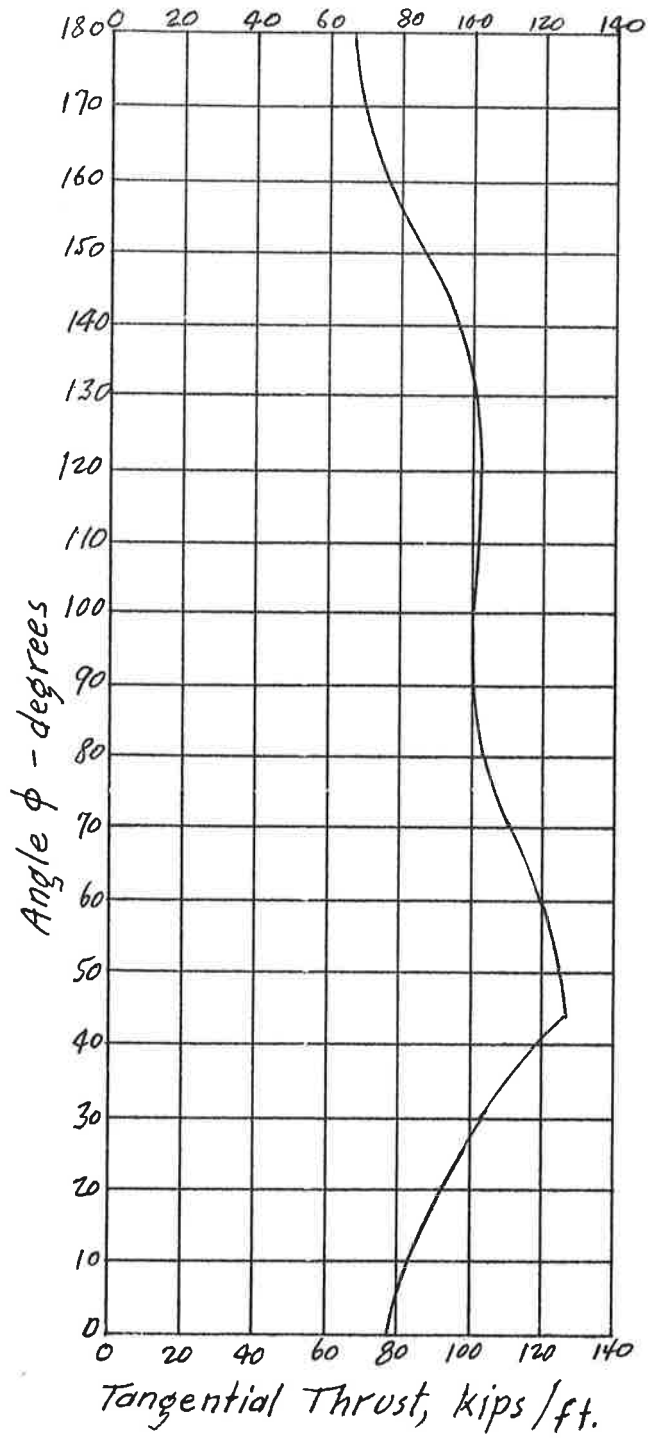
Figure 3. Thrust diagram—Wolf Creek culvert.

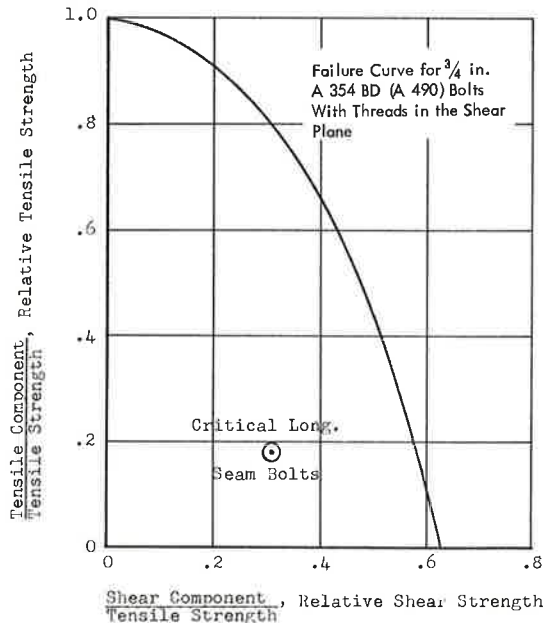
The combination of 9,200 lb maximum possible direct tension and Spangler's value of 15,600-lb shear can be compared to the results obtained by Chesson et al. (5). Figure 2 shows the combined load state for the structural plate bolts as related to an interaction curve from tests on $\frac{3}{4}$ -in. A 354 BD (A 490) bolts with threads in the shear plane. A factor of safety against failure of approximately 1.7 exists.

Figure 2. Comparison of critical longitudinal seam bolts and interaction failure curve from Illionis tests (Fig. 4 of Ref. 5).
