# NCHRP Report 417

## Highway Infrastructure Damage Caused by the 1993 Upper Mississippi River Basin Flooding

6. AUTHOR(S): A.C. Parola et al.		PB99-124240	
7. PERFORMING ORGANIZATION NAME(S) AND ADDRESS(ES) The University of Louisville Research Foundation Louisville, Kentucky		8. PERFORMING ORGANIZATION REPORT NUMBER HR 12-39

The University of Louisville Research Foundation  
Louisville, Kentucky

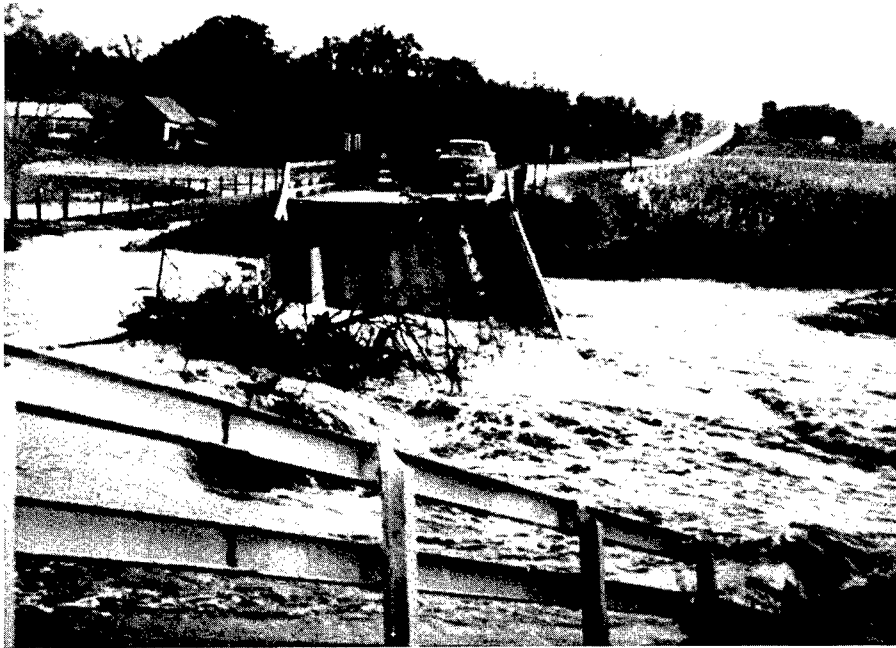
***Florida Creek Bridge Failure Site near Skidmore, Missouri.*** Debris transported by flood flows accumulated on pile bents and caused adverse effects to both bridge and local stream stability at the Skidmore bridge failure site. Figure 3.1 shows the watershed that contributes flow to the site. Figure 3.2 and 3.3 show the collapsed bridge spans. Debris accumulated on the upstream side of the bridge and blocked flow under the bridge. Flow blockage generated forces on the debris sufficient to cause rotation and to rupture the timber pile piers at the streambed. Figure 3.4 shows the bridge location prior to collapse and the debris accumulation as found in its post-collapse position. A large portion of the debris accumulation was compressed between the third span of the superstructure and the streambed. The superstructure and debris were translated downstream as shown in Figure 3.3.

Figure 3.2. Missouri Highway 113 bridge over Florida Creek, near Skidmore, Missouri, hours after collapse (courtesy of Missouri Highway and Transportation Department).

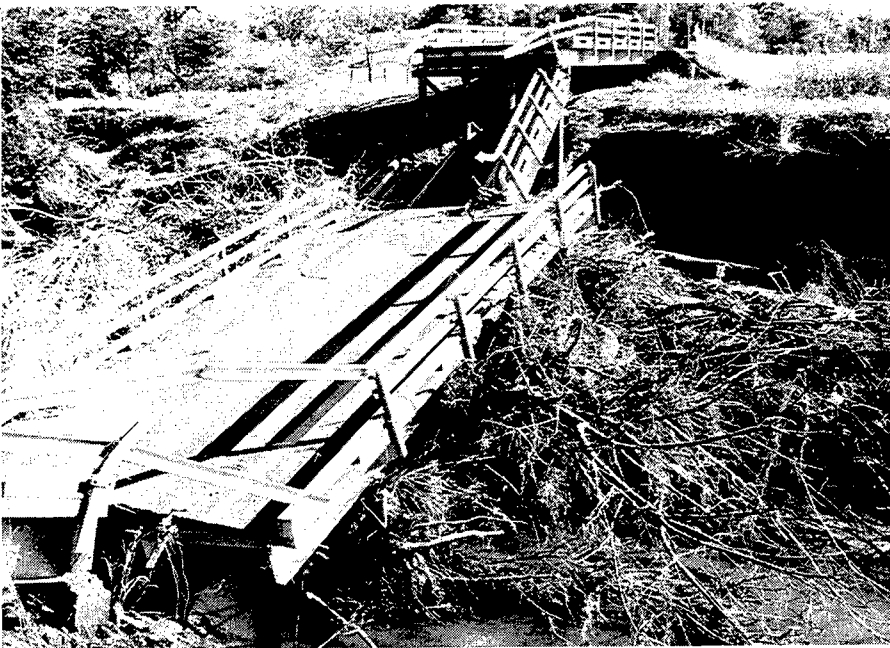
Figure 3.3. View, looking south, of Missouri Highway 113 bridge over Florida Creek, near Skidmore, Missouri.

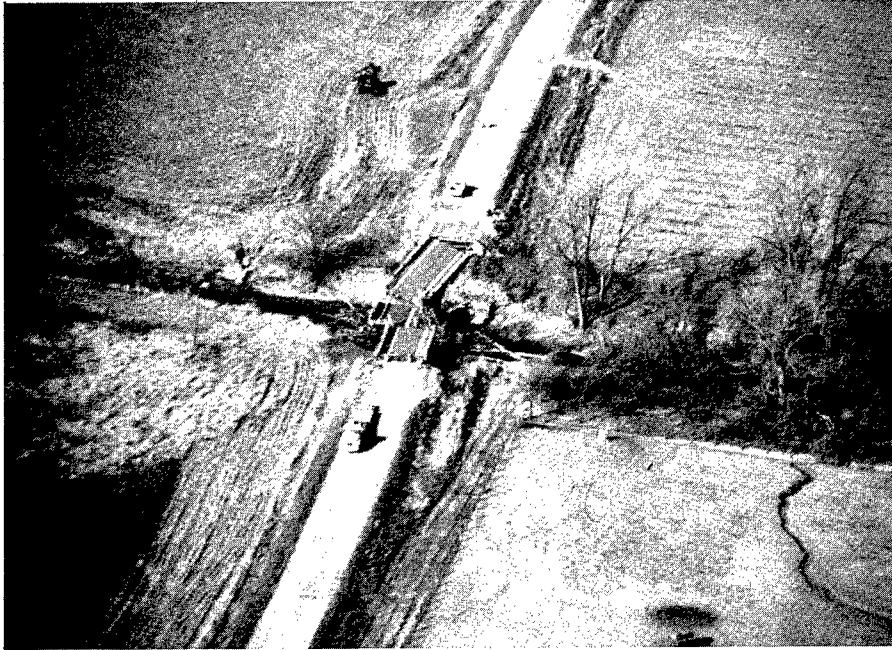
The straight incised reach downstream of the bridge indicated possible channelization. Additionally, channelization or possible bank failures associated with stream widening was indicated by the bank conditions and lack of trees on the downstream banks (Figure 3.5). Trees were thriving on the banks of the upstream channel reach except within 50 m of the bridge. These conditions indicate that channel widening induced by channelization may have progressed upstream slightly

Figure 3.5. Aerial view, looking north, of Missouri Highway 113 bridge over Florida Creek, near Skidmore, Missouri.

The debris accumulation at this site was composed of trees with bark and root masses still attached (Figure 3.6) indicating that those trees were thriving prior to the flooding that dislodged and transported them to the bridge. Elements of debris that supported the accumulation prior to collapse were located beneath the collapsed structure; therefore, no measurements of their geometric characteristics could be obtained. Trees with root masses and limbs intact, with approximately 15-20 m lengths exceeding the 11.4 m bridge spans, were present in the channel immediately upstream of the bridge. The source of the trees most probably was bank erosion upstream of the bridge, as shown in Figure 3.5.

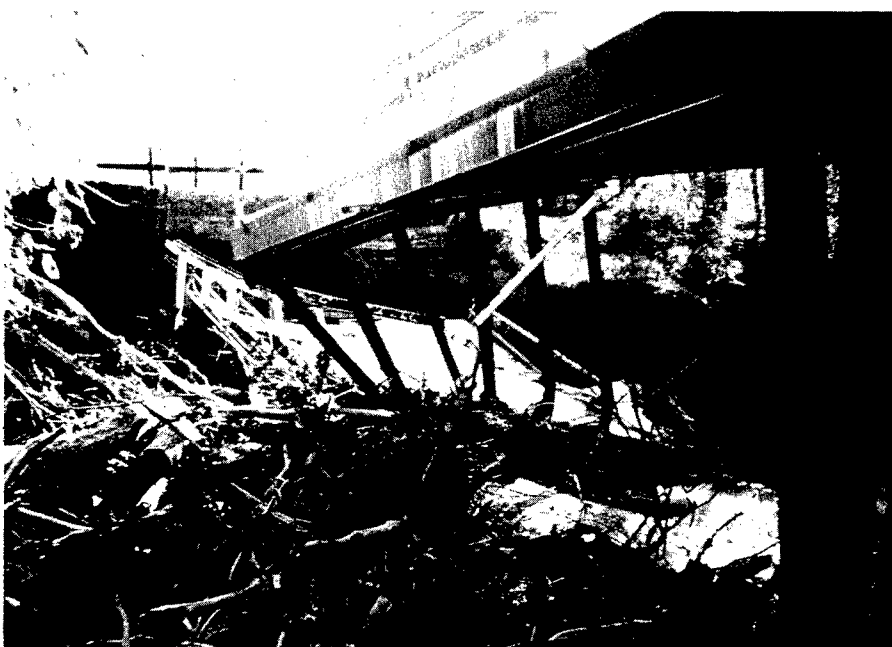
***Halfbreed Creek Bridge Failure Site near Falls City, Nebraska.*** Debris contributed to the collapse of the county bridge over Halfbreed Creek near Falls City, in Richardson County, Nebraska. Figure 3.7 shows the watershed that contributed flow and debris to the bridge site. Halfbreed Creek is an incised tributary of the heavily channelized Muddy Creek. Debris accumulated on two steel pile bents that supported the girder superstructure. Figures 3.8 and 3.9 show the collapsed span and the pile bent consisting of six steel H-piles with the exterior piles battered. The hydrodynamic force developed on the accumulated debris was sufficient to cause the upstream pile of the main channel bent to buckle. The location of the debris accumulation at the time of inspection and the location of the bridge prior to collapse are shown in Figure 3.10.

Figure 3.9. View of county bridge near Falls City, Richardson County, Nebraska.

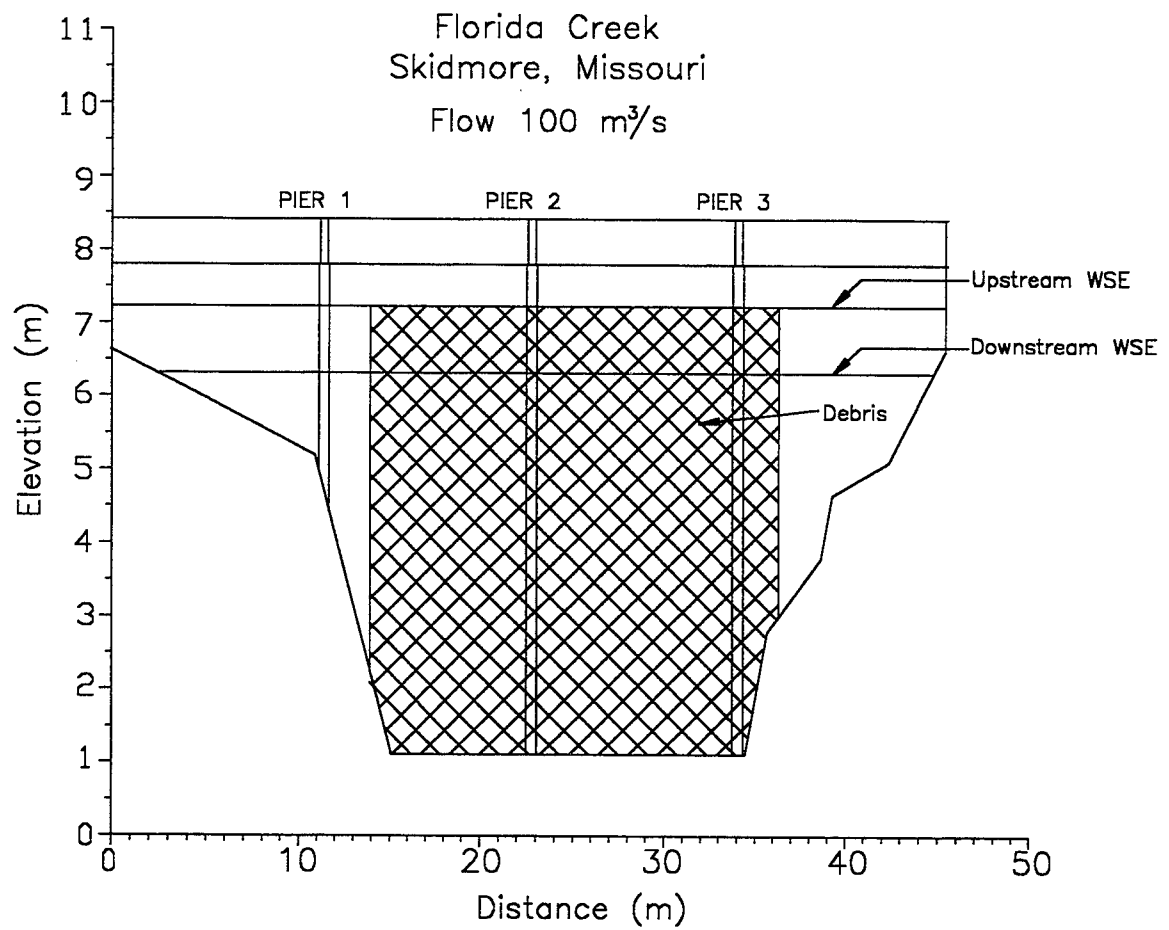
The forces on the debris accumulations were estimated using the water surface profile estimates from the likely range of flow conditions and two blockage widths. Figures 3.11 and 3.12 show the debris accumulations as modeled in the hydraulic analysis with upstream (approach flow) water surface elevations and downstream water surface elevations for selected flow conditions. The debris accumulations were divided into vertical segments as shown in Table B.1 to determine the hydrodynamic force distribution. The horizontal component of hydrodynamic force on each debris segment caused by the variation in hydrostatic pressure between the bridge approach section and the downstream sections was computed over two areas: 1) the projected area above the downstream water surface of the wetted debris parallel to the upstream face of the piers over which the debris spanned, and 2) the projected area below the downstream water surface of the wetted debris parallel to the upstream face of the piers over which the debris spanned. The hydrostatic component of force on the upstream projected area above the downstream water surface was computed as

Figure 3.11. Computed water surface elevations with debris accumulation, Missouri Highway 113 bridge over Florida Creek, near Skidmore, Missouri.

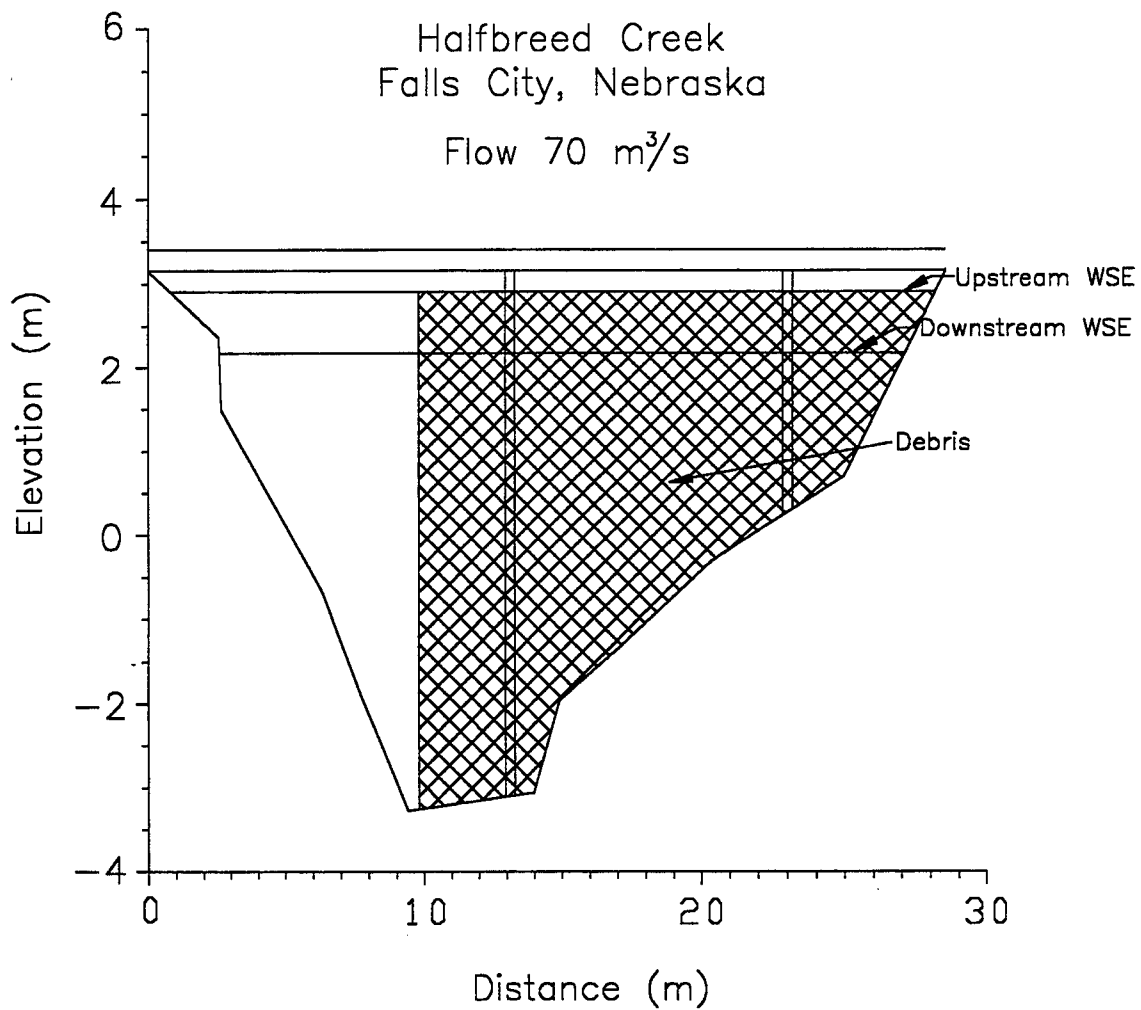
Figure 3.12. Computed water surface elevations with debris accumulation, county bridge over Halfbreed Creek, near Falls City, Richardson County, Nebraska.

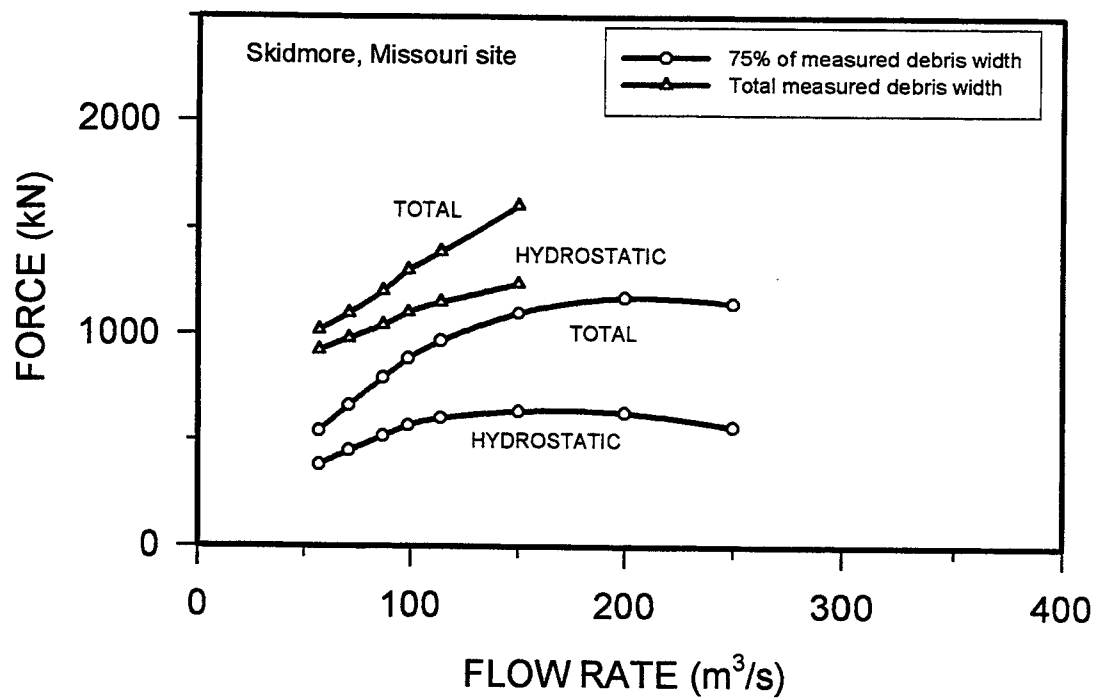
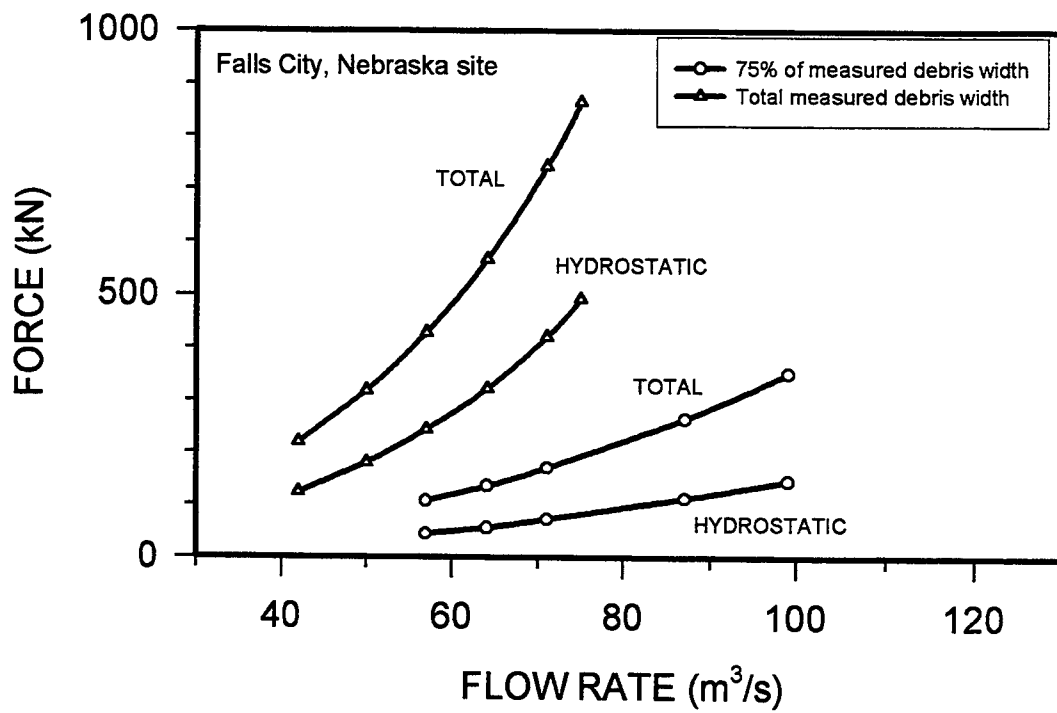
Figure 3.13 shows the range of possible flow conditions, total forces and hydrostatic component of forces on each debris accumulation at both bridge sites. The upper bound lines show the total force. The lower bound lines were developed assuming only a hydrostatic pressure variation. The portion of the computed force attributed to water surface gradients (hydrostatic pressure variation) ranged from 49 to 91 percent at the Skidmore site and from 38 to 39 percent at the Falls City site. The blockage of waterway opening through the bridges ranged from 55 to 82 percent at the Skidmore site and from 48 to 66 percent at the Falls City site.

Figure 3.13. Total and hydrostatic debris force variation with flowrate for Skidmore, Missouri and Falls City, Nebraska sites.

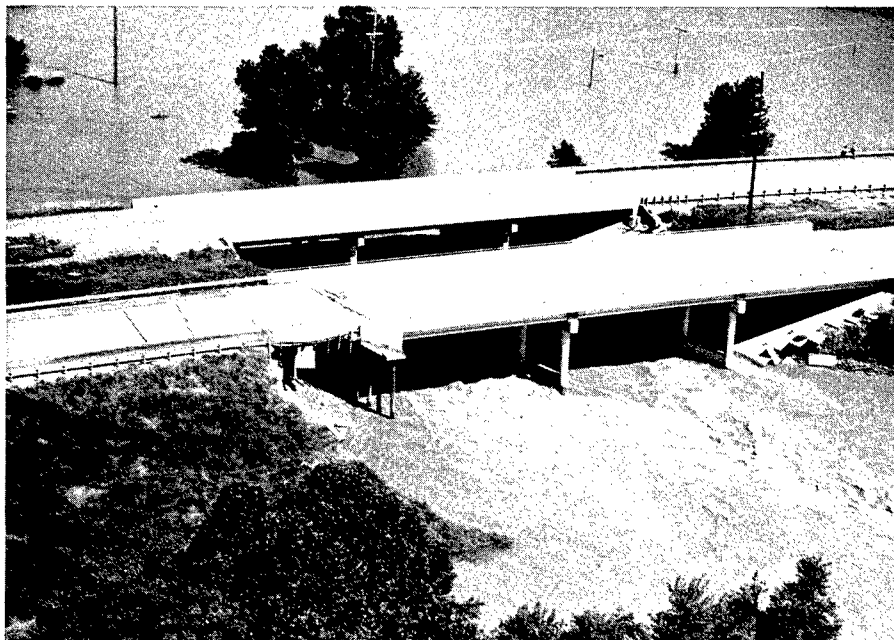
approximately two horizontal to one vertical experienced failure of the downstream portions of the spill slopes and slope protection on those slopes, as shown in Figures 3.14a, 3.14b, 3.14c, and 3.14d. The bridge for U.S. Highway 54 over the KD Trail functioned as a relief bridge for the U.S. Highway 54 embankment that traverses 1.4 km of the Missouri River floodplain. The non-uniform contraction through the bridge opening caused erosion of the ground surface around the KD Trail on the downstream sides of the spill-through slopes. The embankment collapsed into the scour hole by slope failures. The approach flow conditions may have contributed to the lack of scour on the upstream side of the bridge opening; the approach flow velocities were likely to be very low compared to the velocity through the bridge opening. This failure is evidence that the depth and entire pattern of scour is changed by the shape of the embankment and the approach flow conditions. Bridges located on wide floodplains in which the upstream and downstream reaches are essentially shallow lakes may exhibit scour features downstream from the bridges, as shown in Figures 3.14b and 3.14d. At the site shown in Figures 3.14b and 3.14c, the pavement on the side slopes of the spill-through abutment and the roadway pavement through the bridge opening also affected the scour pattern.

Figure 3.14b. Aerial view, looking north, of high-velocity flow at U.S. Highway 54 and KD Trail after southwest embankment erosion, at Jefferson City, Missouri (courtesy of Missouri Highway and Transportation Department).

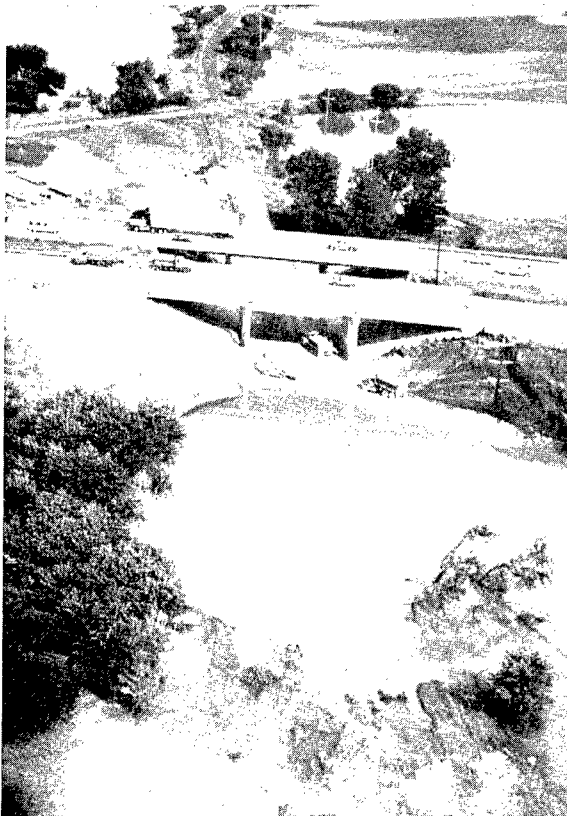
Figure 3.14d. Aerial view, looking northwest, of scour hole and southwest embankment restoration at U.S. Highway 54 and KD Trail, at Jefferson City, Missouri (courtesy of Missouri Highway and Transportation Department).

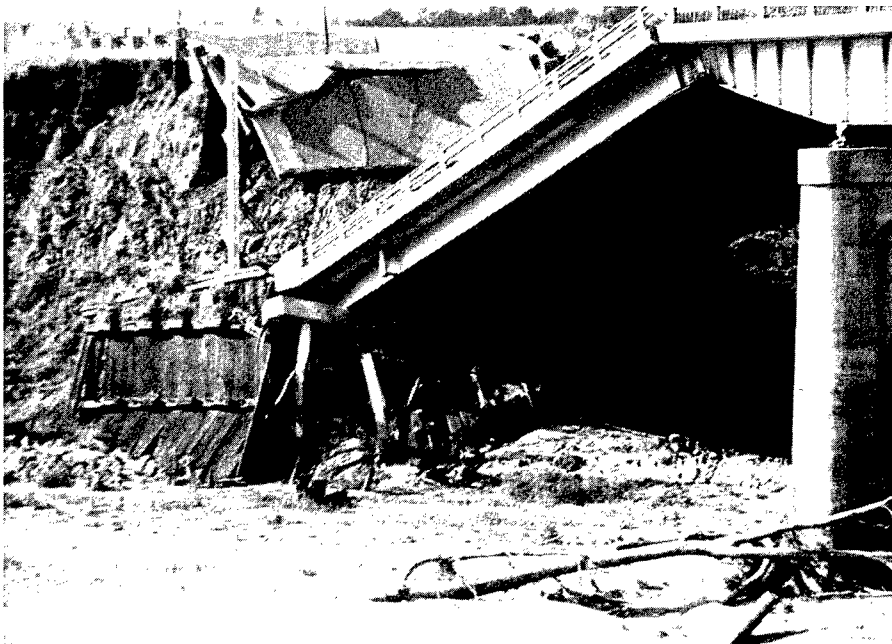
The collapse of the Nebraska Highway 8 bridge over the South Fork of the Big Nemaha River is illustrative of several types of instability problems that occurred widely throughout the affected watersheds. The collapse of the west span of the bridge, shown in Figure 3.16, was caused by lateral bank migration toward the west abutment. The cause of this lateral migration, however, is not immediately obvious from the photograph. Lateral migration and channel widening was caused by

Figure 3.16. Collapsed span of Nebraska Highway 8 bridge over the south fork of the Big Nemaha River (flow was from left to right in figure).

The foundation piles of the collapsed west bridge abutment shown in Figure 3.16 had been exposed by erosion during the first part of the flood event in 1993 and were covered at the time the site was photographed by a recent alluvial deposit that had formed after the meander cutoff. The Damage Assessment Form completed by Nebraska Department of Transportation personnel states that the east abutment then was in danger of damage because of lateral bank migration. The bank line changes at the site, shown in Figure 3.19, occurred over a relatively short time period. Bank failures along large portions of the South Fork of the Big Nemaha River indicated that the river stream system was unstable. The South Fork of the Big Nemaha River was undergoing channel widening caused by channelization for agricultural purposes. Rapid meander migration and meander cutoffs are typical of streams undergoing channel widening.

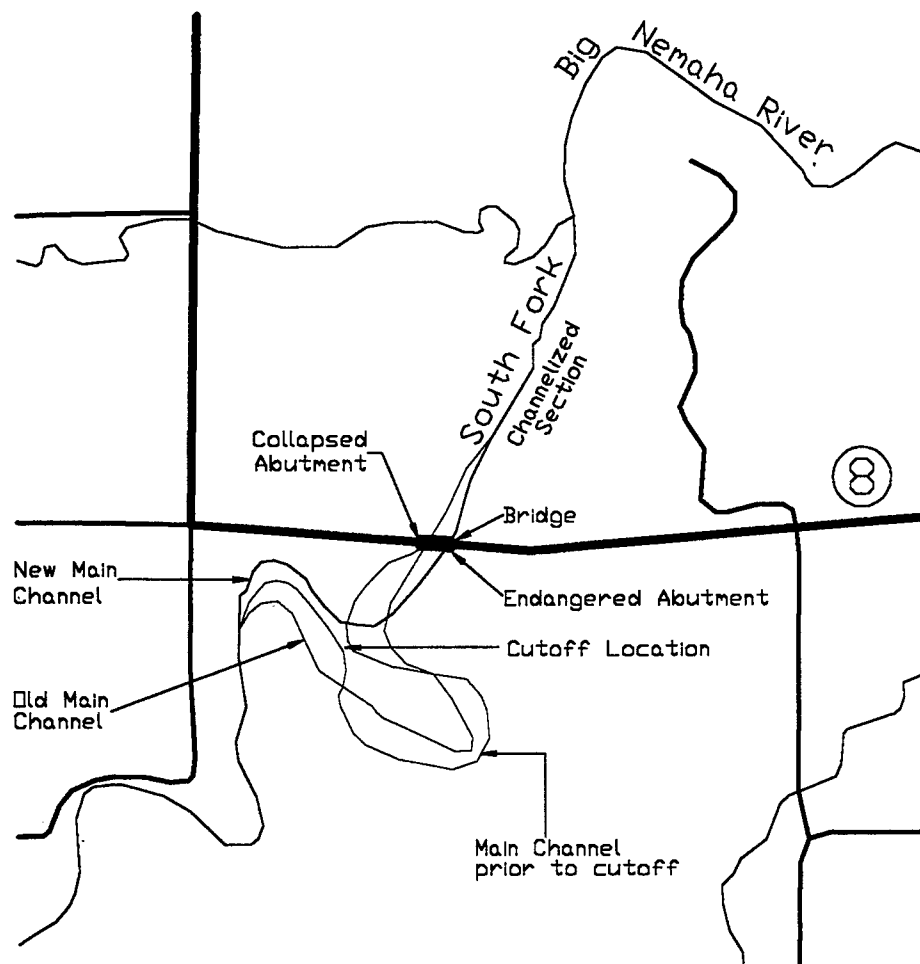
stream instability induced by channelization of reaches upstream and downstream of the Highway 8 bridge (10). Figure 3.17 is a plan view of the section of the river showing the change in planform of the main channel.

Figure 3.17. Changes in main channel, South Fork of the Big Nemaha River south of Nebraska Highway 8, Pawnee County, Nebraska.

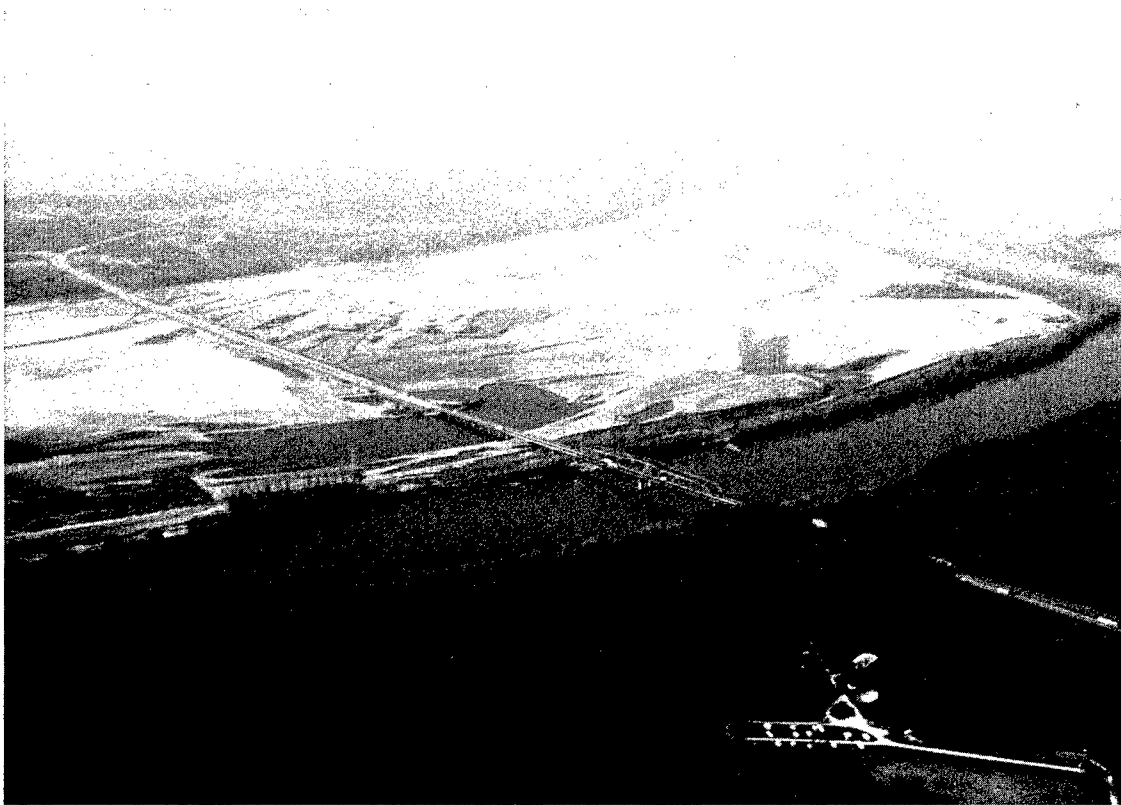
elevation 178.3 m along the river and on the floodplain were breached by flow that overtopped the levees by approximately 2.7 m. A guidebank extended upstream from the west abutment. The resulting scour hole is shown in Figure 3.22. The maximum depth within the scour hole measured in December 1993 (two months after the recession of the flood) was approximately 17 m below the surrounding floodplain elevation of 180 m. The maximum extent of the scour hole perpendicular to the bridge was approximately 430 m. Nine piers of the bridge approach were located within the scour hole. An agricultural access roadway followed the guide bank and the terminus of the levee. A section of the guidebank and a large portion of the levee were breached and eroded as shown in Figure 3.23. A second levee that extended along the main bank of the river also was breached in several locations in the vicinity of the I-70 bridge. Levee breaches complicated the interaction between the flow in the main channel and the flow on the floodplain upstream of the bridge. Although the floodplain upstream of the bridge was relatively flat, the roadways and agricultural levees constrained the flow. In addition, dikes within the main channel made the flow situation extremely complex. Examination of the terrain at the bridge site, shown in Figure 3.23, indicated a natural levee along the edge of the floodplain.

Figure 3.23. View, looking northwest, of the Missouri River floodplain at Interstate 70 crossing, near Rocheport, Missouri.

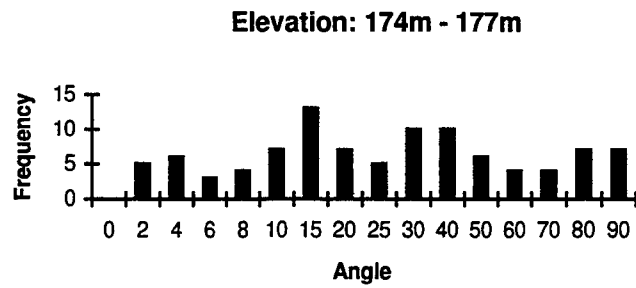
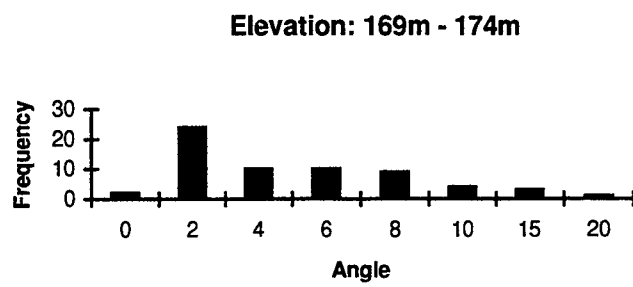
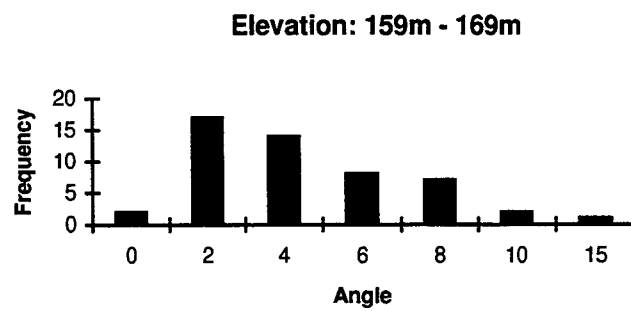
The cross-section data from the fathometer measurements were used to generate side slope angles for the scour hole at the Interstate 70 bridge. Histograms are shown in Figure 3.25 for the scour hole slope angles, for three different ranges of elevation. The first histogram (a) represents the distribution of the angles of the slopes between elevation 174 m and elevation 177 m in unsaturated sandy silts and silty fine sands. The maximum observed slope in the unsaturated silts was nearly vertical. The side slopes in the same type of soils below elevation 174 m are shown in the second histogram (b). The maximum slope angle in the saturated interbedded silts and silty sands was typical of the angles of shearing resistance for saturated medium sands and non-plastic silts. The slope angles in the fine sand layer below elevation 158 m are shown in the third histogram (c). The maximum slope angle in the saturated fine sands was typical of the angle of shearing resistance for loose sands. The maximum observed slope angle in the saturated soils was approximately 22 degrees, but much of the slope area below the water surface in the hole was covered with failed and dislodged soils resting on very shallow slopes typical of soil-flow failures in fine sands. The side slope angles in the deepest part of the scour hole near the upstream end of the guide bank were approximately 22 degrees, and those slopes extended to the base of the scour hole, indicating that the scour hole had not filled at its deepest point with slope failure material.

Figure 3.25. Side slope angles in scour hole at Interstate 70, near Rocheport, Missouri.

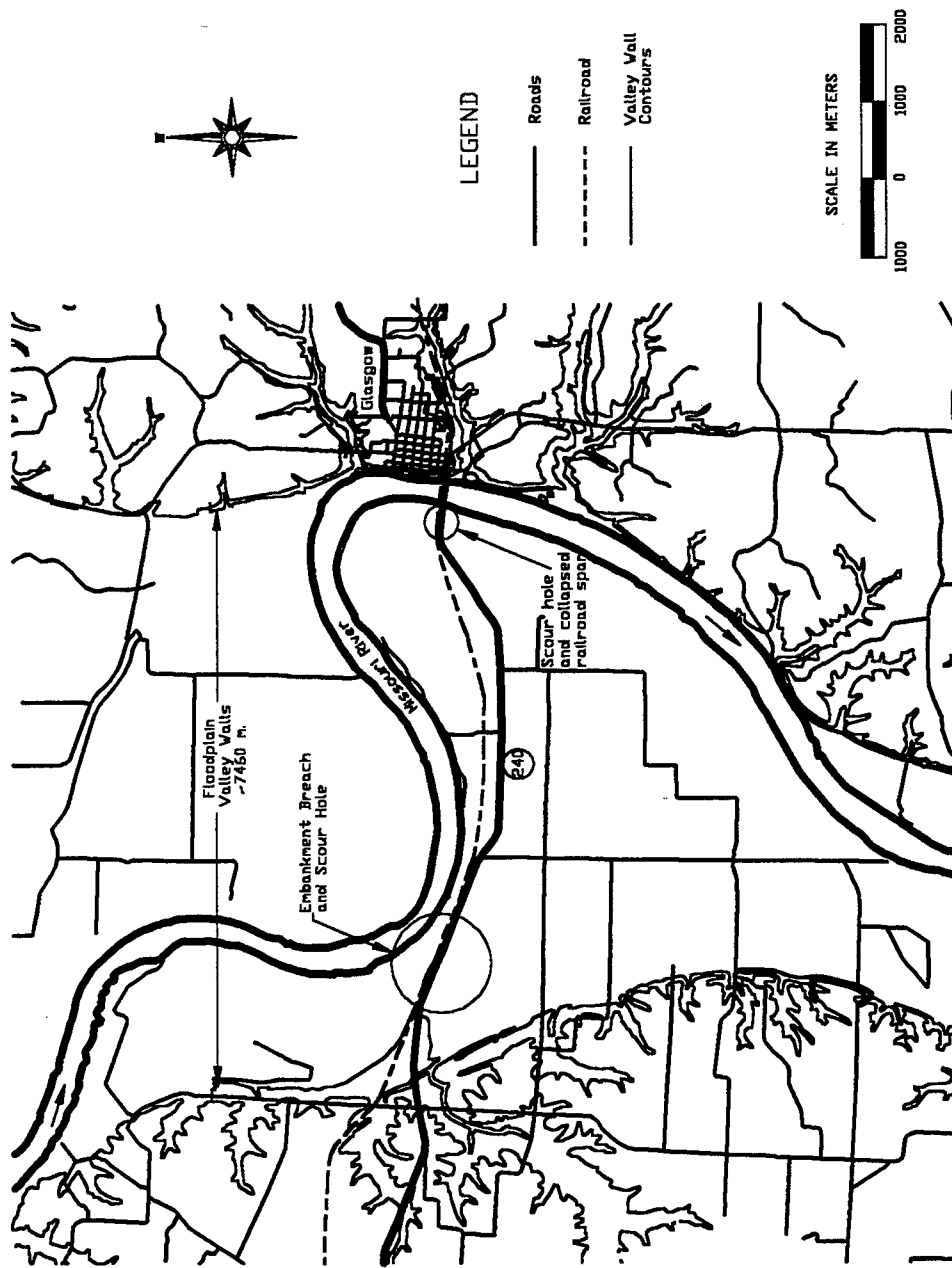
The scour hole that formed at Glasgow, Missouri occurred at the connections of a levee to the upstream and downstream sides of parallel railroad and highway embankments. The railroad embankment was located upstream of the highway embankment. As can be seen from Figure 3.26, the 674 m-long railroad bridge spanned 250 m of floodplain and 420 m of main channel. The embankment blocked approximately 6.9 km of the floodway that is 7.7 km wide. A portion of the railway embankment and part of the highway embankment failed at the location shown in Figure 3.26. The agricultural levee located along the south side of the main channel had breached in several locations. High water marks upstream of the confluence of the Calton River and the Missouri River (192.2 m), and downstream of the Missouri Highway 240 embankment (190.6 m) indicated that the difference in water surface elevation from upstream of the embankment to downstream of the embankment was on the order of 1.6 m. Floodplain elevations in this region ranged from 186.0 m to 187.5 m. The top elevation of the levees that terminated at the railroad embankment and highway embankment was approximately 189 m. The levees were overtopped by 1.5 m to 3.0 m of water on the upstream side of the railroad bridge.

Figure 3.26. Locations of large scour holes on the Missouri River floodplain, at Missouri Highway 240, near Glasgow, Missouri.

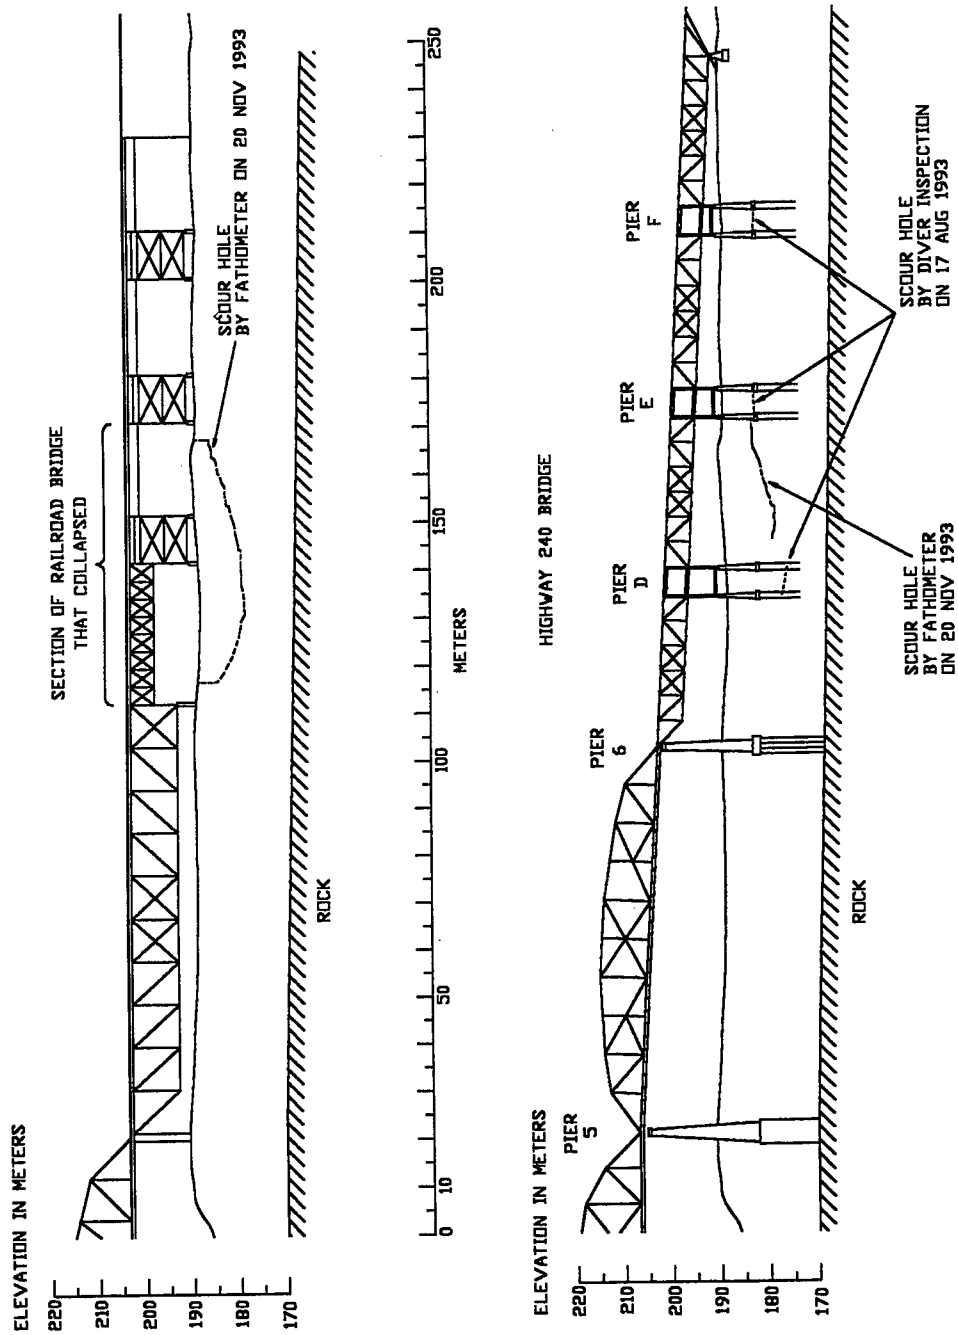
Figure 3.30. Downstream view of west floodplain section at railroad bridge and Missouri Highway 240 bridge, with sections of scour holes, near Glasgow, Missouri (bridge design courtesy of Missouri Highway and Transportation Department).

The dominant mechanism of failure was scour by water transporting little bedload sediment to the edge of the constriction in flow over the floodplain. The sides of the scour holes contained cavities when the holes were inspected after the floods receded. The cavities appeared to have been caused by groundwater seeping into the scour holes. The seeping water originated as temporary storage into the floodplain during inundation. The water levels in the holes were still considerably above the level of the Missouri River even in November, but well below the original floodplain elevation. Outflow seepage effects were minor compared to the scour during the flood, but the outflow seepage caused delayed failures in the scour hole sides. The exposed surfaces of the scour holes could not be considered necessarily representative of the shapes of the scour holes during the flooding.

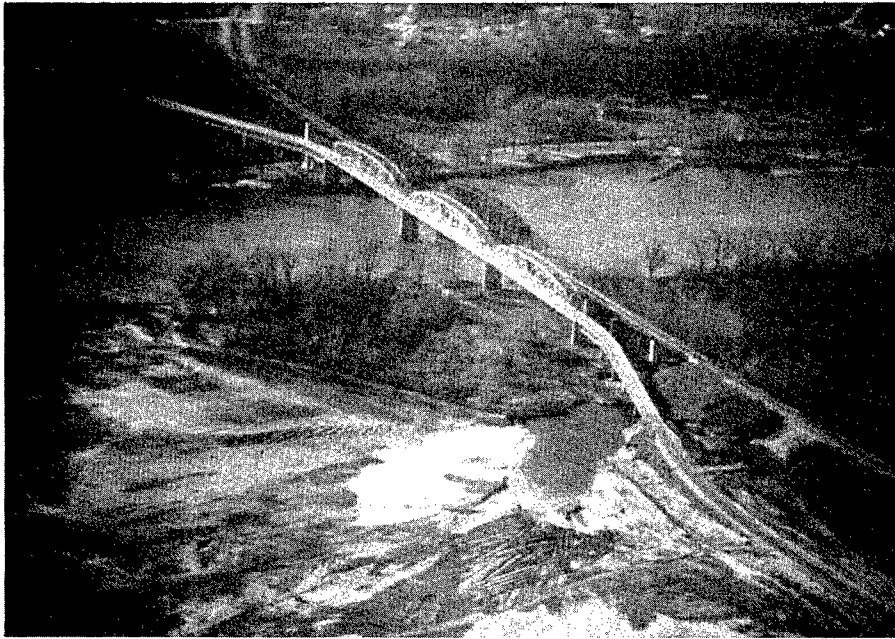
Figure 3.33. Aerial view, looking northwest, of U.S. Highway 159 bridge embankment on Missouri River floodplain, near Rulo, Nebraska. (Flow from right to left).

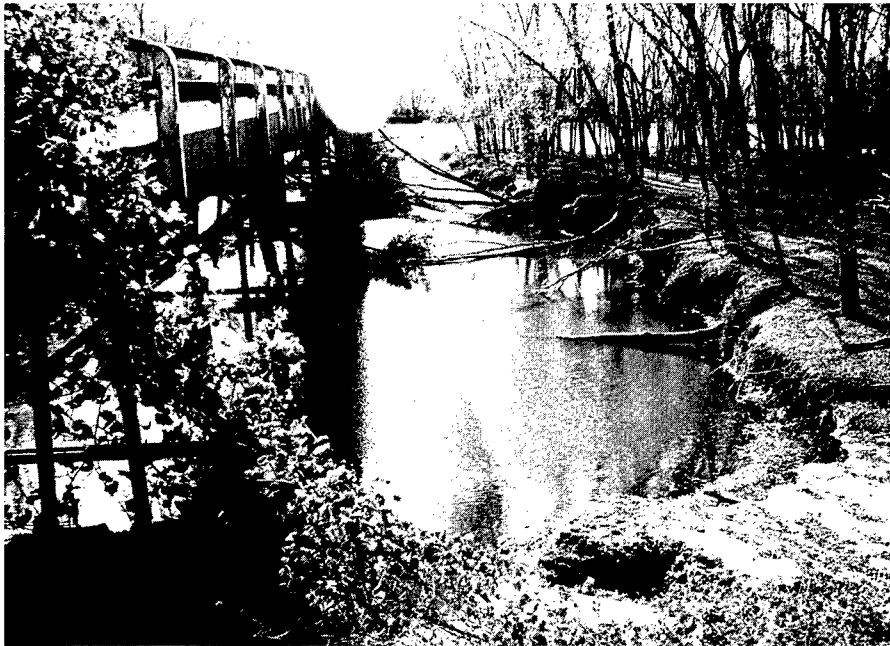
Figure 3.37. View, from east abutment of county road bridge, toward the Des Moines River, upstream vegetation and root systems affected scour pattern.

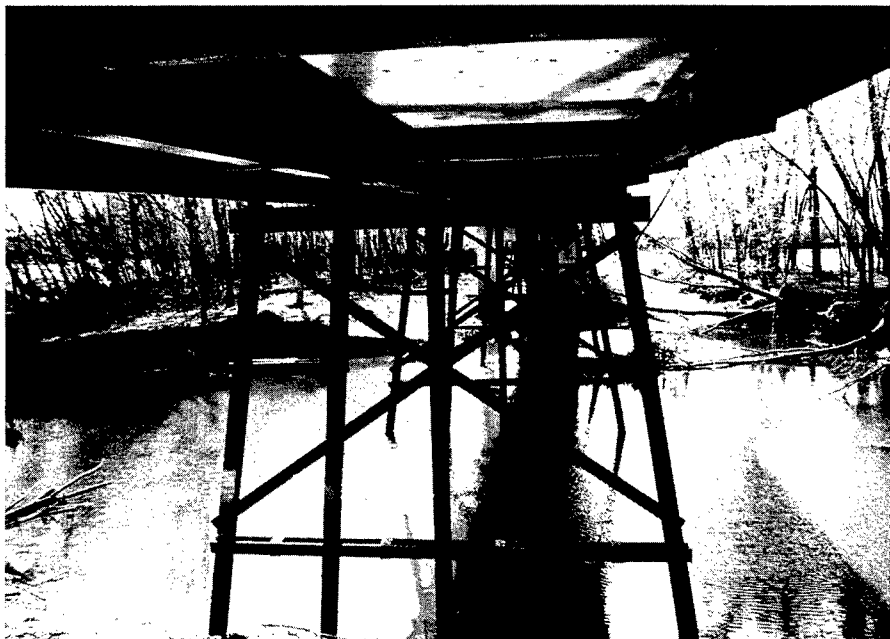
Figure 3.38. View, looking southwest, from east abutment toward the Des Moines River, and Chillicothe, Iowa.

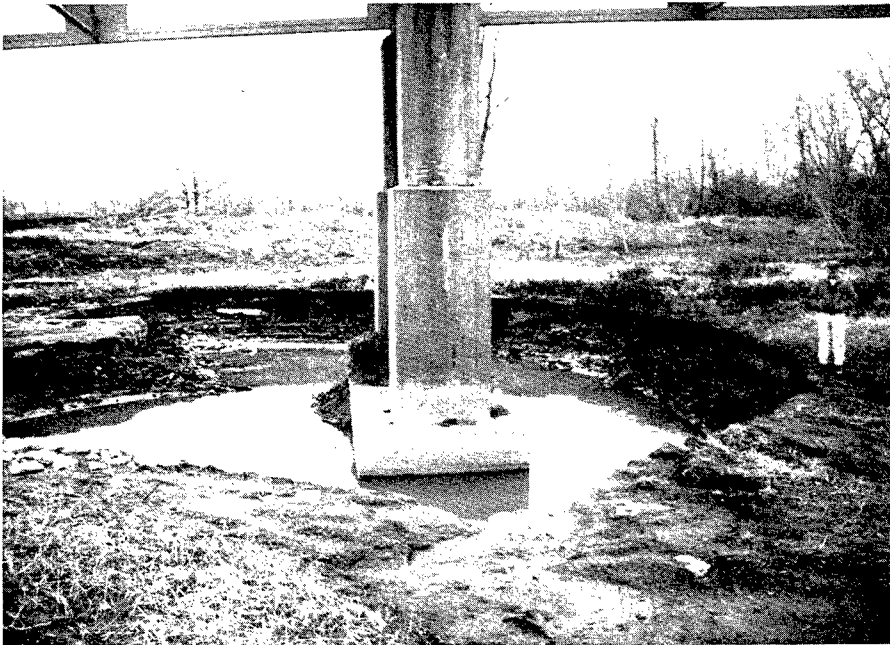
Figure 3.44. U.S. Highway 159 bridge pier located downstream of pier shown in Figure 3.45.

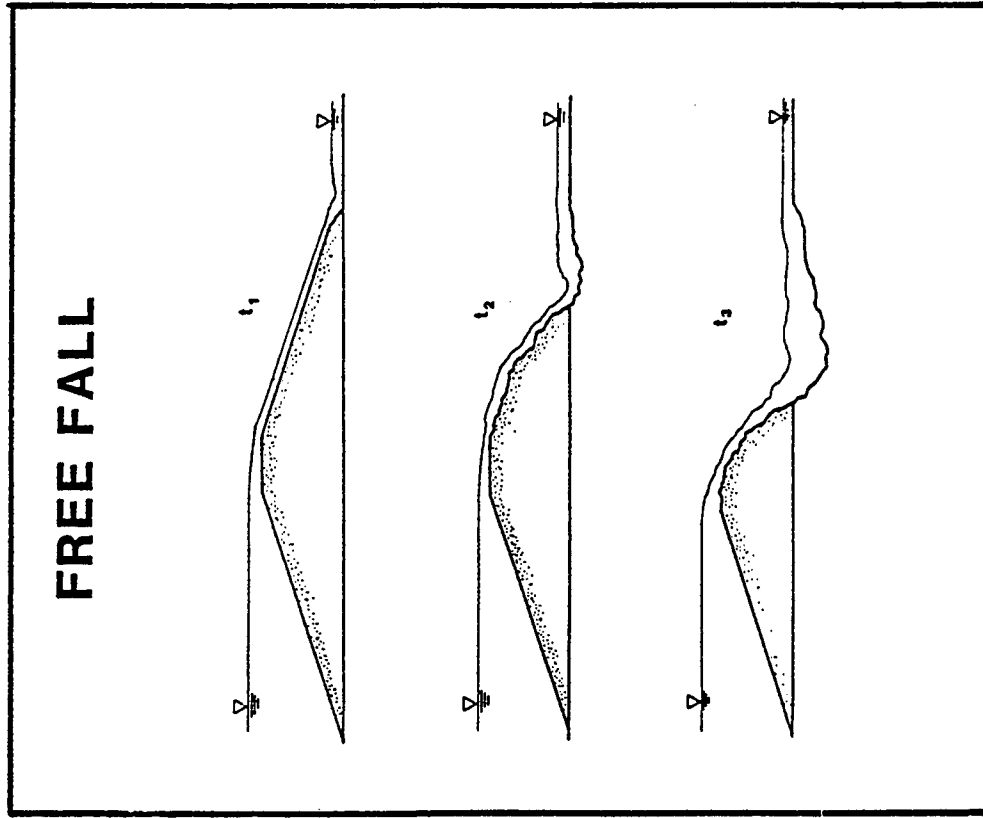
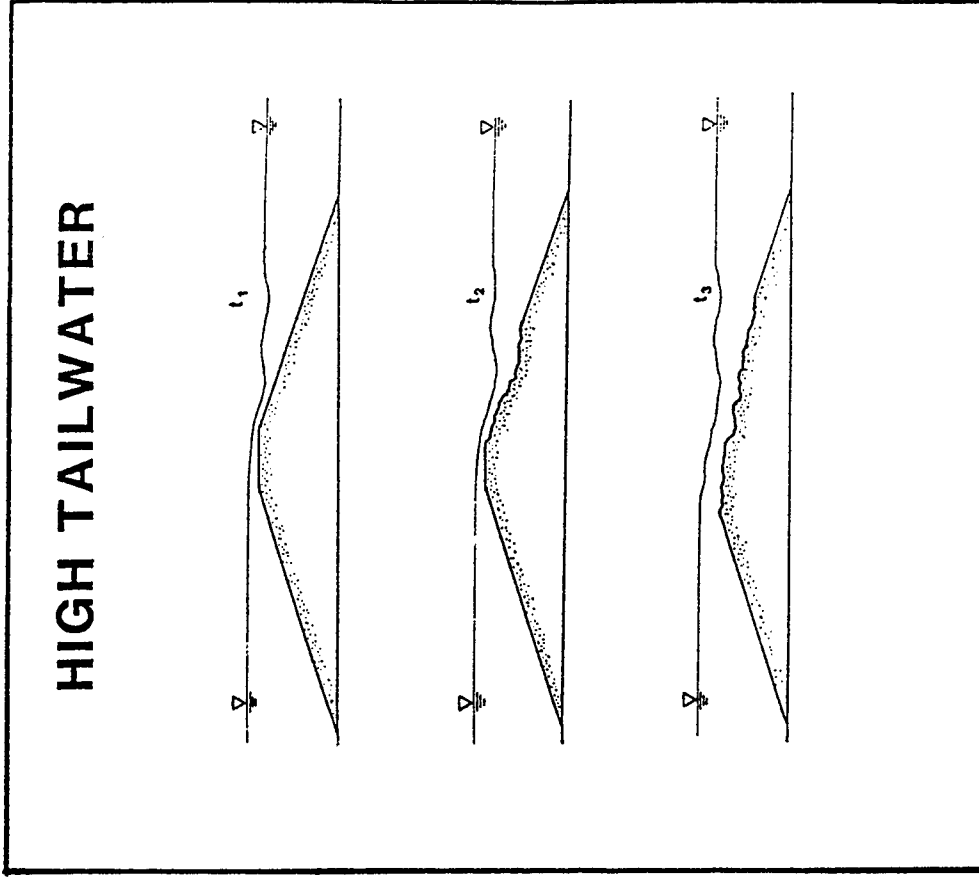
Figure 3.49. Progressive stages of unprotected embankment erosion under freefall and high tailwater conditions (14).

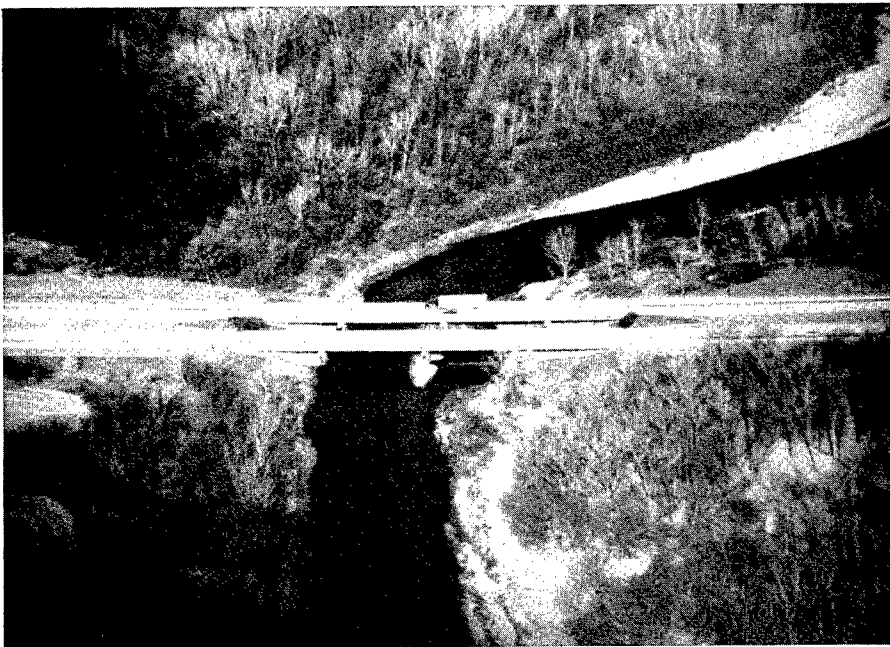
Sediment deposition downstream of debris accumulations were found on the Raccoon River (Figure 3.55) and the Des Moines River (Figure 3.56). These sediment accumulations filled voids between the debris elements, forming a composite body similar to a mass of reinforced earth. Combined debris and sediment accumulation may yield a composite structure that is capable of blocking a large portion of a channel. Flow deflected by a debris accumulation eroded the inside of the bend on the Raccoon River, as shown in Figure 3.55. Flows deflected by the accumulated debris

Figure 3.55. Raccoon River debris accumulation and downstream sediment deposit (Flow from top to bottom).

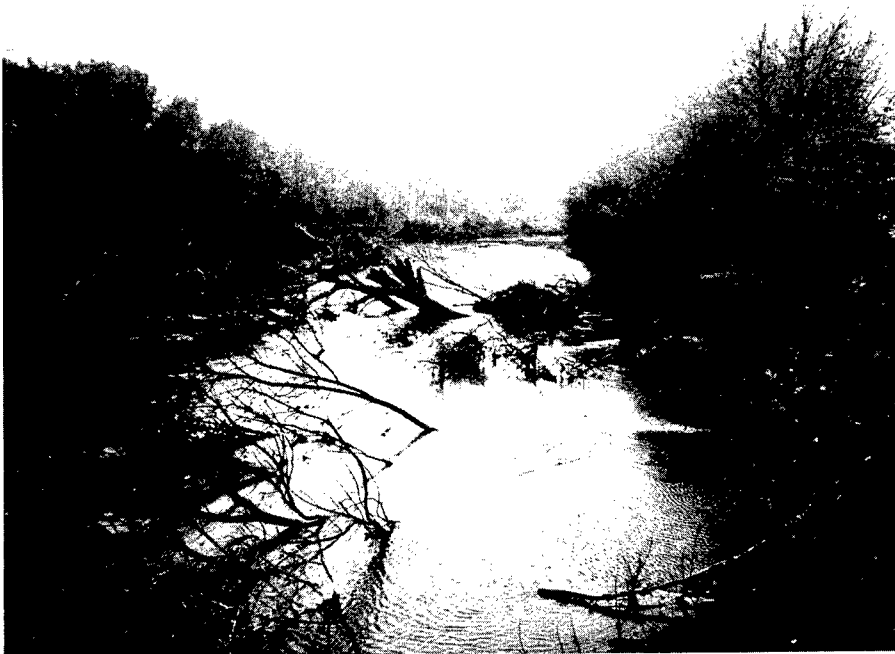
Figure 3.57. View, looking northwest, of the South Skunk River, northwest of U.S. Highway 65 bridge, northeast of Des Moines, Iowa.

***Sources of Debris.*** Debris was found in channels after flood recession where bank failures occurred. Figure 3.57 shows debris along the banks of the South Skunk River in Polk County, Iowa upstream of the U.S. Highway 65 bridge. The presence of fine leafed branches, attached root masses and bark indicated that the dislodged trees had been thriving in the growing season prior to their failure and entrance into the river. The root masses with loose soil and the tree orientations with respect to the bank and flow direction indicated that the trees had not been transported far from their original locations at the points of bank failure. The concentration of trees upstream of the bridge was attributed to turbulence created along the banks by the flow returning to the main channel from the floodplain. The flow returning to the main channel from the floodplain upstream of the bridge, had a substantial component perpendicular to the streambank; that component caused large-scale turbulence which increased the tendency for upstream banks to erode. The supply of debris depended upon the type and density of vegetation growing on those banks.
