# NCHRP Report 417

## Highway Infrastructure Damage Caused by the 1993 Upper Mississippi River Basin Flooding

6. AUTHOR(S): A.C. Parola et al.		PB99-124240	
7. PERFORMING ORGANIZATION NAME(S) AND ADDRESS(ES) The University of Louisville Research Foundation Louisville, Kentucky		8. PERFORMING ORGANIZATION REPORT NUMBER HR 12-39

The University of Louisville Research Foundation  
Louisville, Kentucky

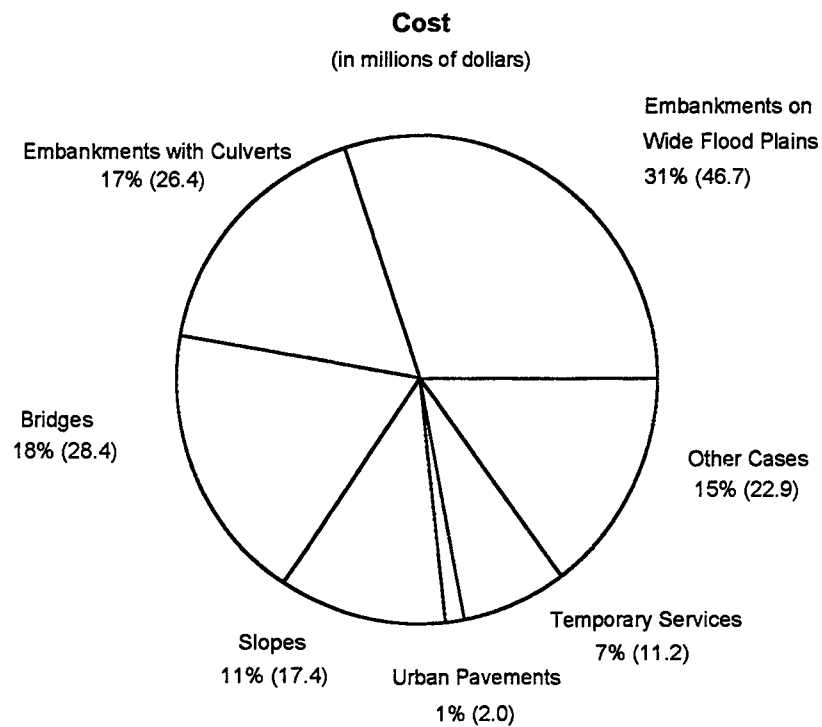
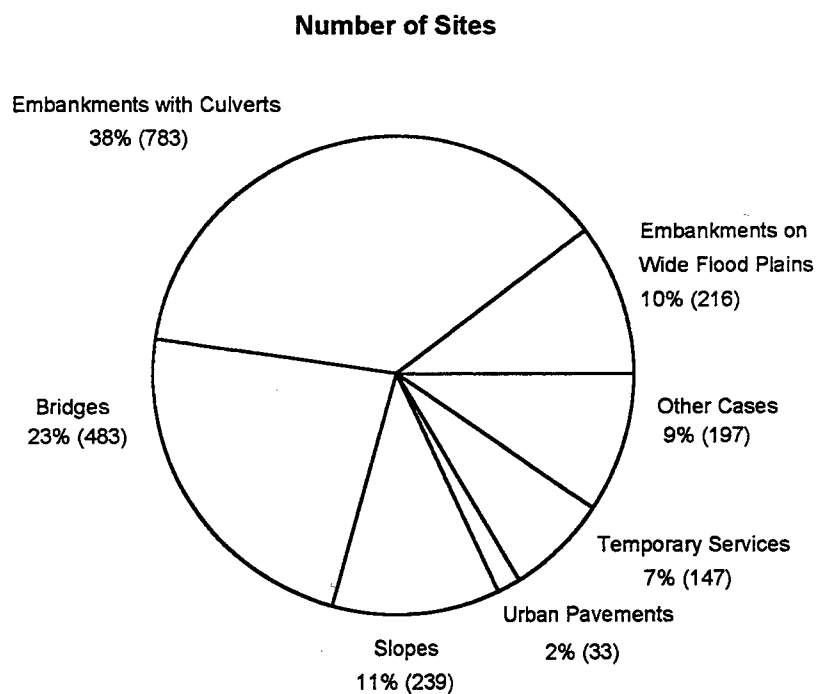
**Bridge Damage.** Damage to bridges included damage to substructures, superstructures, approach embankments, and the drainage ways around the bridge occurred at approximately 23 percent (483 sites) of the sites and accounted for 18 percent (\$28.4 million) of the total cost of damages (Figure 4.1). The primary cause of damage at 77 percent (370) of the bridges was scour around the abutments or approach embankments (Figure 4.3). Damage caused by scour around piers occurred at only 8 percent of the bridge sites reported as having damage. In most of those cases, the scour around the pier was caused by contraction of the entire waterway, by debris, and/or by scour and flow from an approach embankment. Only one case of pier scour could be identified as being caused by "local scour," scour caused solely by the flow around the pier. The remaining cases involved flow and scour around the pier affected by approach embankments or debris accumulations.

Figure 4.1. Federal Highway Administration Emergency Relief Funding.

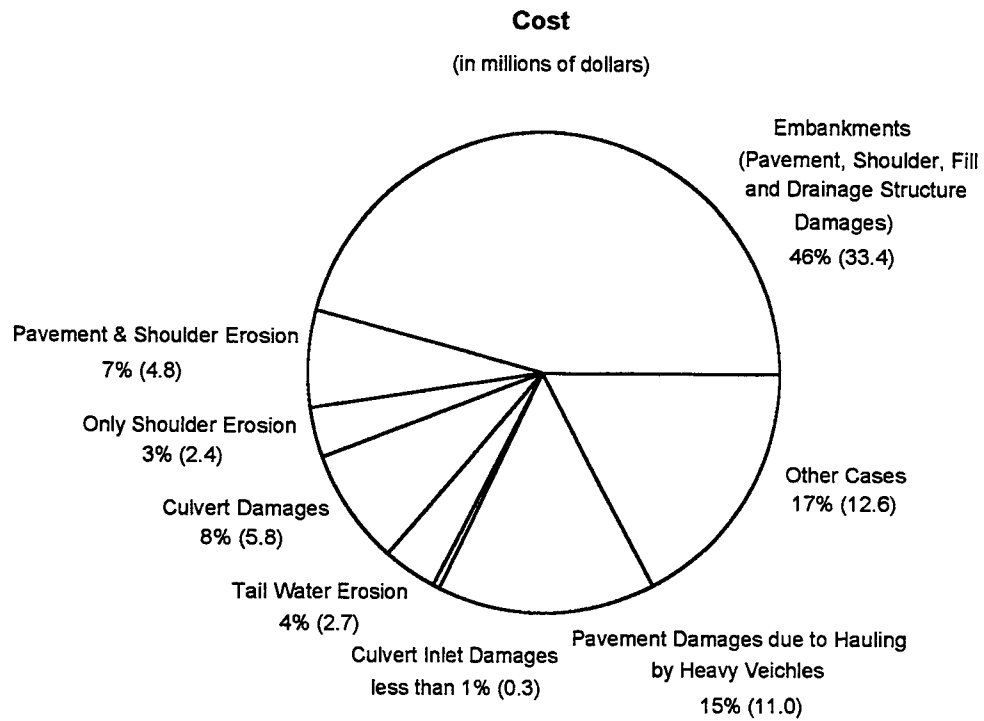
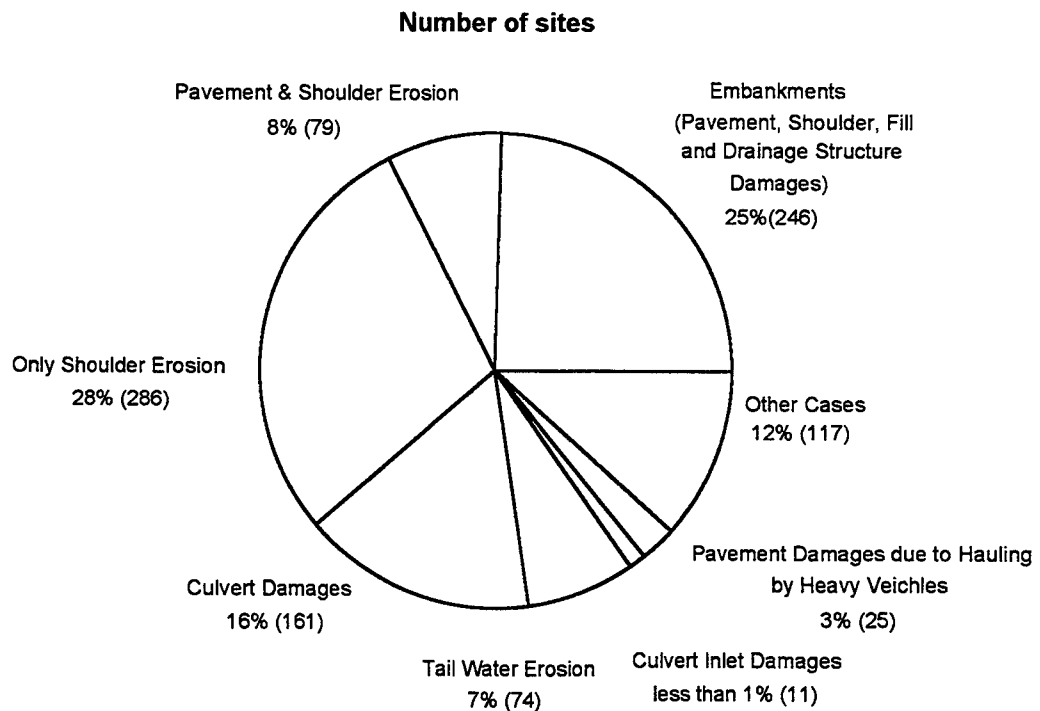
**Embankment Damage.** Failures at 999 sites and approximately 48 percent of the total cost of Emergency Relief Funding were attributed to highway embankment damage that included

damage to the associated pavement, shoulder, and drainage systems. Embankments were divided into three groups according to drainage structures, relative length, and proximity to a stream bridge: *culvert embankments*, *wide floodplain embankments*, and *bridge approach embankments*.

Embankments where culverts were the main drainage structures providing through flow were considered to be *culvert embankments*. Approximately 17 percent (\$26.4 million) of the total damage cost and 38 percent of the sites (783 sites) involved damage to culvert embankments.

Figure 4.2. Damage to embankments of federal aid highways.

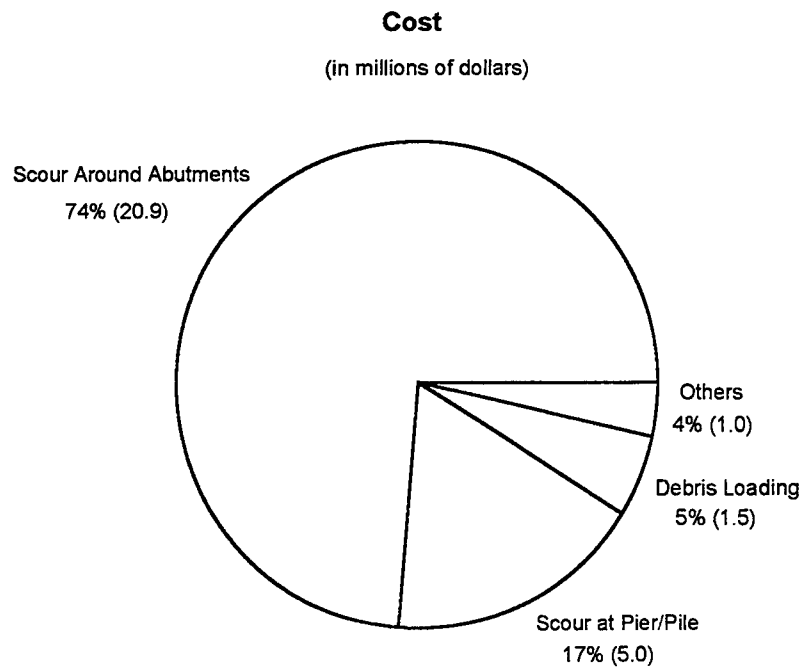
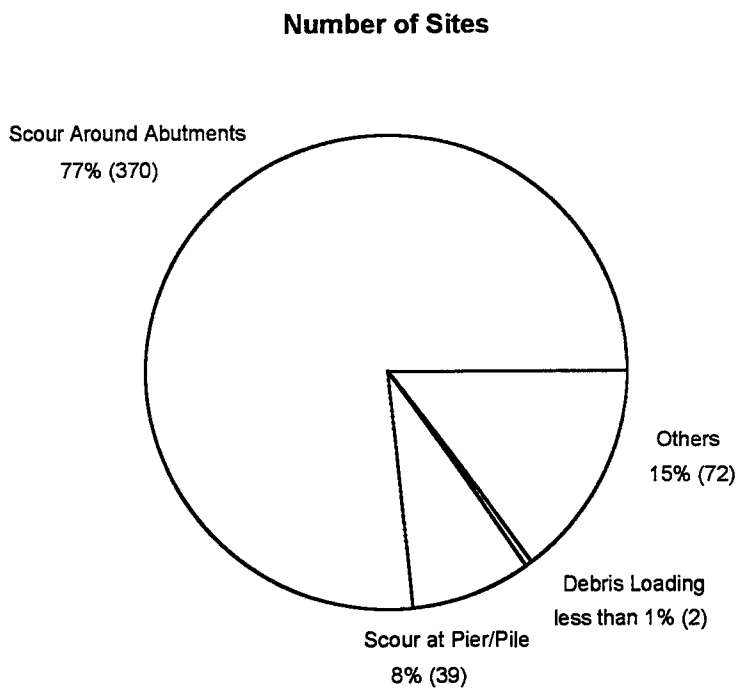
Note: Debris was present in 87 (18%) of 483 cases of bridge damage.  
Figure 4.3. Cause of bridge damage on federal aid highways.

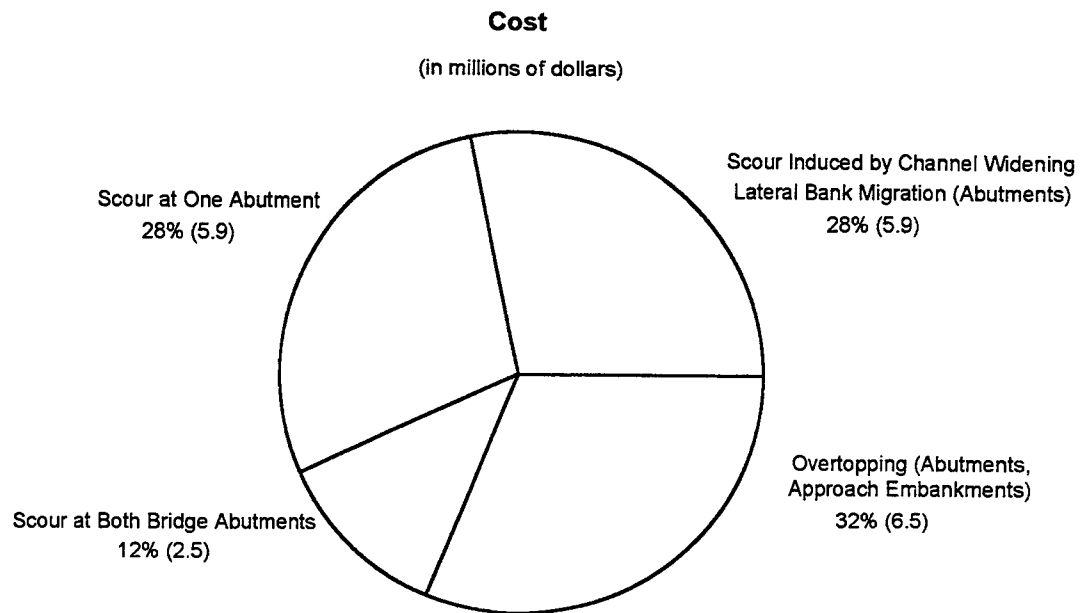
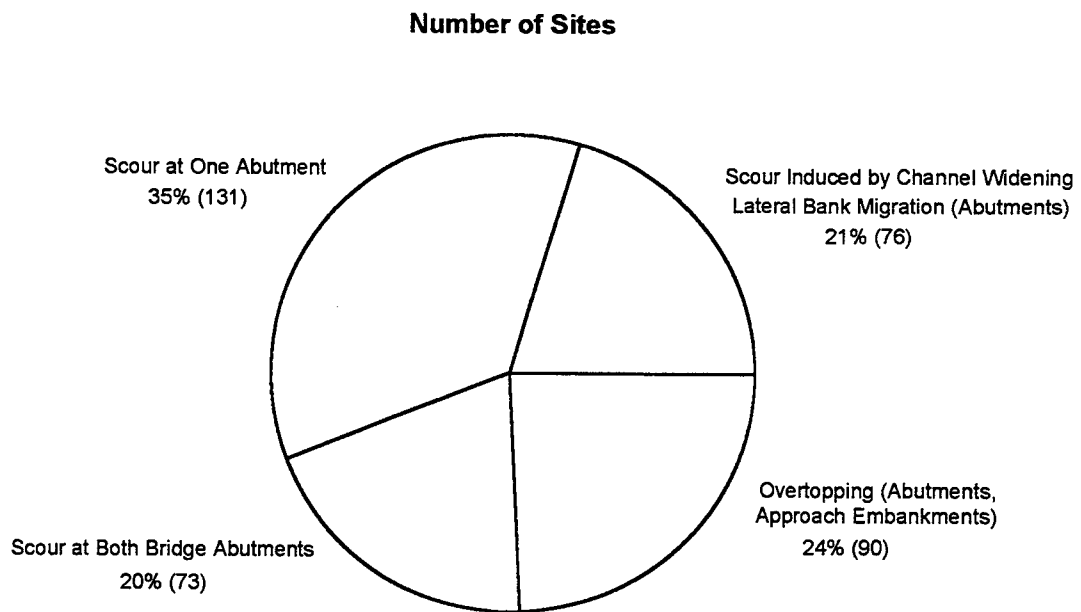
Scour around abutments was caused by one or more processes, as shown in Figure 4.4. Although most of the spectacular scour holes described in Chapter 3 were located on floodplains far from the main channel of a stream or river, the most numerous of the damaged abutments were those located at or very close to the bank line of a main channel. Lateral migration of the channel or channel widening caused conditions in which abutments were damaged. The category of damage to abutments designated "scour at one abutment" also may have included cases of lateral bank migration, but the information provided was insufficient to show that lateral migration was a primary cause. Scour at both abutments was an indication that flow contraction through the entire bridge opening and/or channel widening occurred. Damage to embankments both under and around bridge

Figure 4.4. Causes of abutment scour on federal aid highways.

abutments was caused most frequently by the complex flow that occurred when the bridge was submerged and flow over the approach embankment breached that embankment behind the abutment.

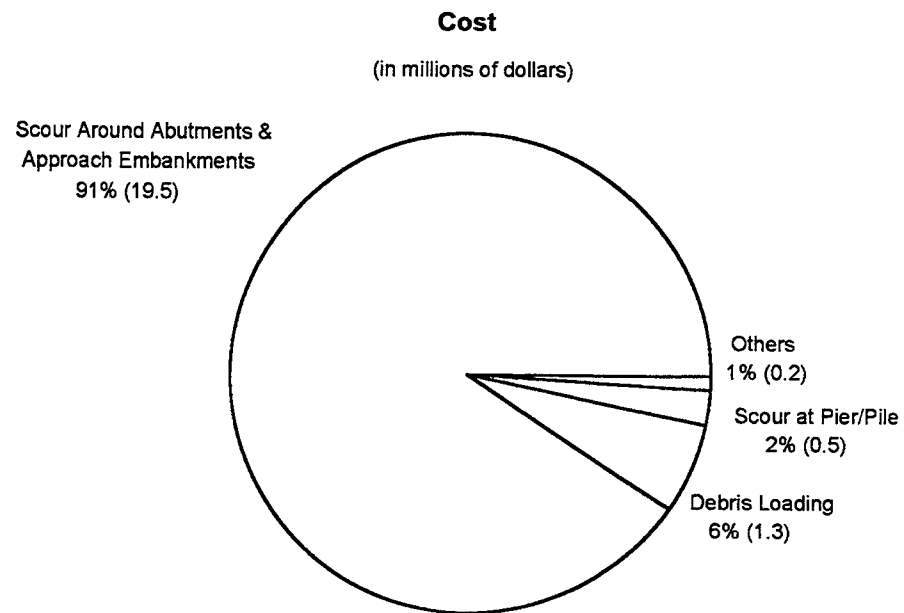
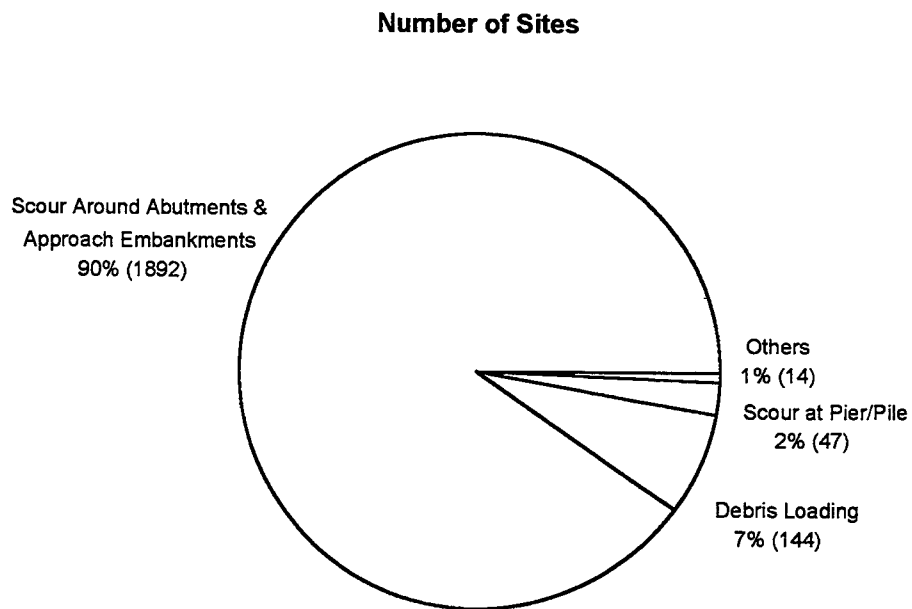
Figure 4.5. Causes of bridge damage on non federal aid highways.

on non-federal aid routes contributed to 2 percent of total damage assistance cost and 14 percent of bridge damage cost. At least 38 bridges had one or more collapsed spans. Scour around abutments was the major cause of structural damage and bridge collapse.

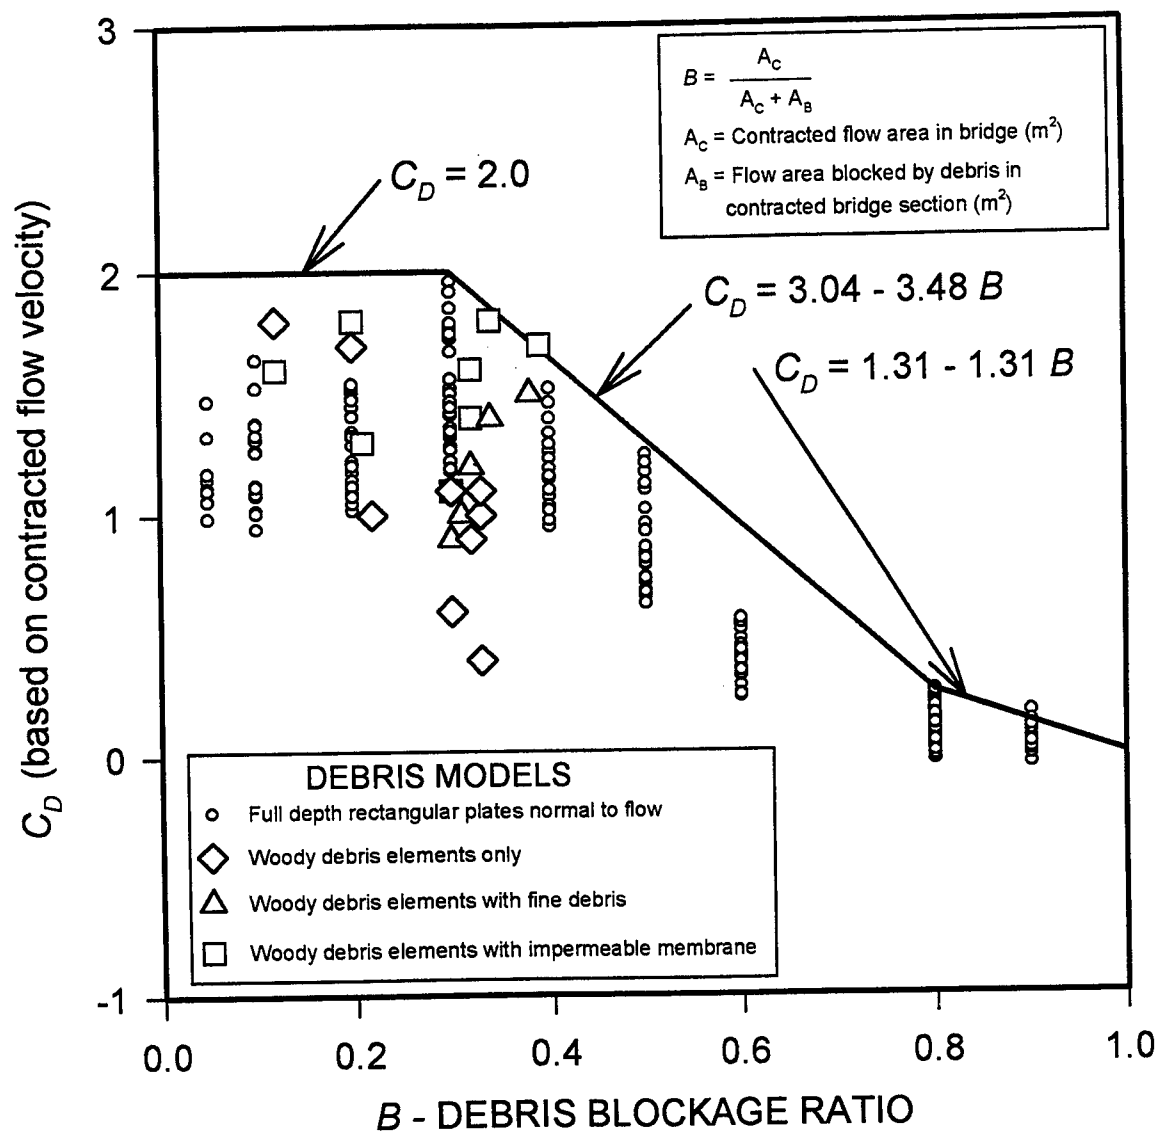
Figure B.1. Variation in drag coefficient for debris on piers (Parola, et al., NCHRP Project 12-39 unpublished interim findings, 1996).
