SHRP-C-620

**Evaluation of NORCURE Process  
for Electrochemical Chloride Removal  
from Steel-Reinforced Concrete Bridge Components**

ELTECH Research Corporation  
Fairport Harbor, Ohio

**Strategic Highway Research Program  
National Research Council  
Washington, DC 1993**

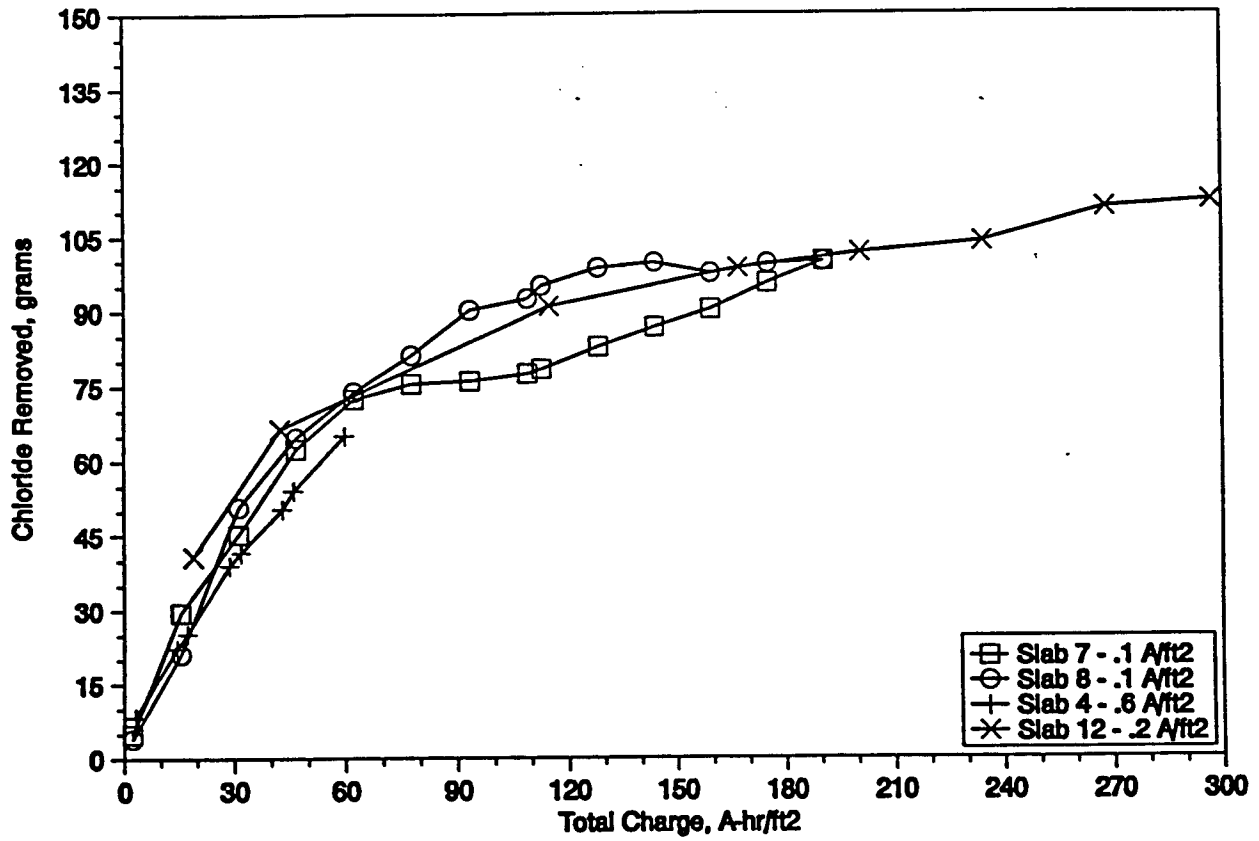
Figure 2. Slab Chloride Removal Rate

Operation of the slabs was halted on September 1, 1989, because the horizontal Slab Number 7 was drastically reducing in chloride removal rate as shown in Table 1. There was severe staining of the concrete surface with the horizontal slab without the fiber mat, and significant staining of the vertical slab. Both slabs required sandblasting. The slabs were restarted on September 25, 1989. After four more weeks of operation, the total chloride removed from each slab was analyzed to be similar. At this point, the voltage of the vertical Slab Number 8 escalated due to significant drying, of the cellulose fiber and a highly consumed anode. The tests were subsequently halted, accumulating a total of 13 weeks of treatment. Solution analyses show that chloride was removed at the same rate as with the SHRP slabs that used an inert DSA anode. This is shown in Figure 2 as a graph of grams Cl<sup>-</sup> removed versus charge passed for the NORCURE™ Slab Numbers 7 and 8 along with the SHRP Slab Number 4 and 12.

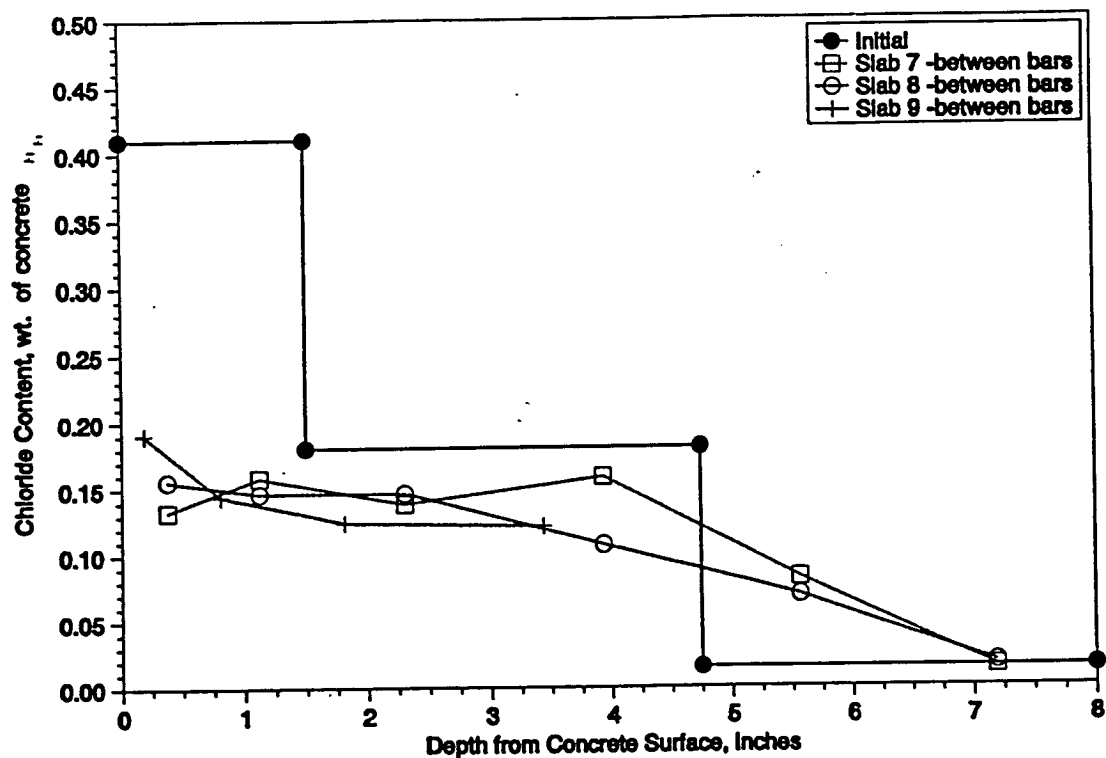
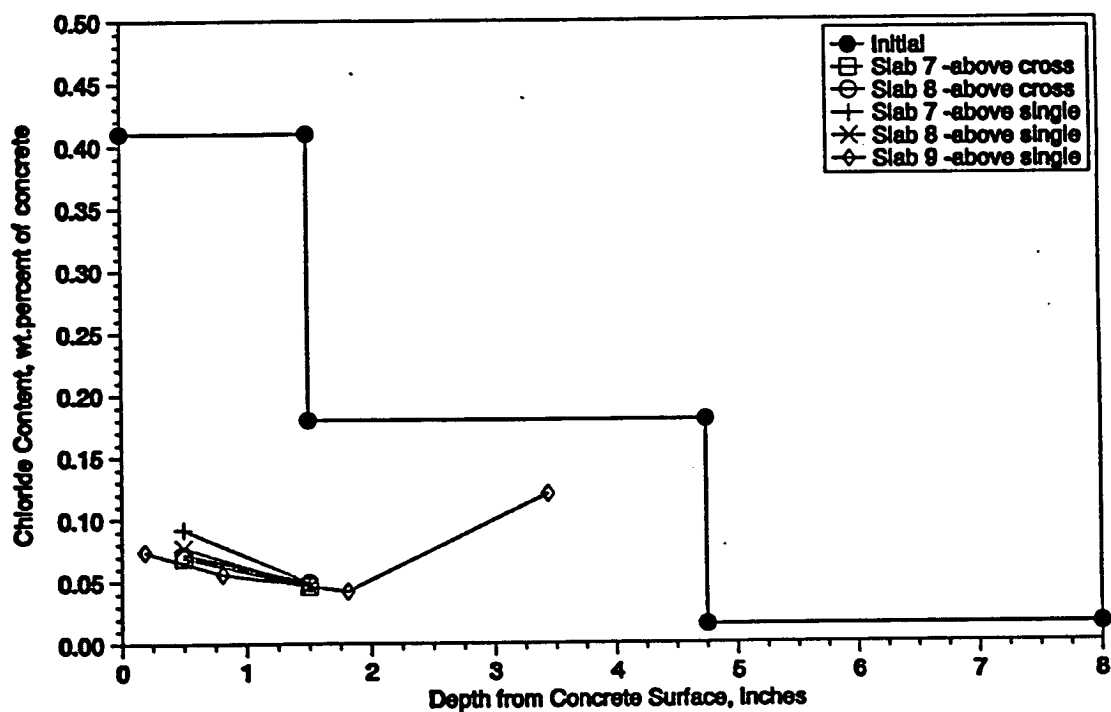
Figure 3. Concrete Chloride Content After Removal Treatment

Concrete powder samples were collected from the slabs and analyzed for chloride content. Results of the analyses are shown in Table 2 and plotted in Figure 3 along with SHRP Slab Number 9 for comparison. Slab Number 9 was the only slab treated where the electrolyte was allowed to become acid. It was also for a total of 300 A-hr/ft<sup>2</sup> of total charge compared to 191 A-hr/ft<sup>2</sup> for the Norcure slabs, and this explains the lower chloride levels remaining above straight bars after treatment for SHRP Slab Number 9.

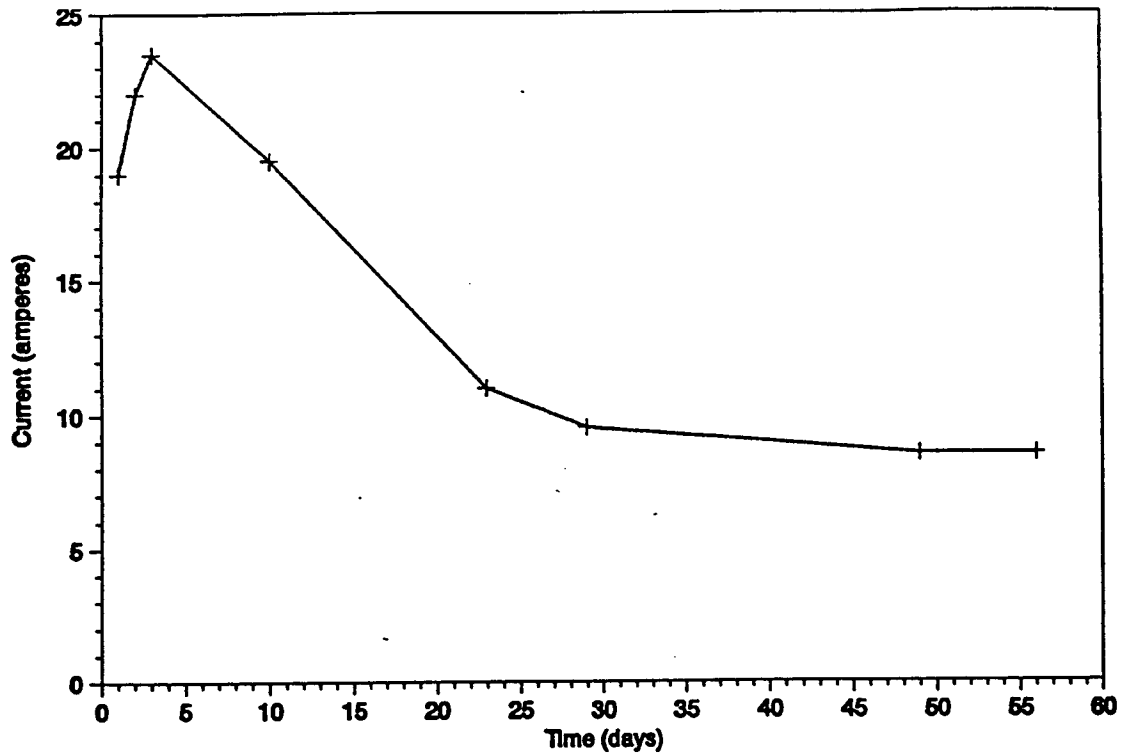
**Figure 7. Burlington Current Profile**

The system was energized July 5, 1989 at 15 amps, 23 volts. After a few hours, current was increased to 20 amps, 34 volts. A complete current and voltage profile over the operating life of the system is shown by Figures 7 and 8. The voltage required by this trial was somewhat high for the level of current used. This is apparently a result of both the high concrete cover and wide spacing of the reinforcing steel. Voltage was maintained at or below 40 volts for safety reasons and, as a result, current decreased over the course of the test to about one-third its original value.
