SHRP-H-354

Innovative Materials Development and Testing

Volume 3: Treatment of Cracks in Asphalt Concrete-Surfaced Pavements

October 1993

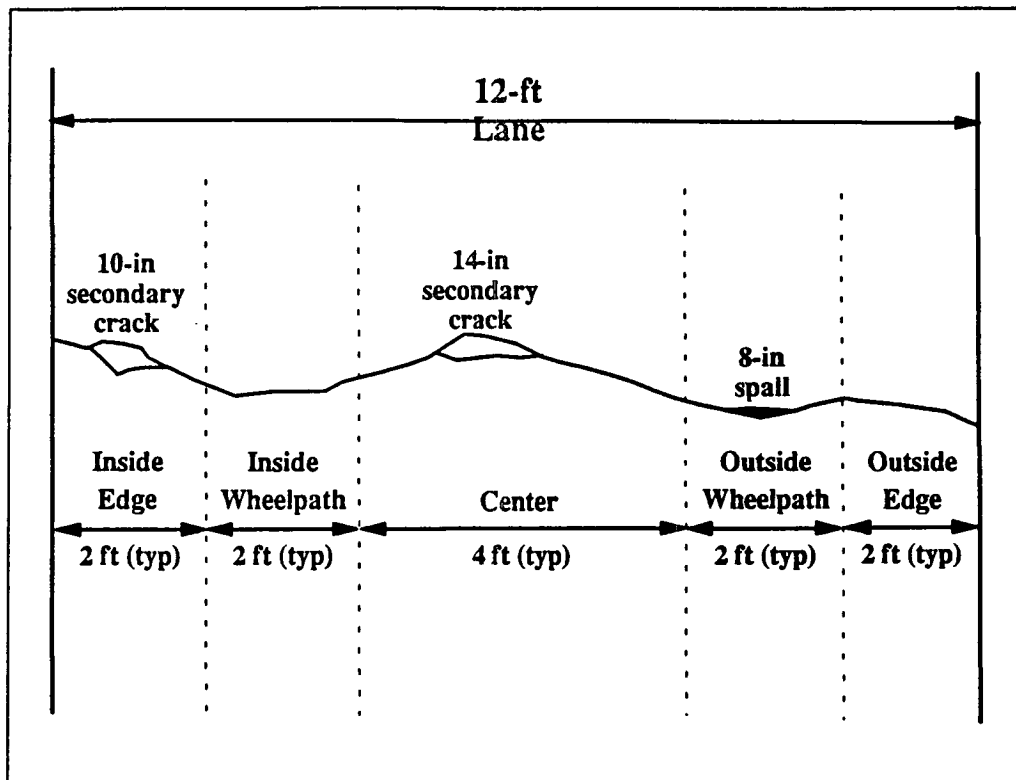
Figure 9. Initial inspection sketch of transverse crack

At the crack-seal sites, a detailed inspection of experimental cracks three through ten in each test section was performed. This inspection involved sketching the general pattern of each crack and recording the location(s) of deteriorated segments as a function of lane position (see figure 9). A similar, less-intensive inspection was done on experimental cracks five through twelve in each section at the crack-fill site. Since the longitudinal cracks were much straighter and more deteriorated, only the excessively wide or potholed crack segments were identified and recorded.

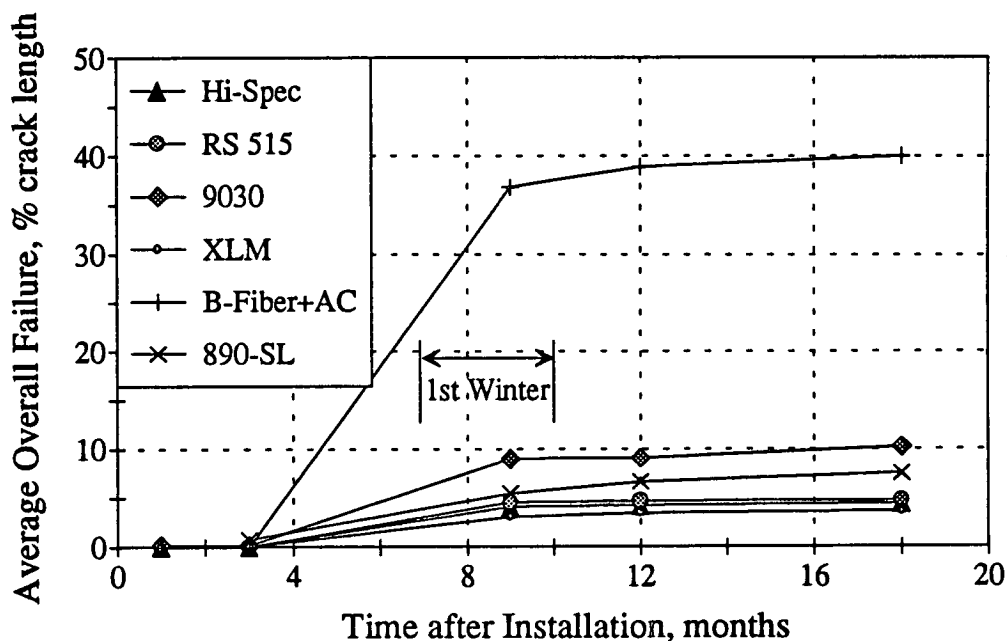
Figure 26. Time progression of primary sealant failures

The fifth and final round of evaluations under the H-106 contract was performed in the fall of 1992. While some treatment distresses had progressed steadily since the third- and fourth-round evaluations, the overall number of failures increased only slightly, as seen in figure 26.

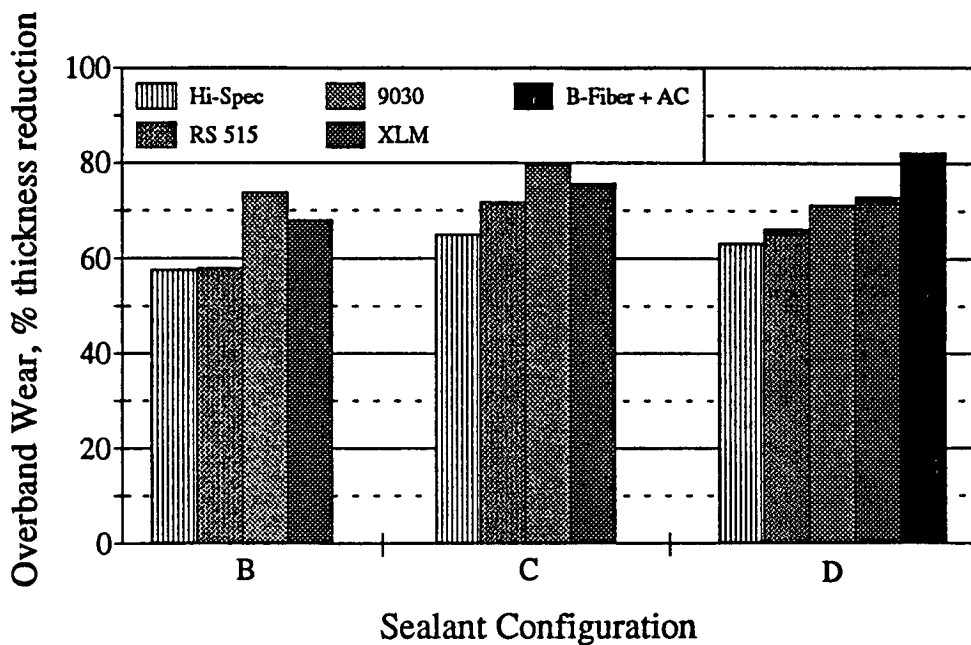
Figure 27. Average overband wear levels after 18 months (all sites)

Figure 27 shows the relative overband wear levels based on data averaged over all sites. From a material standpoint, fiberized asphalt and the low-modulus rubberized asphalt sealants generally have experienced greater wear. Tackiness and the lack of resilience in warm weather have caused the fiberized asphalt overbands to experience both wear and a flattening

effect not exhibited by the other sealants. Among the rubberized asphalt products, XLM and 9030 have experienced very high overband wear, followed by RS 515 and Hi-Spec.
