SHRP-H-356

Innovative Materials Development and Testing

Volume 5: Partial Depth Spall Repair in Jointed Concrete Pavements

Cynthia A. Good Mojab
Arti J. Patel
A. Russell Romine
ERES Consultants, Inc.
Savoy, Illinois

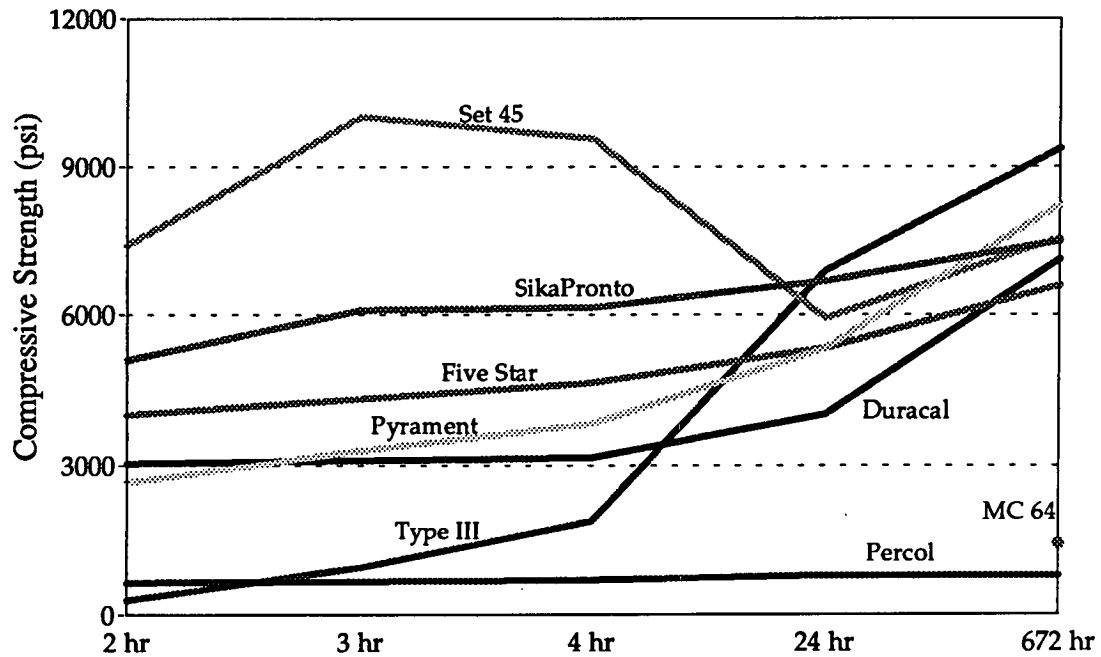
Figure 15. Compressive strength of spall repair materials

Compressive strength often is used for specifying and evaluating cementitious spall repair materials. For rapid repairs, early strength gain is of interest. Figure 15 shows the strength-gain curves for the spall repair materials that were tested. It is interesting to see that materials with the highest early strengths are not necessarily those with the highest ultimate strength. The unusual strength-gain curve for Set-45 cannot be explained at this time. Based on Least Square Difference T test and a confidence level of 95 percent, at 2 hours, Set-45 is significantly stronger than the other materials and Percol FL and Type III PCC are significantly weaker than the others. However, at 28 days, Type III PCC is significantly stronger than all other materials, with Pyrament 505 having the next highest compressive strength. MC-64 and Percol FL are significantly lower in compressive strength than all other materials at 28 days. Set-45, Five Star HP, and Duracal are not significantly different in terms of compressive strength at 28 days.

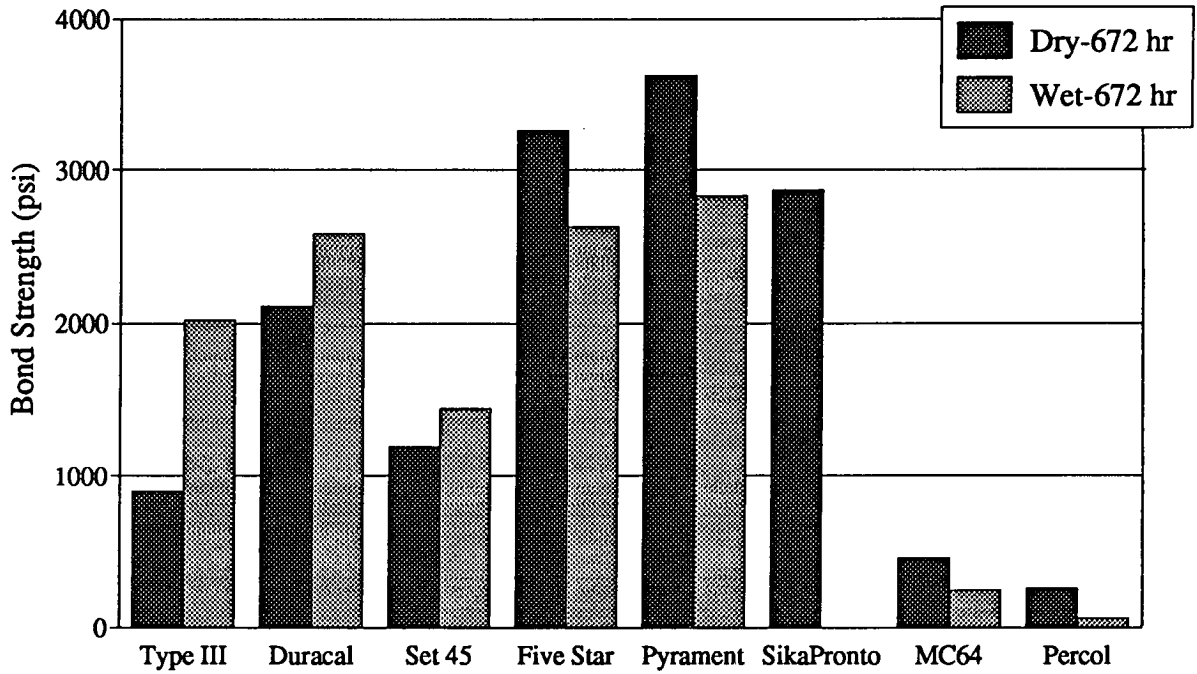
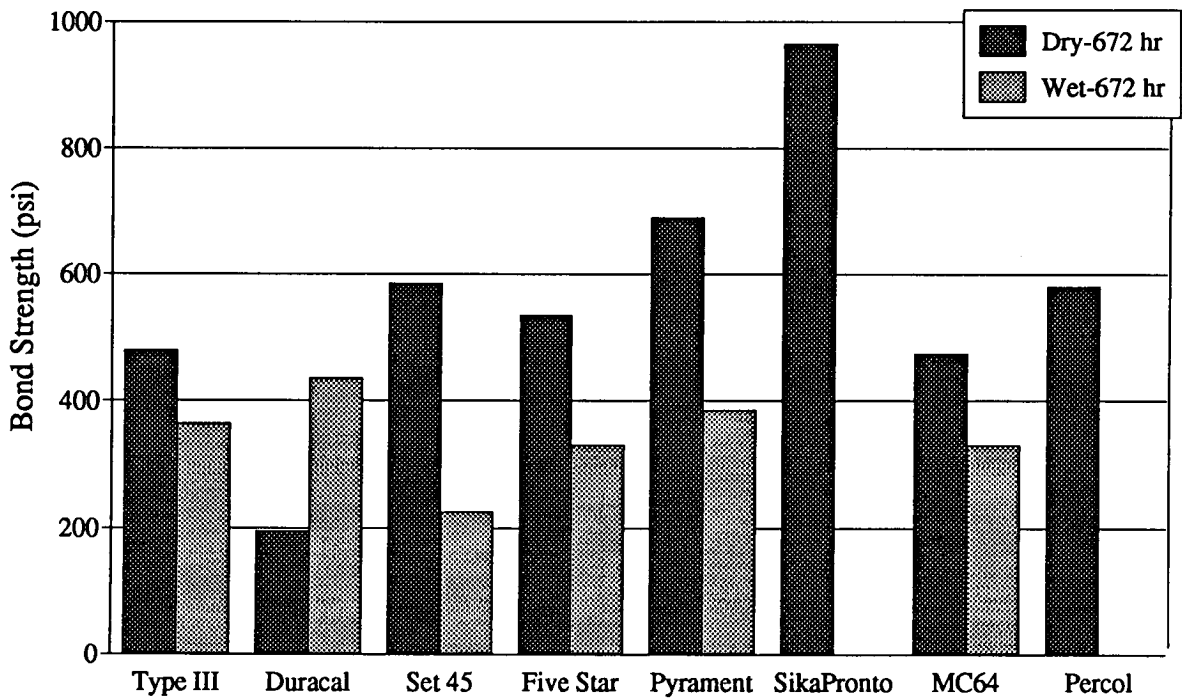
Bond strength is thought to be an important factor in determining field performance. The bond strength of the spall repair materials is shown in figures 16 and 17. It is interesting to note that, in general, the bond strength of the materials that are specified to be installed wet decreases when tested using a dry substrate, and materials that are specified to be installed dry lose bond strength when tested using a wet substrate. Several exceptions to that statement should be noted. Percol FL, whose manufacturer claims that the material is moisture tolerant, loses strength significantly when applied to a wet substrate. Also, Five Star HP and Pyrament 505 manufacturers recommend that their materials be applied to a saturated, surface dry (SSD) surface. The slant-shear and center-point bond strength tests indicate that the bond strength is weaker when applied to a wet substrate. It can also be seen that some materials are more tolerant of changed conditions than others.

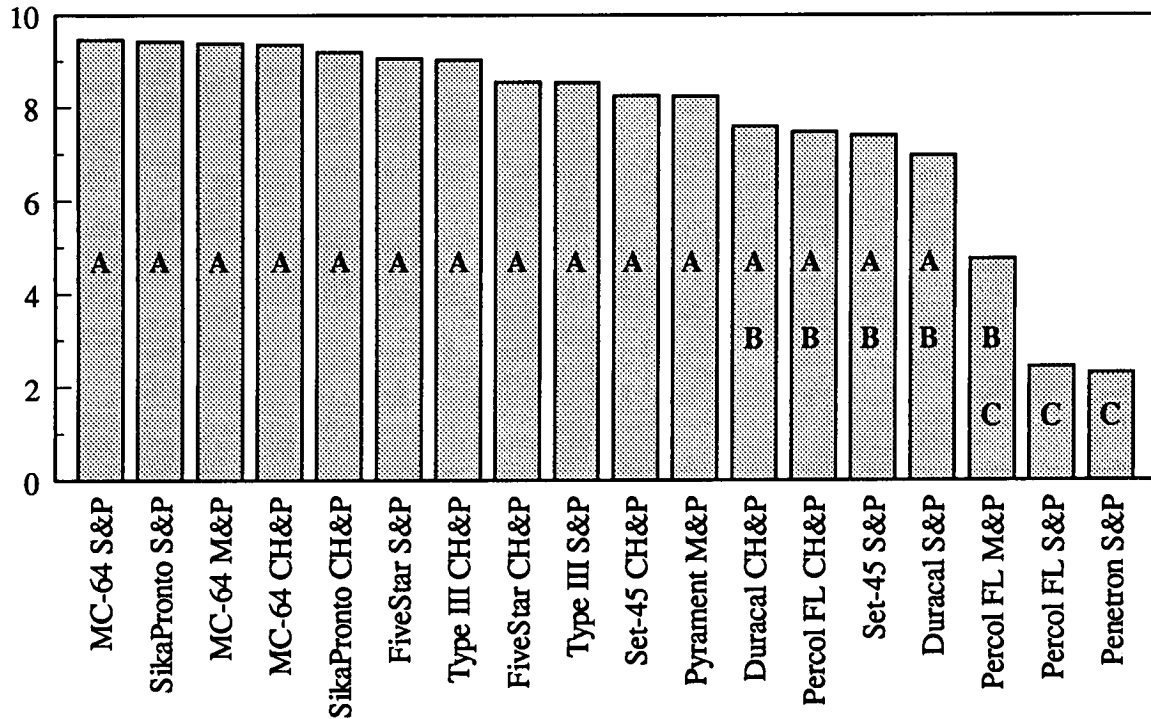
Figure 27. Tukey groupings of Arizona cementitious and polymer overall ratings, grouped by material-procedure treatments

Figure 27 shows that the following material-procedure treatments do not have significantly different overall patch ratings from each other: Type III PCC patches prepared with the saw-and-patch or chip-and-patch procedure; Duracal patches prepared with the chip-and-patch procedure; Set-45 patches prepared with the saw-and-patch or chip-and-patch procedure; Five Star HP patches prepared with the saw-and-patch or chip-and-patch procedure; MC-64 patches prepared with the saw-and-patch, chip-and-patch, or mill-and-patch procedure; SikaPronto 11 patches prepared with the saw-and-patch or chip-and-patch procedure; Percol FL patches prepared with the chip-and-patch procedure; and Pyrament 505 patches prepared with the mill-and-patch procedure. However, they do have significantly better overall patch ratings than Percol FL patches prepared with the saw-and-patch procedure and Penatron R/M-3003 patches prepared with the saw-and-patch procedure, which do not have significantly different overall patch ratings from each other.

Figure 27 also shows that the following material-procedure treatments do not have significantly different overall patch ratings from each other: Type III PCC patches prepared with the saw-and-patch or chip-and-patch procedure; Set-45 patches prepared with the chip-and-patch procedure; Five Star HP patches prepared with the saw-and-patch or chip-and-patch procedure; MC-64 patches prepared with the saw-and-patch, chip-and-patch, or mill-and-patch procedure; SikaPronto 11 patches prepared with the saw-and-patch or chip-and-patch procedure; Percol FL patches prepared with the chip-and-patch procedure; and Pyrament 505 patches prepared with the mill-and-patch procedure. However, they do have significantly better overall patch ratings than Percol FL patches prepared with the saw-and-patch or mill-and-patch procedure, and Penatron R/M-3003 patches prepared with the saw-and-patch procedure, which do not have significantly different overall patch ratings from each other.

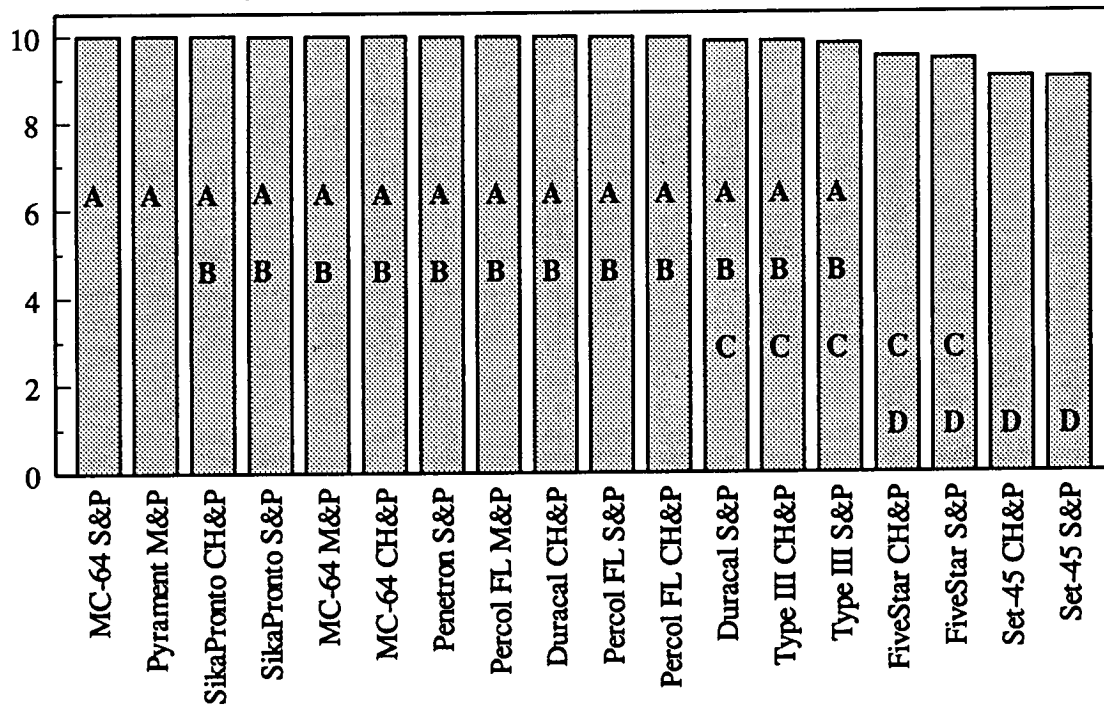
Figure 28. Tukey groupings of Arizona cementitious and polymer wear ratings, grouped by material-procedure treatments

Figure 28 shows that the following material-procedure treatments do not have significantly different wearing ratings from each other: Type III PCC patches placed with the saw-and-patch or chip-and-patch procedures; Duracal patches prepared with the saw-and-patch or chip-and-patch procedures; MC-64 patches prepared with the saw-and-patch, chip-and-patch, or mill-and-patch procedures; SikaPronto 11 patches prepared with the saw-and-patch or chip-and-patch procedures; Percol FL patches prepared with the saw-and-patch, chip-and-patch, or mill-and-patch procedures; Pyrament 505 patches prepared with the mill-and-patch

procedures; and Penatron R/M-3003 patches prepared with the saw-and-patch procedure. However, they do have significantly better wearing ratings than Set-45 patches prepared with the saw-and-patch or chip-and-patch procedure, which do not have significantly different wearing ratings from each other.

Figure 28 also shows that the following material-procedure treatments do not have significantly different wear ratings from each other: Duracal patches prepared with the chip-and-patch procedure; MC-64 patches prepared with the saw-and-patch, chip-and-patch, or mill-and-patch procedure; SikaPronto 11 patches prepared with the saw-and-patch or chip-and-patch procedure; Percol FL patches prepared with the saw-and-patch, chip-and-patch, or mill-and-patch procedure; Pyrament 505 patches prepared with the mill-and-patch procedure, and Penatron R/M-3003 patches prepared with the saw-and-patch procedure. However, they do have significantly better wear ratings than Set-45 patches prepared with the saw-and-patch or chip-and-patch procedure; and Five Star HP patches prepared with the saw-and-patch or chip-and-patch procedure, which do not have significantly different wear ratings from each other.

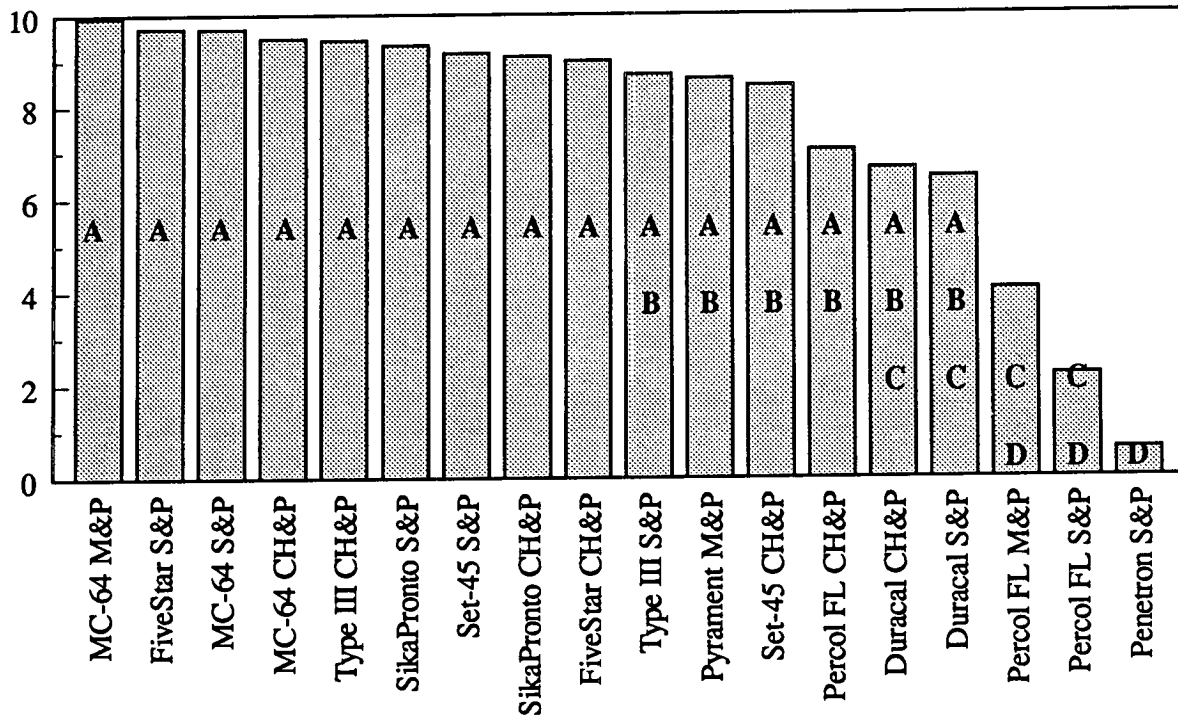
Figure 29. Tukey groupings of Arizona cementitious and polymer bonding ratings, grouped by material-procedure treatments

Figure 29 shows that the following material-procedure treatments do not have significantly different bonding ratings from each other: Type III PCC patches prepared with the saw-and-patch or chip-and-patch procedure; Duracal patches prepared with the saw-and-patch or chip-and-patch procedure; Set-45 patches prepared with the saw-and-patch or chip-and-patch procedure; Five Star HP patches prepared with the saw-and-patch or chip-and-patch

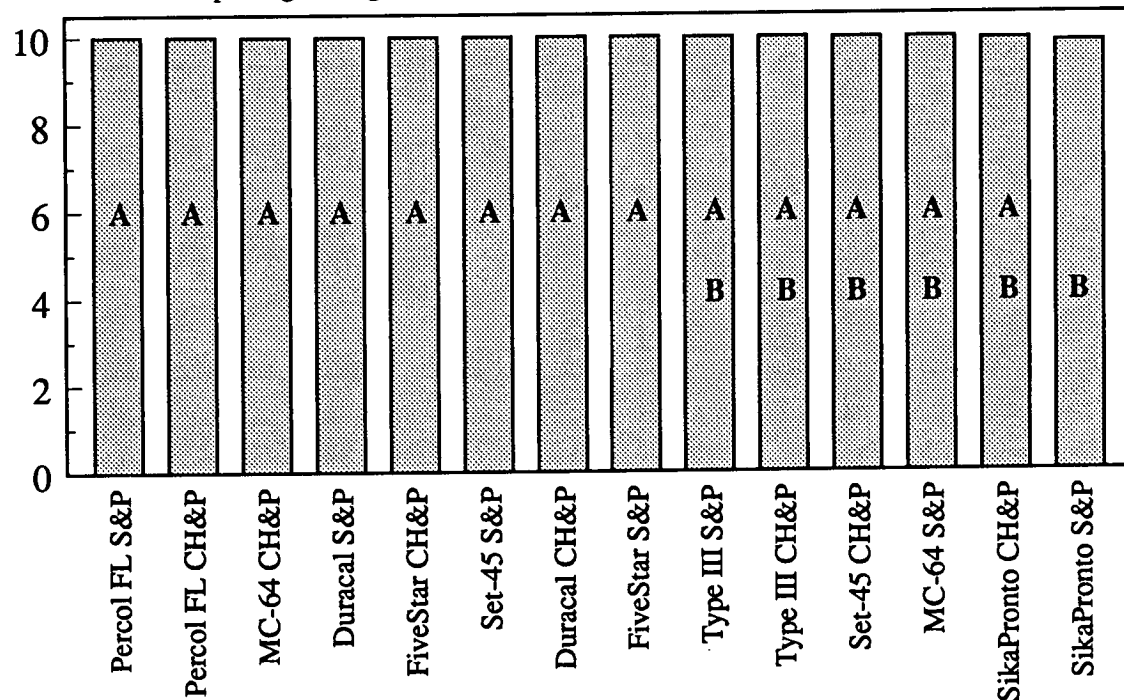
Figure 32. Tukey groupings of South Carolina cementitious and polymer spalling ratings, grouped by material-procedure treatments

Carolina. Figure 32 indicates that Duracal patches prepared with the saw-and-patch or chip-and-patch procedure; Set-45 patches prepared with the saw-and-patch procedure; Five Star HP patches prepared with the saw-and-patch or chip-and-patch procedure; MC-64 patches prepared with the chip-and-patch procedure; and Percol FL patches prepared with the saw-and-patch or chip-and-patch procedures do not have significantly different spalling ratings from each other. However, they do have significantly better spalling ratings than SikaPronto 11 patches prepared with the saw-and-patch procedure.

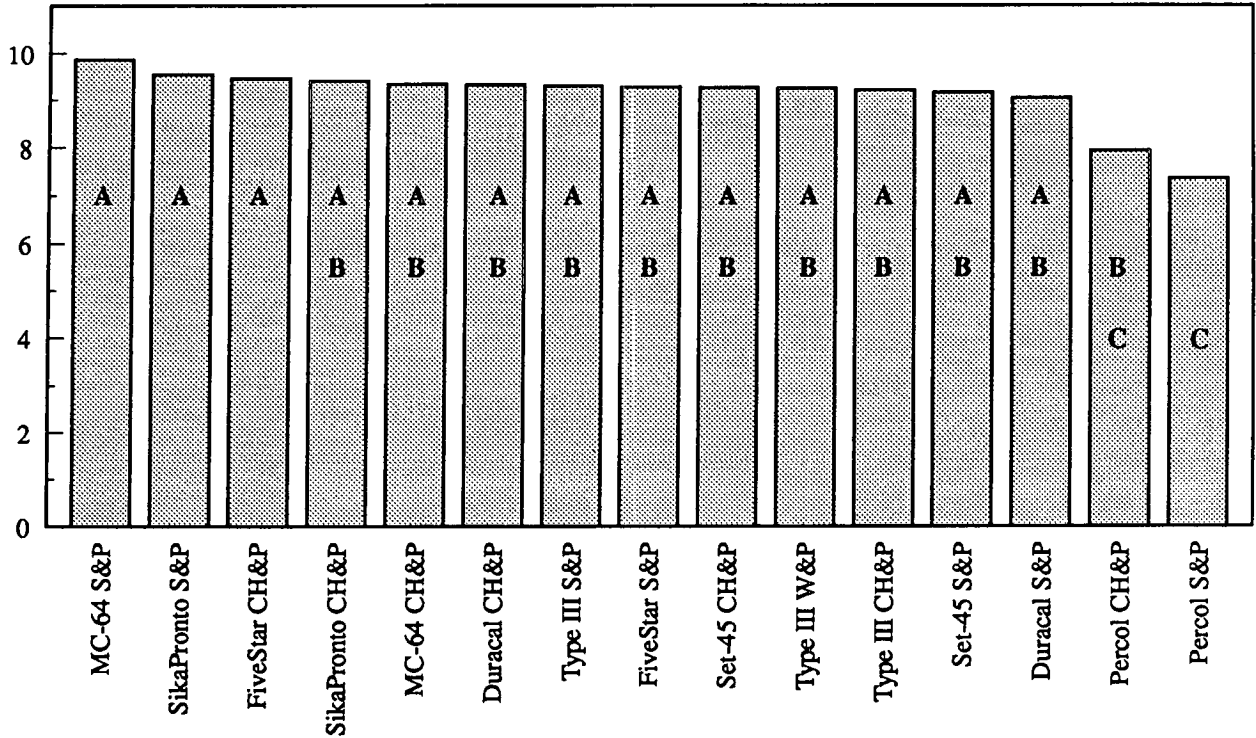
Figure 33. Tukey groupings of Utah cementitious and polymer overall ratings, grouped by material-procedure treatments

Figure 33 also shows that SikaPronto patches prepared with the following material-procedure treatments do not have significantly different overall patch ratings from each other: chip-and-patch procedure; MC-64 patches prepared with the chip-and-patch procedure; Duracal patches
