SHRP-S-669

# **Electrochemical Chloride Removal and Protection of Concrete Bridge Components: Field Trials**

ELTECH Research Corporation  
Fairport Harbor, Ohio

**Strategic Highway Research Program**  
National Research Council  
Washington, DC 1993

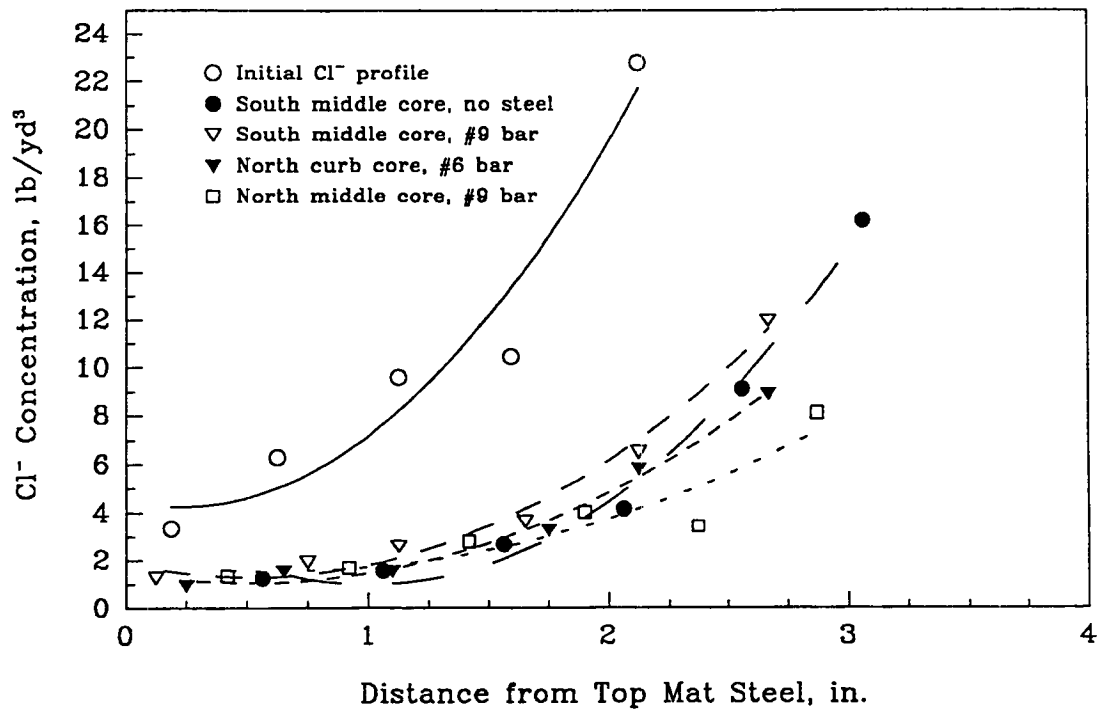
Figure 2-7. Initial Versus Final Cl<sup>-</sup> Profiles for Ohio Bridge Deck Field Trial

Chloride analyses were performed on concrete powder samples taken from the four cores according to the Standard Method AASHTO T 260. Initial and final results are plotted on the graph in Figure 2-7. All these results are from cores containing steel, and laboratory testing indicated that much more chloride is removed from the concrete above steel than from concrete between steel. Since the major goal of the chloride removal process was to move chlorides away from the steel and reduce corrosion of chloride on steel, the results can be considered successful. The data show that, with only 60 A-hr/ft<sup>2</sup> (600 A-hr/m<sup>2</sup>) of total charge passed, chlorides within 1 in. (2.5 cm) of the steel were reduced from 3 to 6 lb/yd<sup>3</sup> (1.8 to 3.6 kg/m<sup>3</sup>) to 1-1/2 to 2 lb/yd<sup>3</sup> (0.9 to 1.2 kg/m<sup>3</sup>). Similar results were obtained with the laboratory slabs.

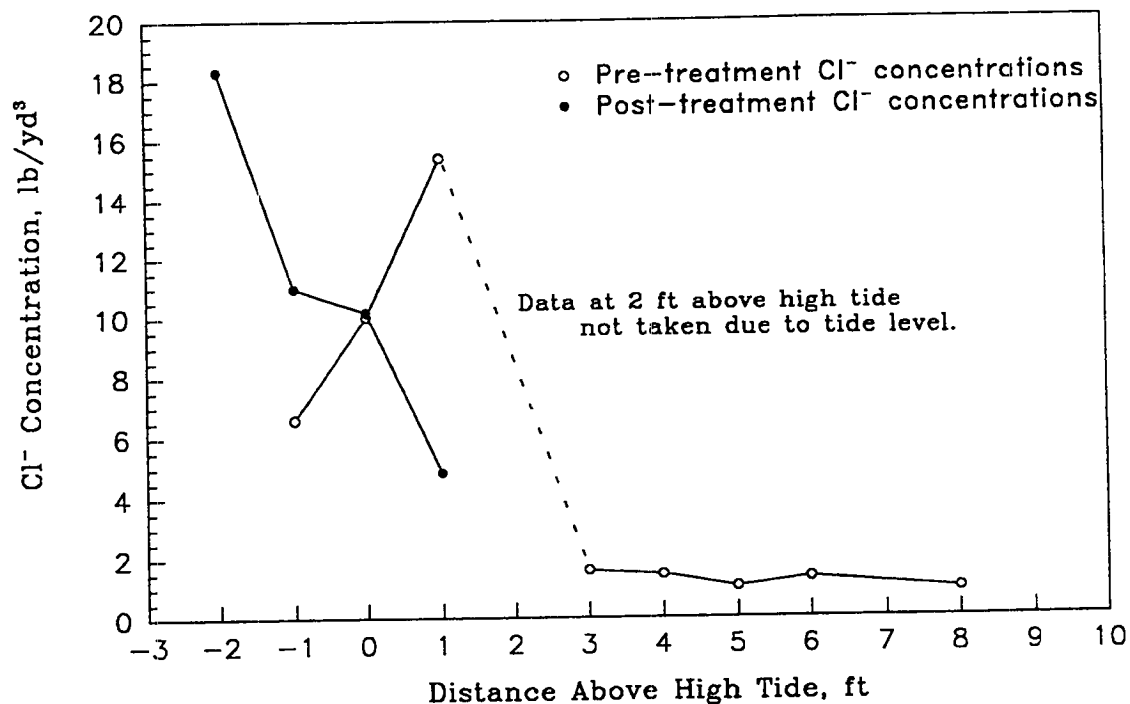
**Figure 3-9. Pre-Treatment and Post-Treatment Chloride Concentrations**

Concrete powder was collected from 1/2-in. (12-mm) diameter holes for chloride analysis. Large concrete core samples were not taken for structure reasons. The pre-treatment and post-treatment results of the chloride analyses are shown in Figure 3-9.

From this data, conclusions about the effectiveness of the removal cannot be made.

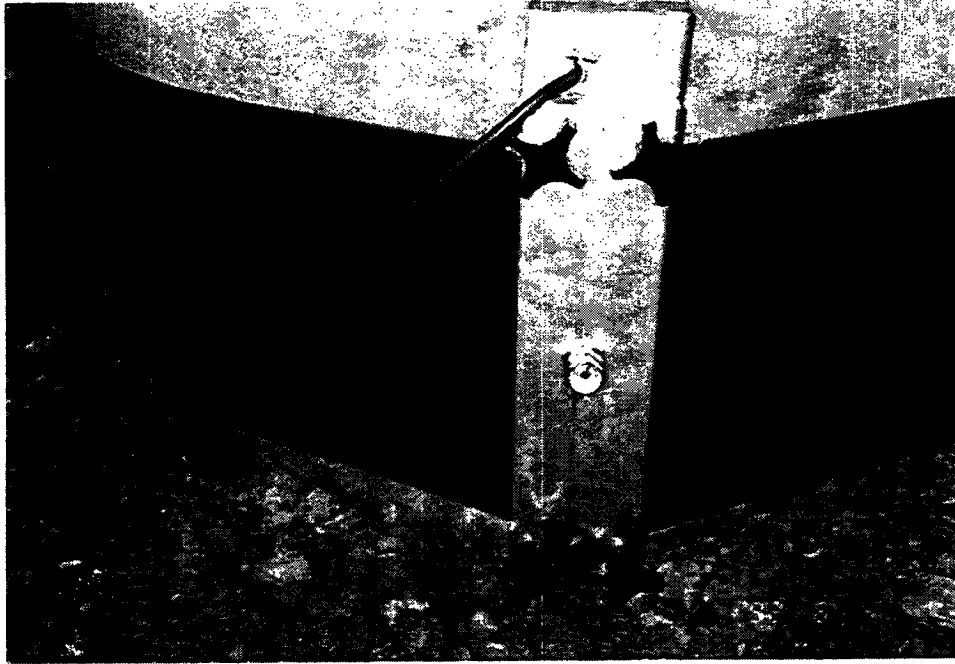
**Figure 4-4. Vulcanizer Joining Rubber Collector**

Several difficulties were encountered with the installation of the electrolyte collection system at the bottom of the columns. Since a seal between a 2-in. (5-cm) diameter collection hose and the concrete could not be accomplished initially, the system was redesigned. This involved making a 1-ft (30-cm) wide rubber band to fit snug around the column. The ends of the strip were vulcanized together after it was wrapped around the column (Figure 4-4).

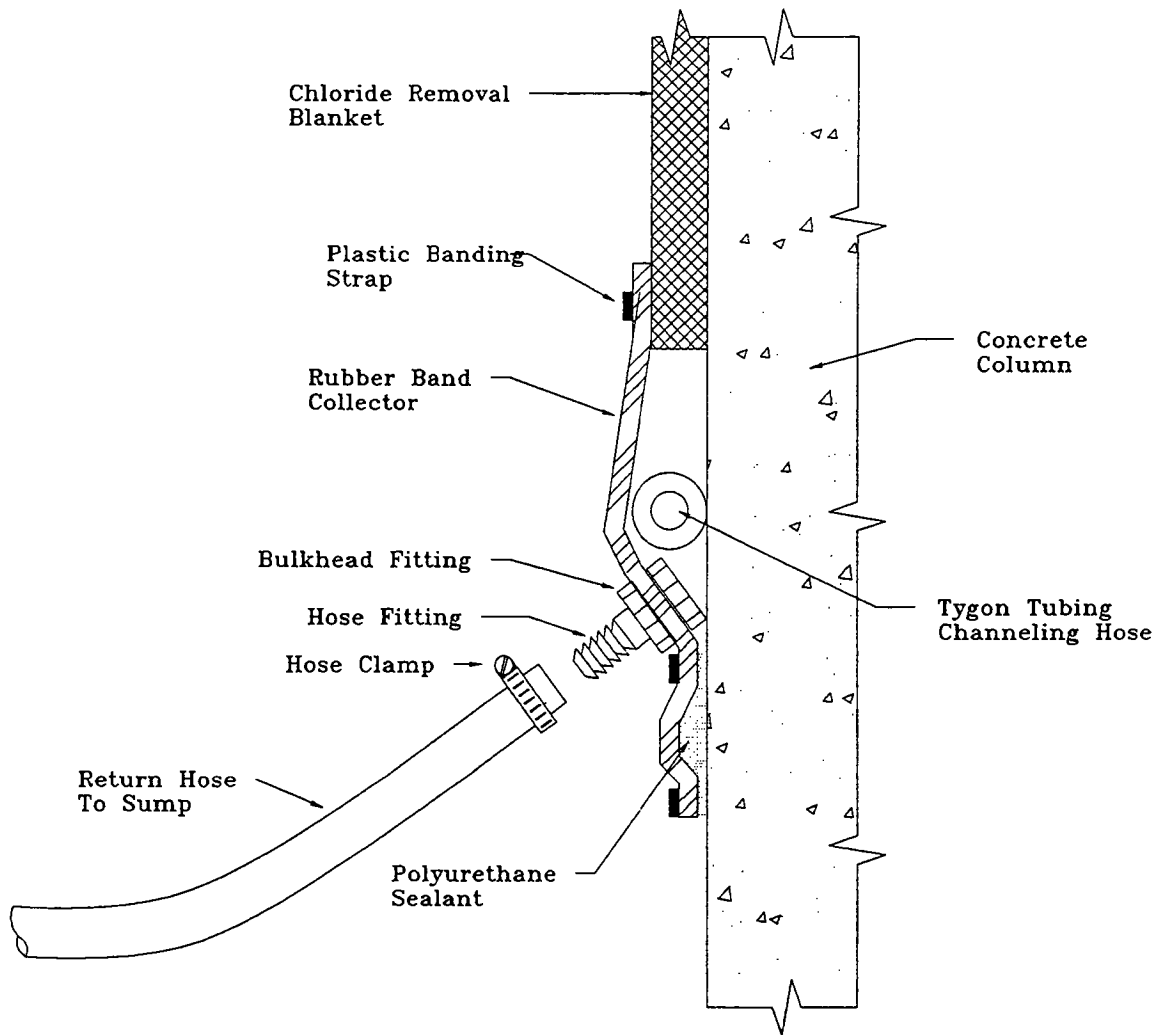
**Figure 4-6. Electrolyte Collection Detail**

The bottom of the band was sealed with urethane caulk and secured with plastic banding. The top of the band extended above the bottom of the lower anode blanket and was secured. A 1-1/4 in. (3 cm) diameter semi-rigid plastic tube (Figure 4-5) was under the band and channeled the electrolyte around the column to a bulkhead fitting connected to the return line (Figure 4-6).

When the system was checked for leaks, two major leaks were found. One was located at a crack in column 4 that traversed the seal at the bottom of the band, and the other was located at the bulkhead seal in the band of column 1. Attempts to repair these leaks were unsuccessful and columns were removed from the system and used as untreated controls.

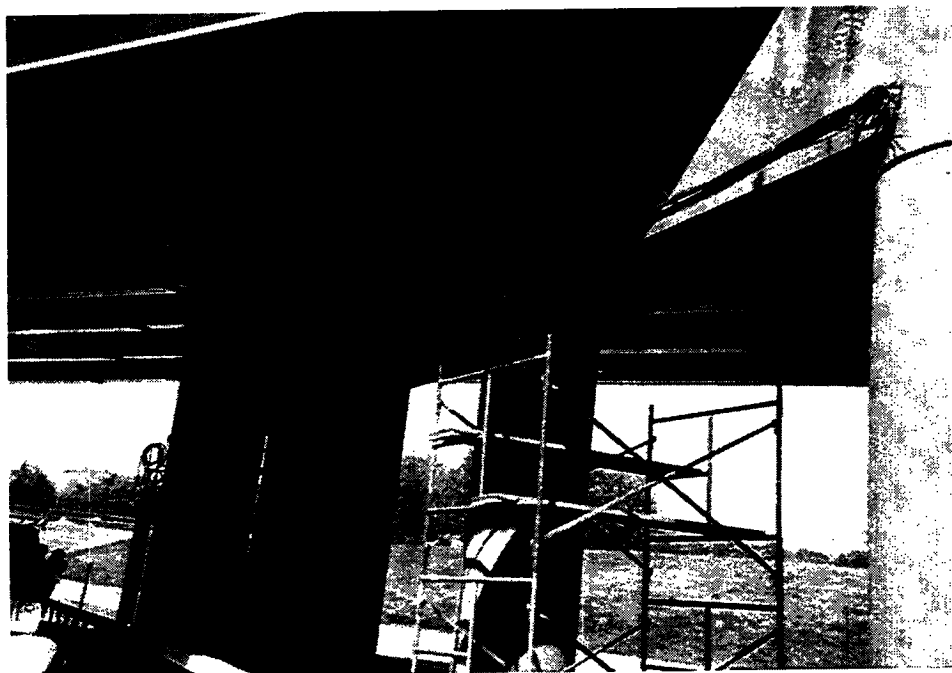
**Figure 4-9. Bundled DC Wires and Electrolyte Manifold Above Columns**

The negative and positive (anode) leads were N<sup>o</sup> 6 (black) and N<sup>o</sup> 10 (red) AWG wires, respectively, and were reused from the Florida field trial. The wires were measured, labeled, cut, and bundled together. The bundles were tied to the J-clamps which held the manifold (Figure 4-9). The bundles also contained AC power lines for the pumps.

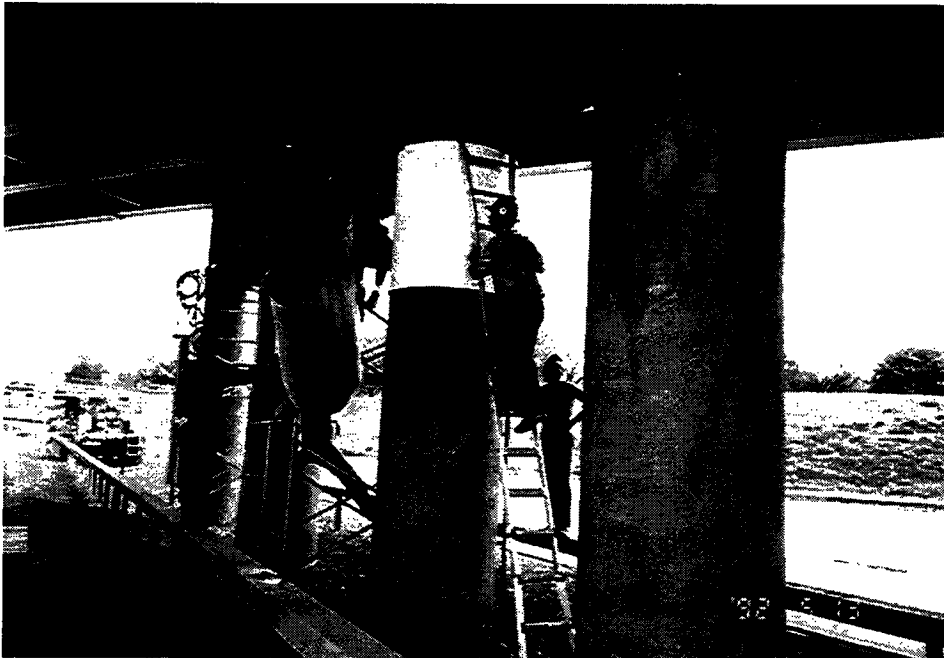
**Figure 4-10. Column Wrapped with Inner Blanket and Anode/Blanket Assembly**

A description of a typical chloride removal blanket system is described in Chapter 3 and shown in Figure 3-6. The electrolyte gravity return required the blankets to be installed no lower than 2 ft (60 cm) from the ground. Installation of an anode/blanket assembly over the inner blanket of Sorb<sub>x</sub> is shown in Figure 4-10. Figure 4-11 shows the installation of three blankets per column.

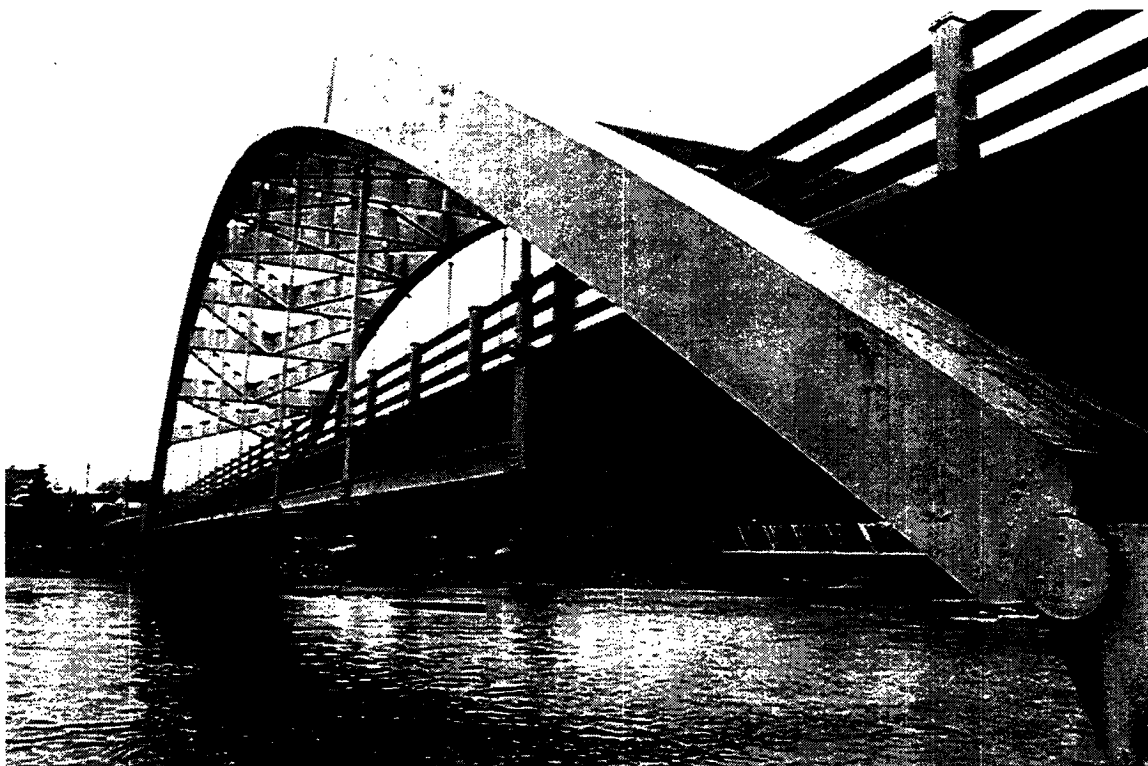
**Figure 5-1. Bridge Site 47-58, Highway 11 Over the Montreal River**

The last chloride removal field trial was in Latchford, Ontario, Canada. The system was installed on the abutments of the bridge over the Montreal River, Site No. 47-58, on Highway 11. Figure 5-1 shows the structure looking toward the north abutment.

The concrete in this structure contained alkali-silica reactive aggregate. Consequently, this structure was treated using lithium borate ( $\text{Li}_3\text{BO}_3$ ) buffered electrolyte, which, in laboratory tests, controls ASR. A core sample from this substructure was operated in the laboratory at  $0.6 \text{ A/ft}^2$  ( $6 \text{ A/m}^2$ ), and petrographic evaluations confirmed no physical signs of ASR as a result of the treatment.

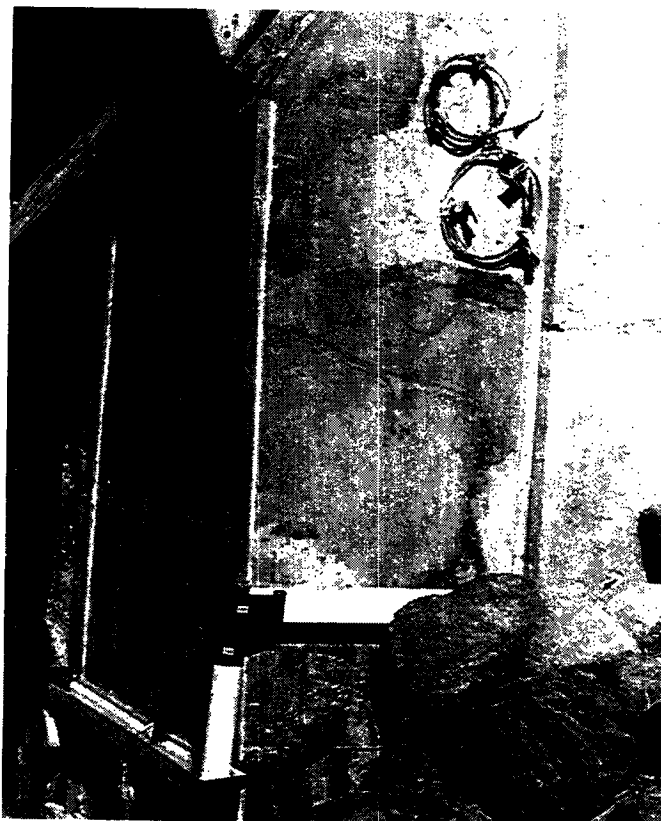
**Figure 5-5. Zone Framework, Electrolyte Collection Trough, and Reference Cell Wiring**

mounted to the concrete surface at the perimeter of the treatment areas on each zone. This was done by drilling holes in the concrete, inserting plastic anchors into the holes, and fastening screws through the boards into the anchors. Urethane caulk was used to seal the gaps between the boards and the concrete. The framework was necessary to secure the electrolyte distribution hoses, the electrolyte collection troughs, and the anode blankets. Figure 5-5 also shows the wires from the embedded graphite reference electrodes.

Plastic gutter was used to collect electrolyte at the bottom of the zones, and piping returned it to the bulk tanks. The gutter was fastened to the bottom board of the framework and urethane caulk was used to seal the top lip of the gutter to the concrete. The ends of the gutter were capped and sealed. (Figure 5-5)

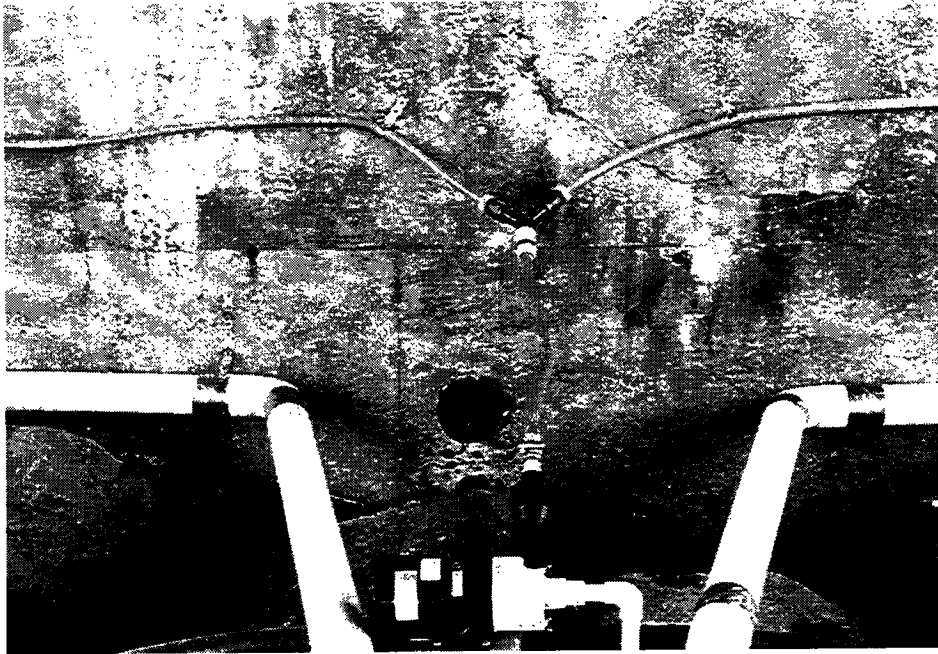
**Figure 5-6. Electrolyte Pump and Piping System**

Figure 5-6 shows the pump, distribution hose lines, and the PVC collection lines for each side of the abutment. Figure 5-7 shows the electrolyte distribution hose fastened to the top of the zone framework.

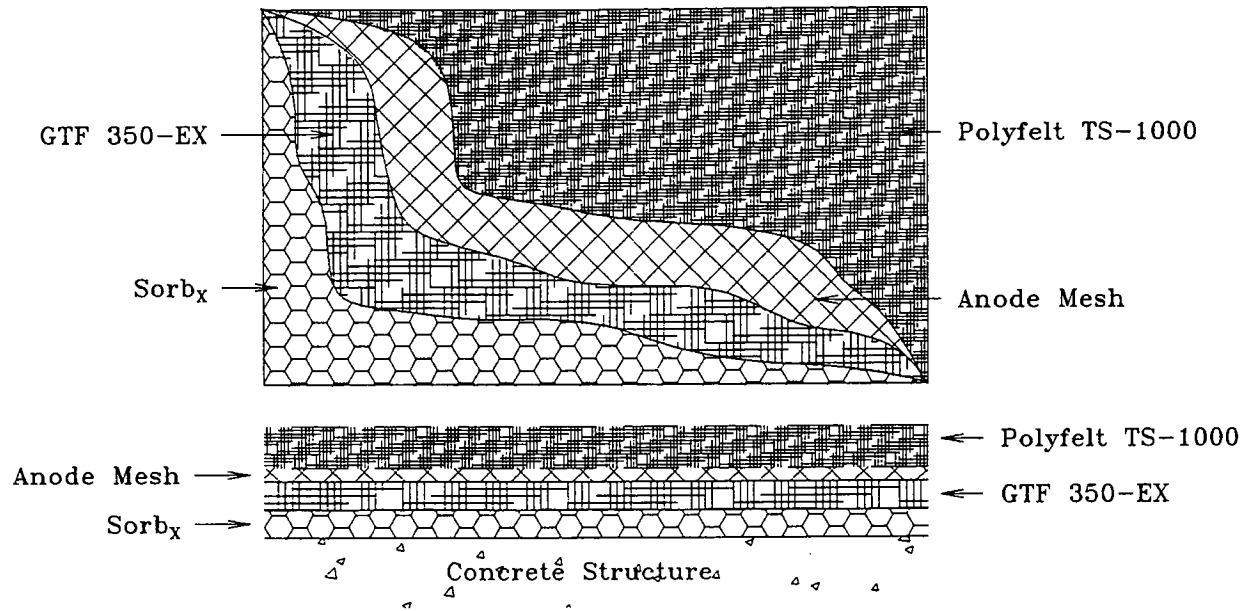
**Figure 5-8. Anode Blanket Configuration**

Titanium conductor strip was welded to the anodes with a resistance welder. The TS-1000 was lifted and the anode was then slipped into place between the geotextiles and held the anode by friction. Figure 5-8 shows the anode blanket configuration, and Figure 5-9 shows the blanket in place against the abutment wall.

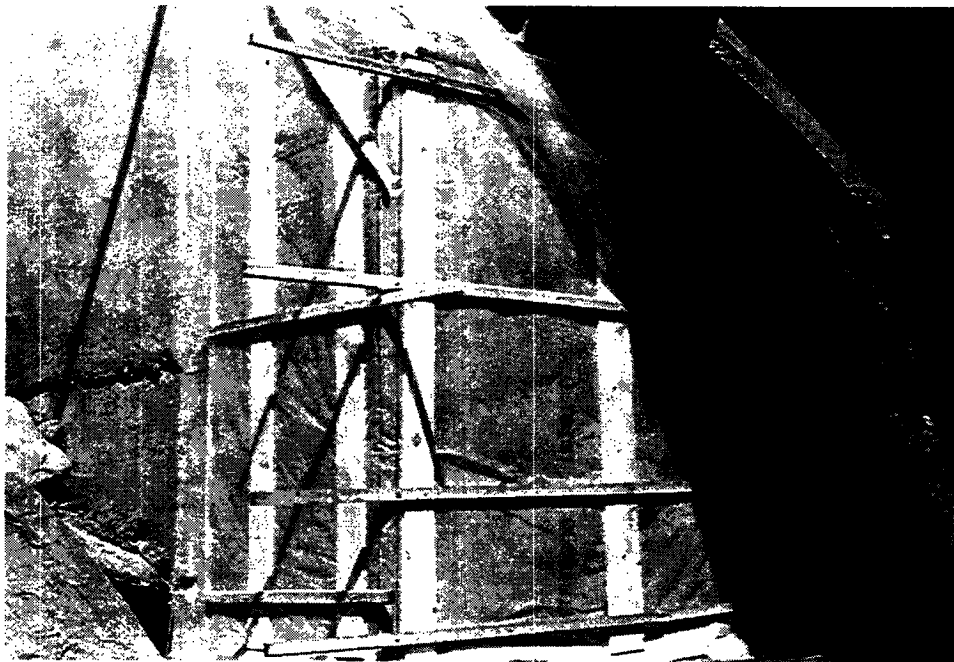
**Figure 5-10. Installed Blanket Assembly**

Wooden slats were used to hold the assembly next to the concrete to ensure good electrolyte retention between the anode and the concrete. Figure 5-10 shows the final assembly.

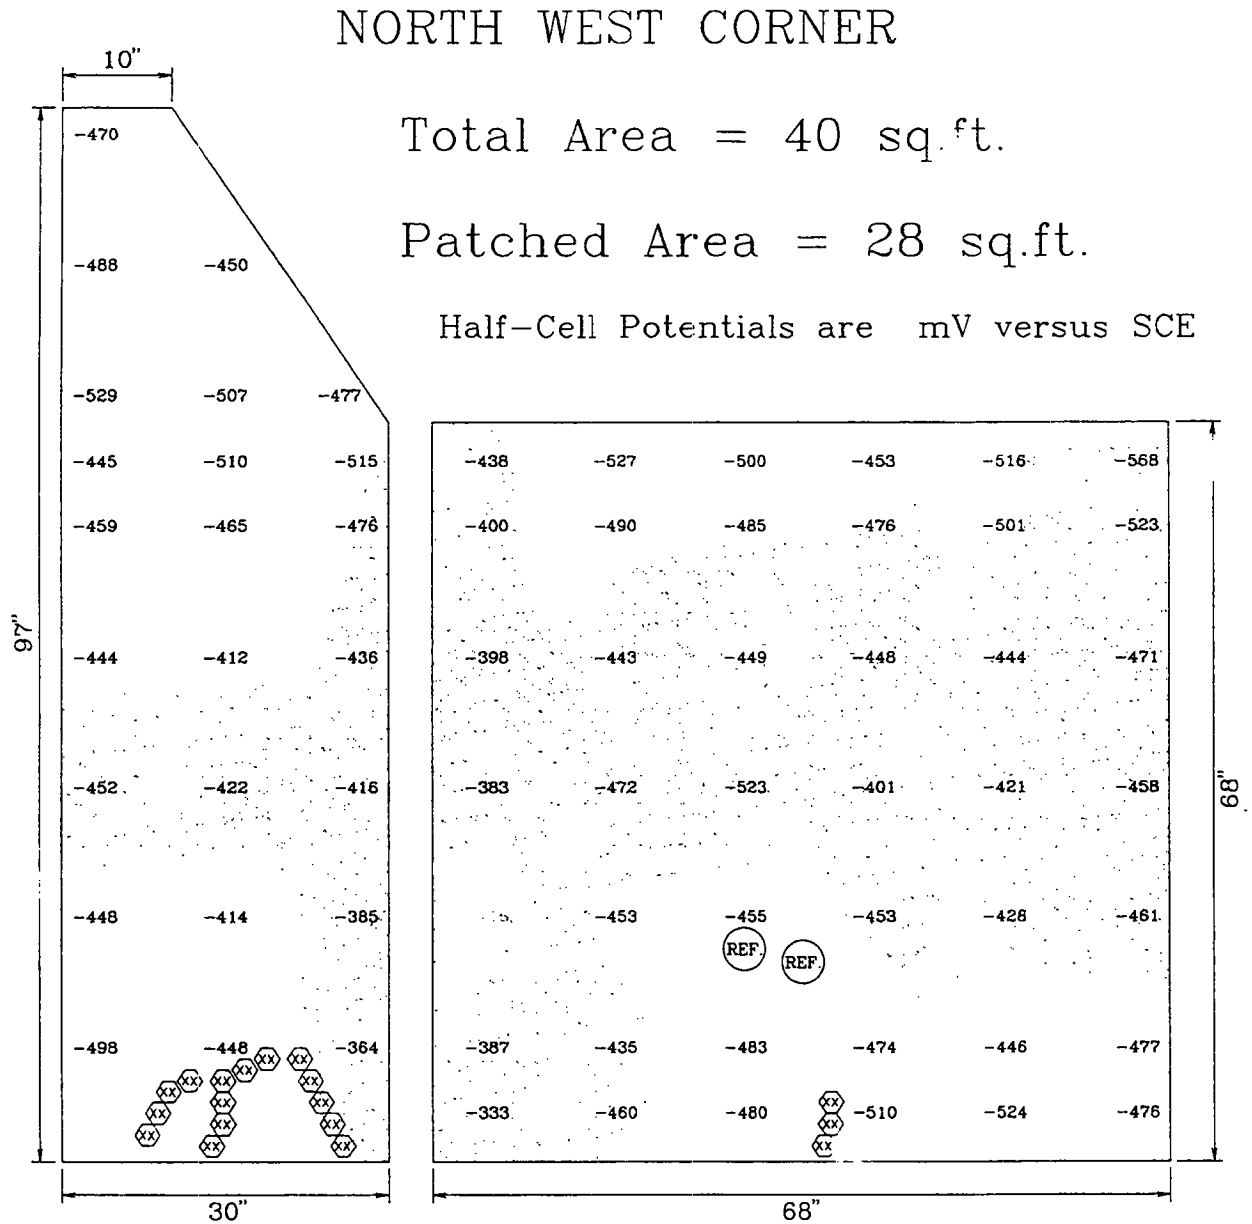
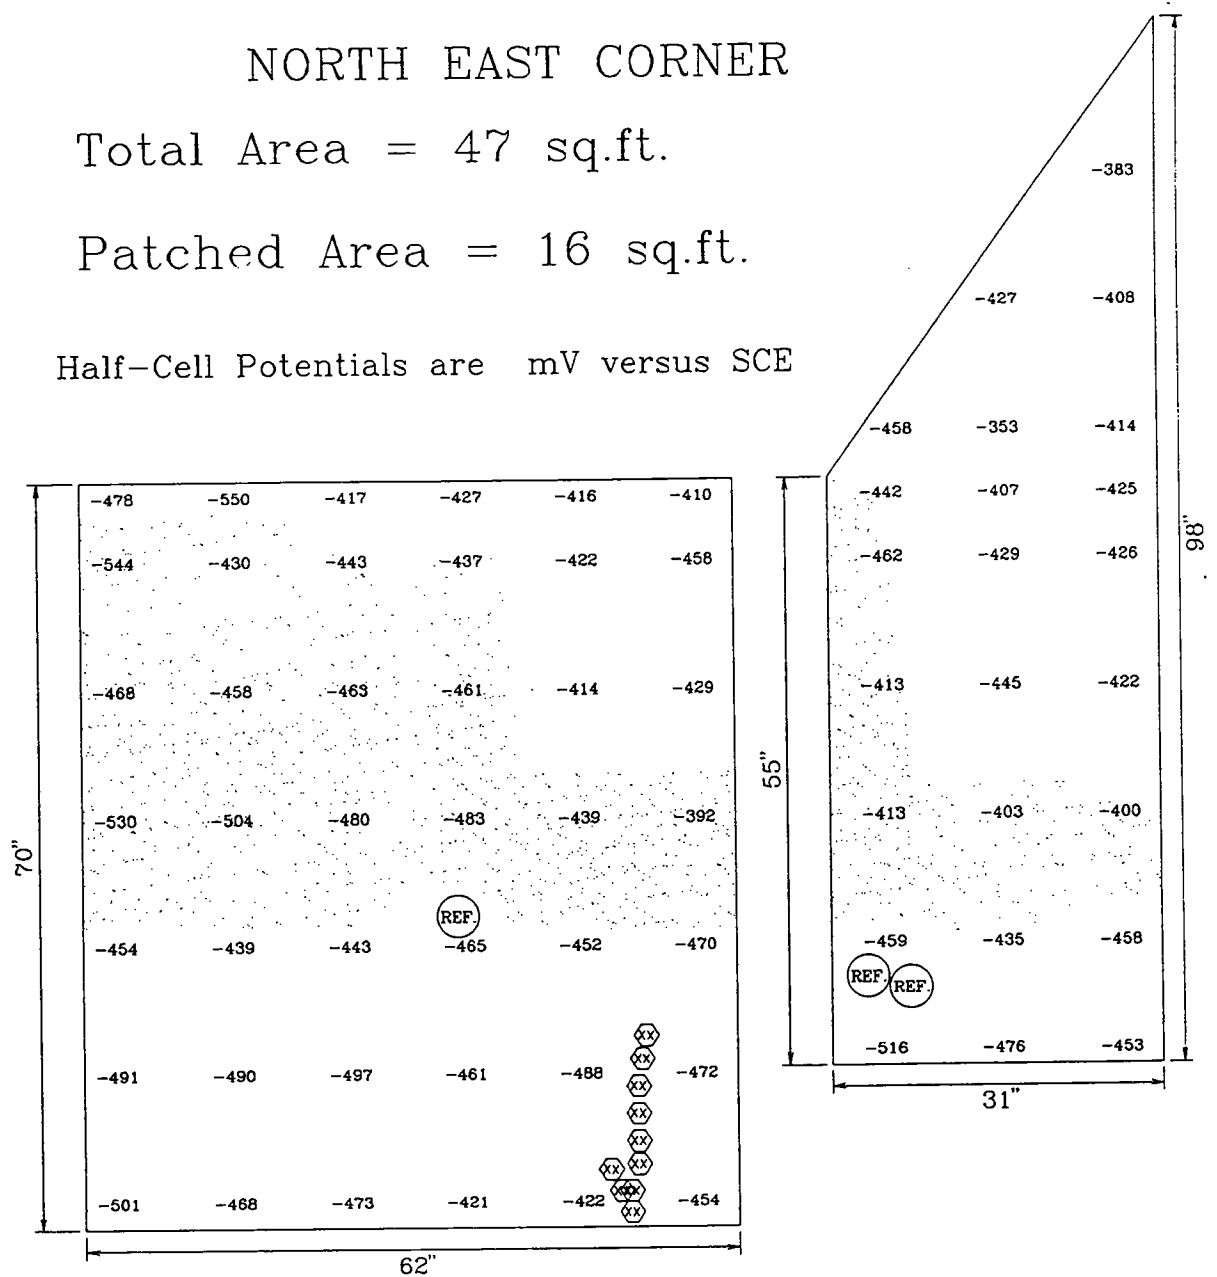
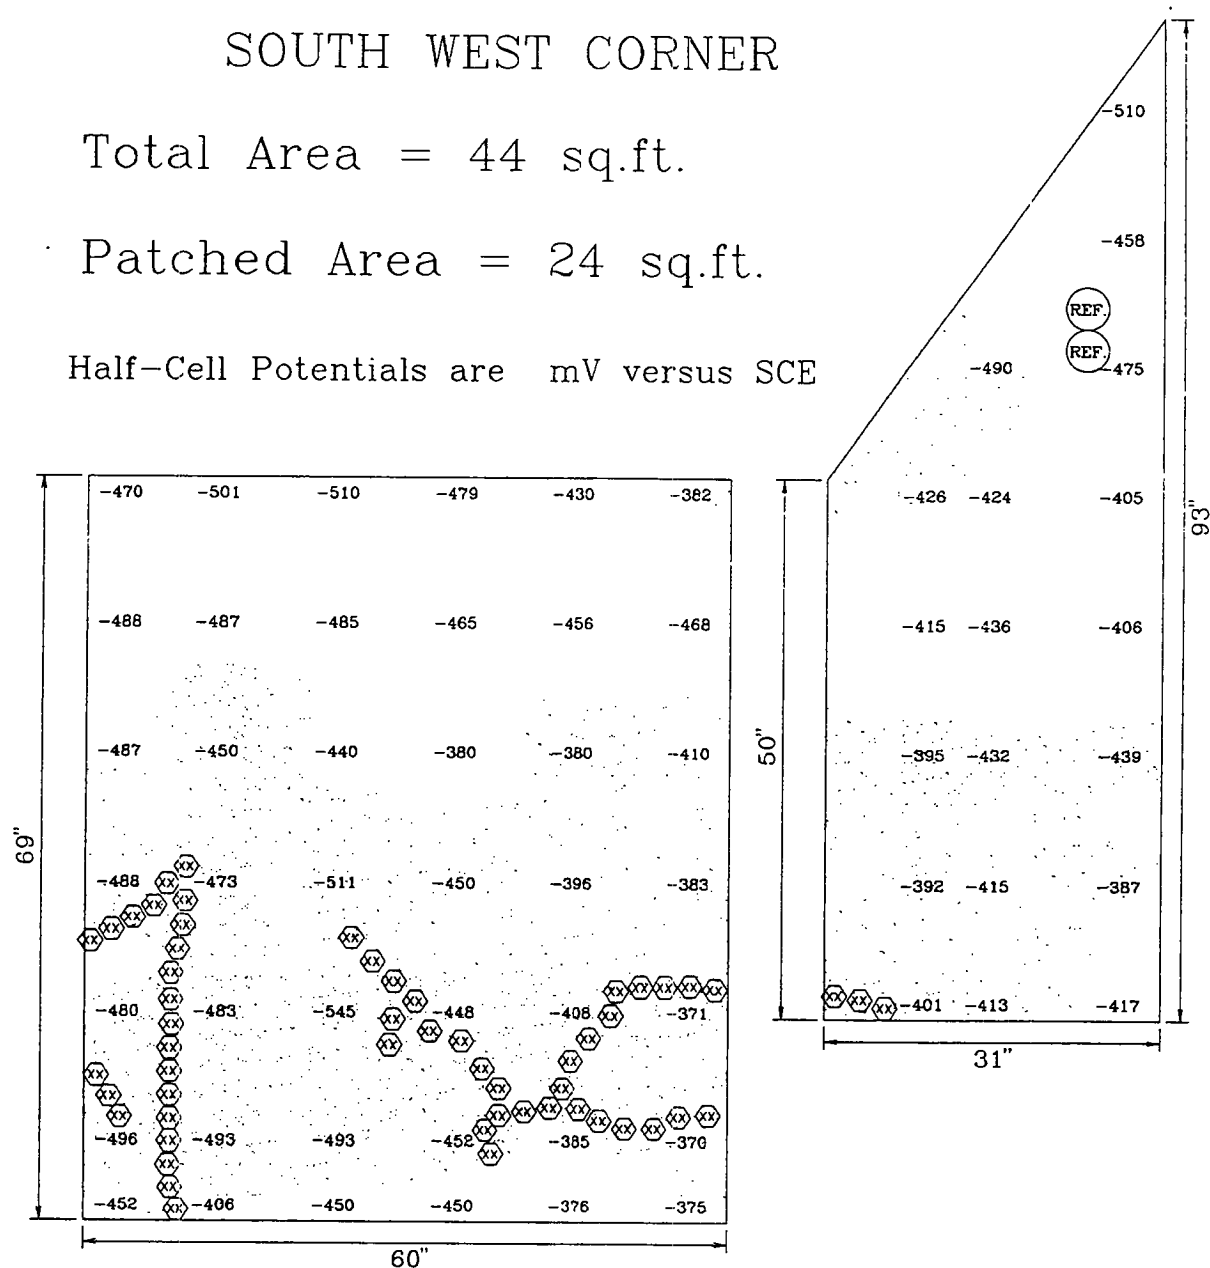
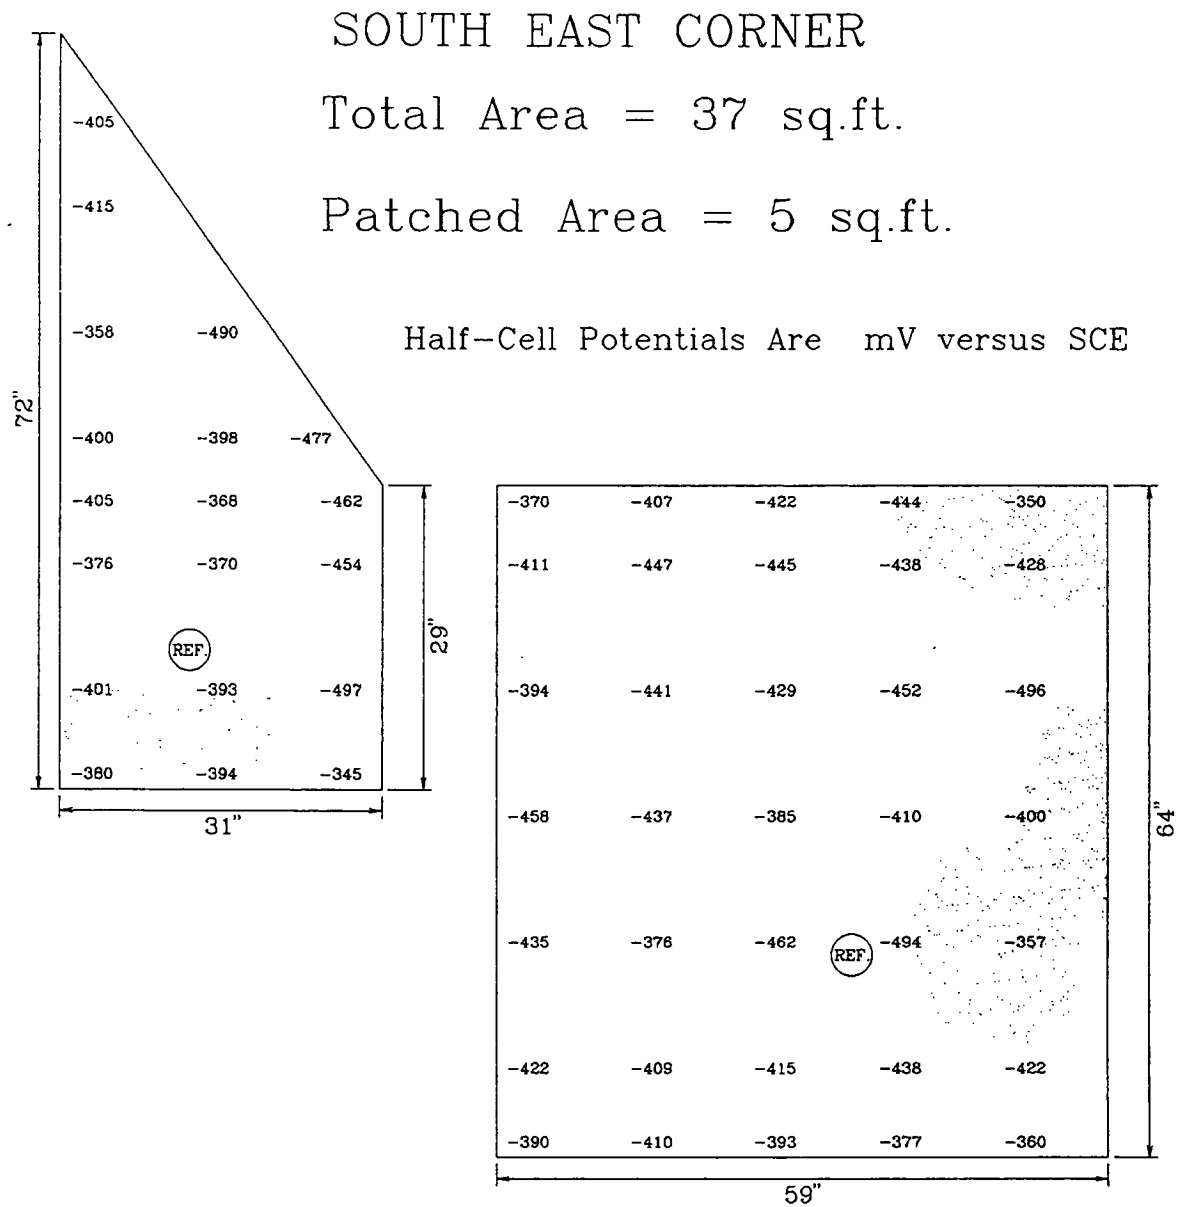
The areas treated were the faces forming the corners of the bridge abutments beneath the bridge bearing supports. The area at each of the four corners, or zones (NW, NE, SW, and SE), was approximately 40 ft<sup>2</sup> (4 m<sup>2</sup>). Drawings of these zones are in figures 5-11 through 5-14.

Several weeks prior to installation, all delaminated concrete in the areas to be treated was patched with their compatible patching material. Concurrently, concrete cores were taken, and embedded graphite reference electrodes for monitoring were installed.

A half-cell potential survey was done over each treatment zone using an saturated calomel reference electrode (SCE) and a Fluke 27 multimeter. The results are in figures 5-11 through 5-14. The data show that the reinforcing steel in all areas is actively corroding.

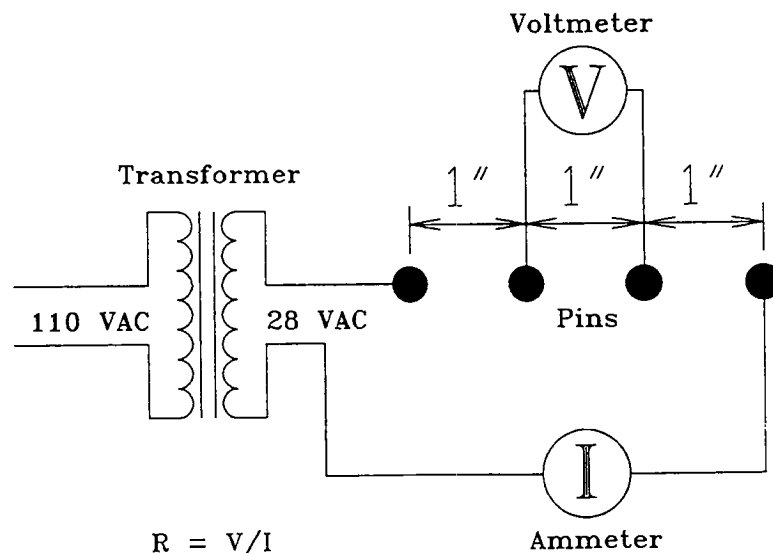
**Figure 5-15. Field Assembled Resistivity Device**

Because an AC resistance meter was not available, another method had to be devised to determine the concrete resistivity. To obtain the data a circuit was wired as shown in Figure 5-15. The current and voltage could be determined by using this test device and two meters.

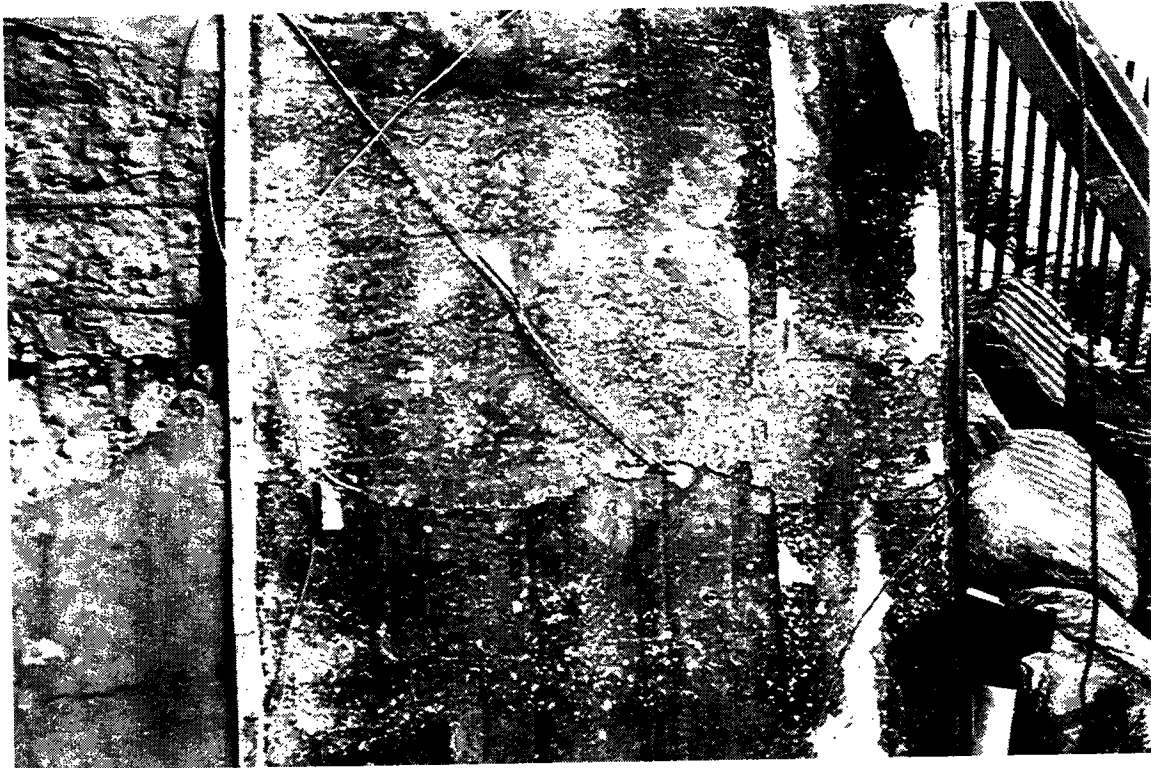
**Figure 5-17. Concrete Surface After Treatment**

Visual observation of the treated area after system removal indicated little or no damage to the concrete surface. Figure 5-17 is a photograph of the surface of the concrete after system removal. Each area had a series of shrinkage cracks in the patched areas. These cracks were present before treatment and were not a result of the chloride removal process.
