SHRP-S-669

# **Electrochemical Chloride Removal and Protection of Concrete Bridge Components: Field Trials**

ELTECH Research Corporation  
Fairport Harbor, Ohio

**Strategic Highway Research Program**  
National Research Council  
Washington, DC 1993

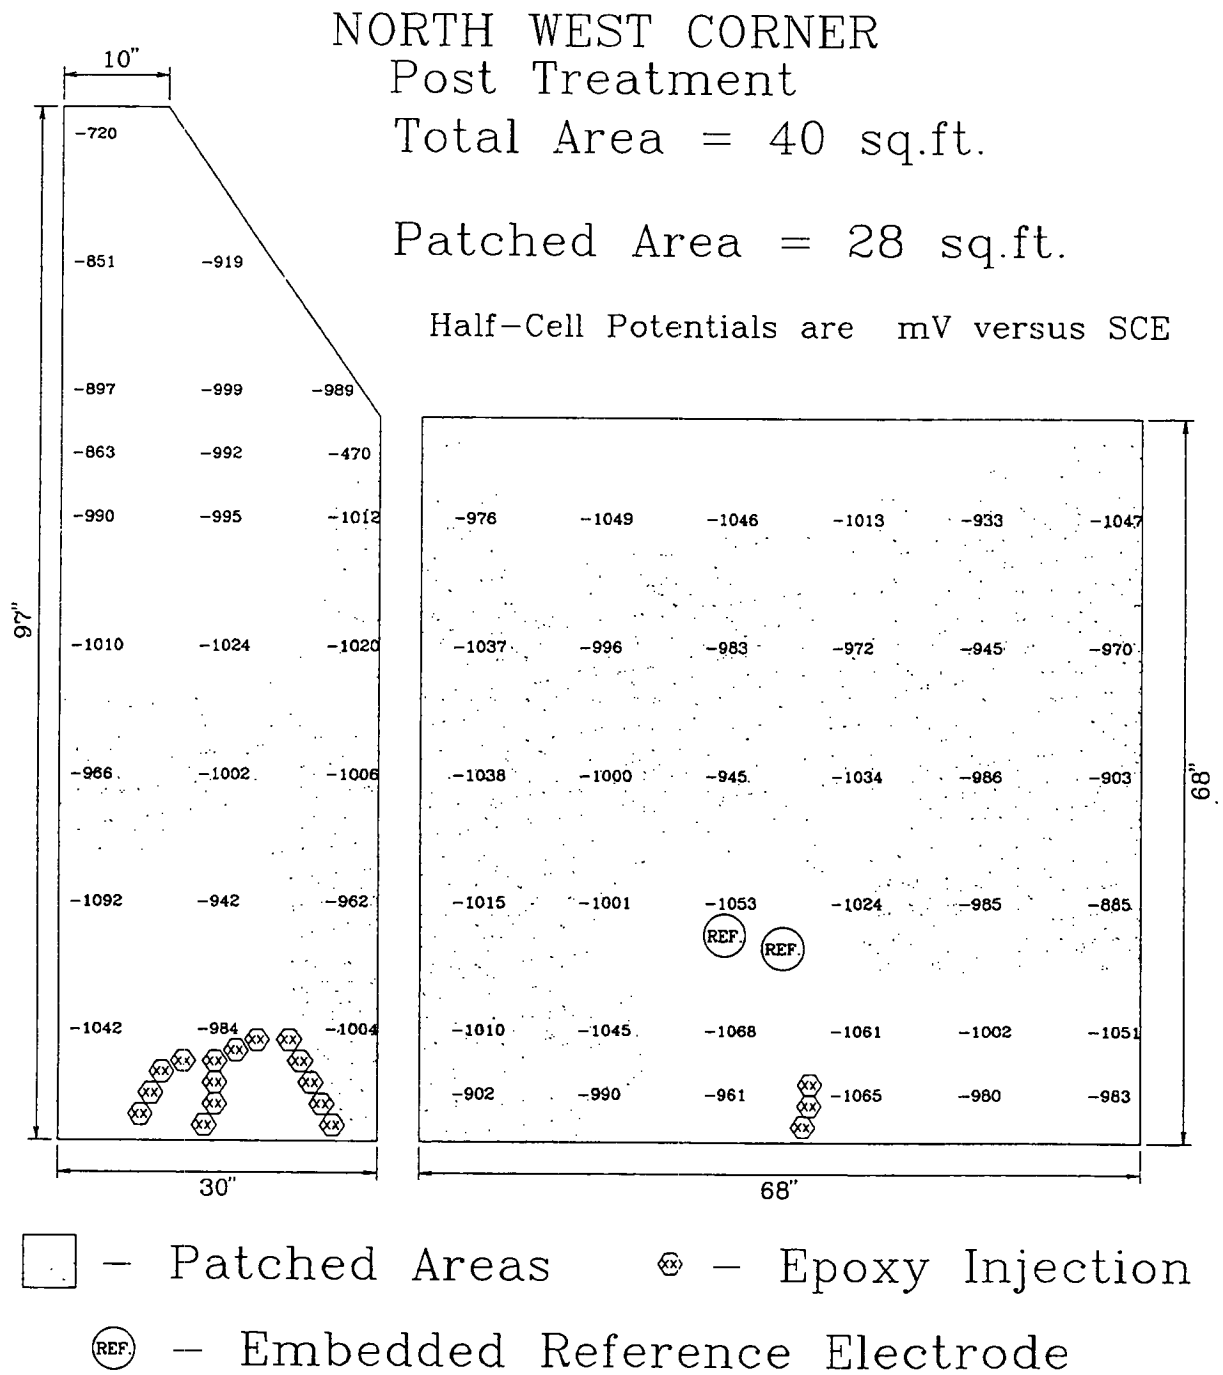
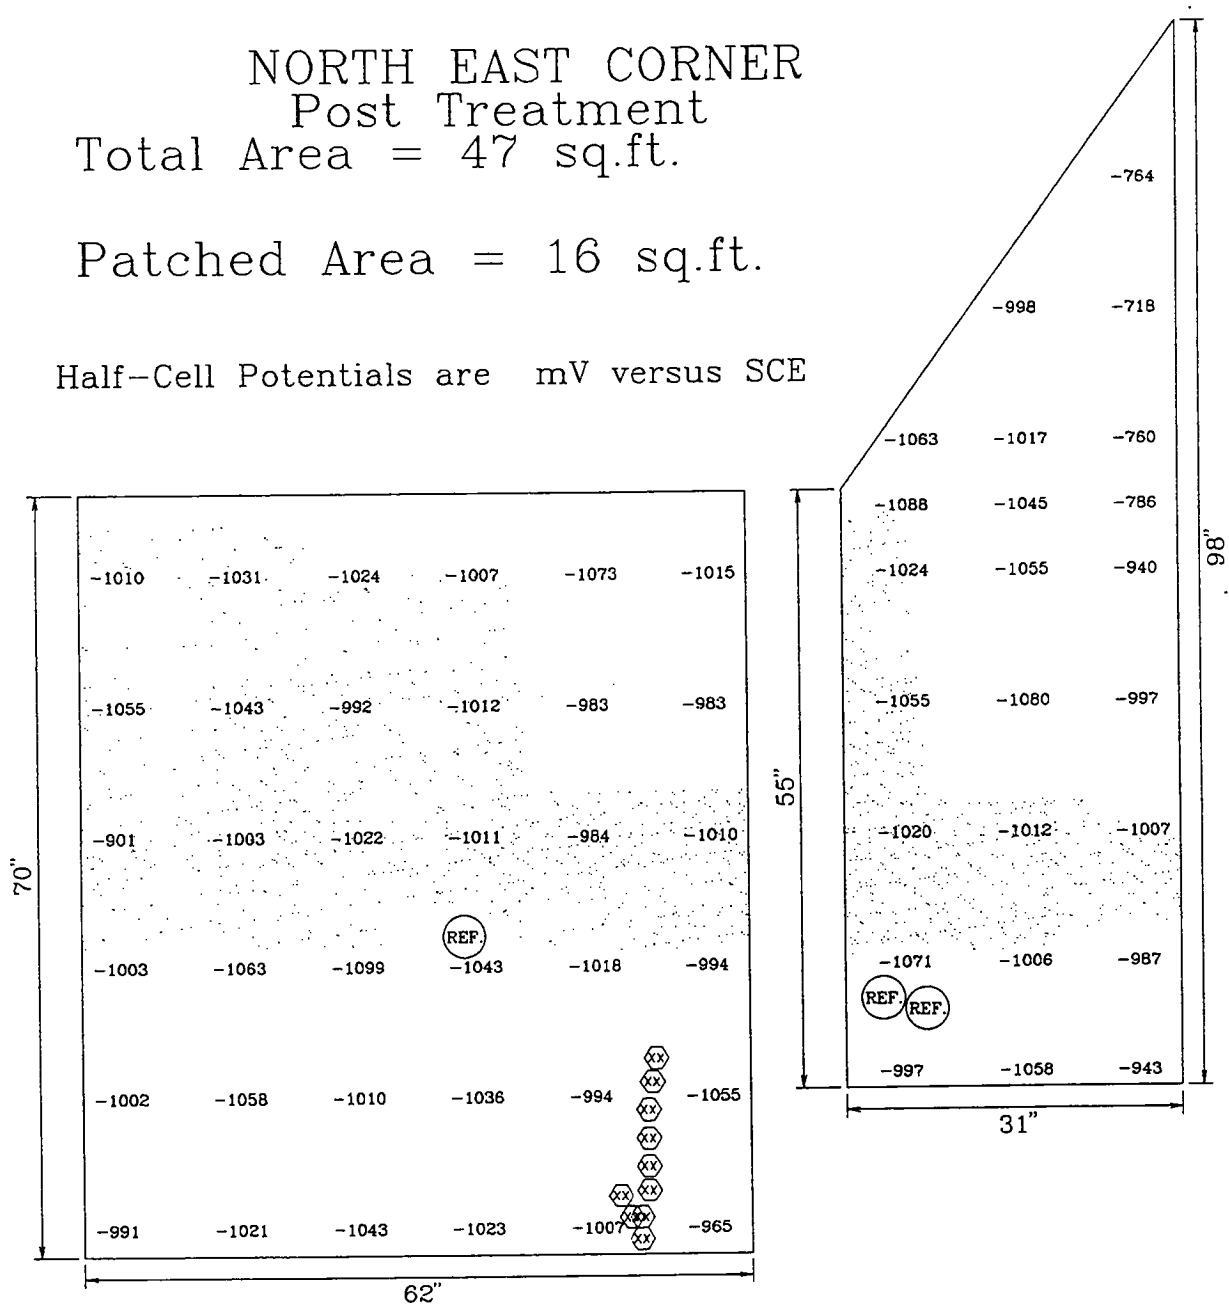
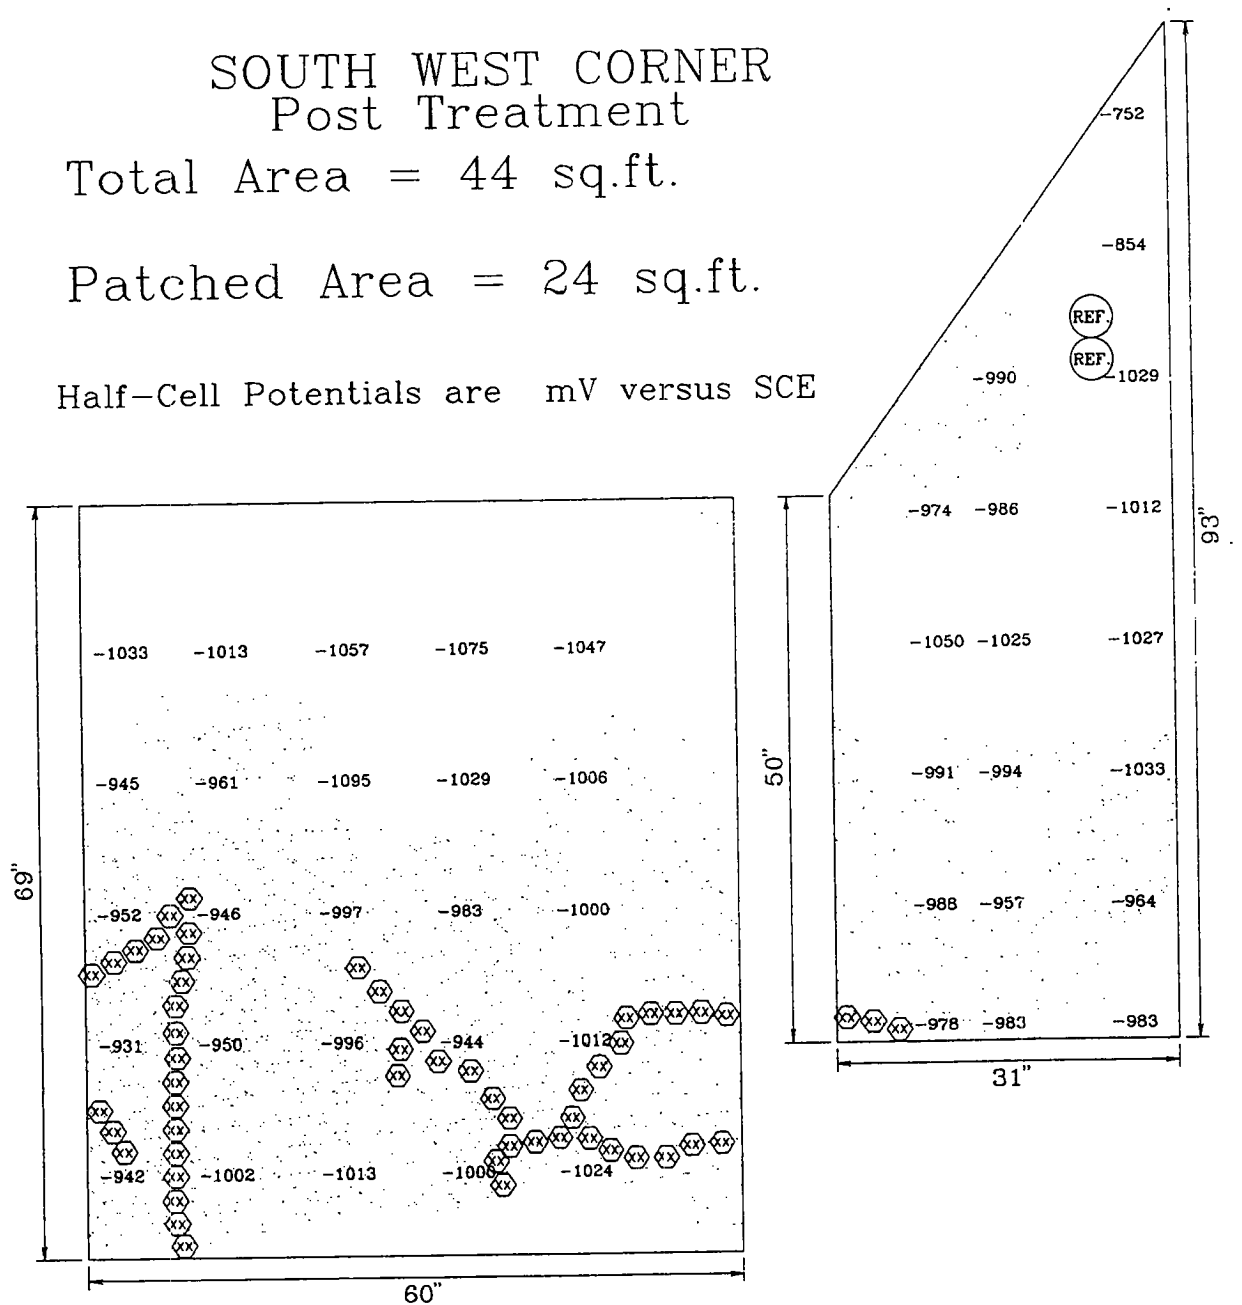
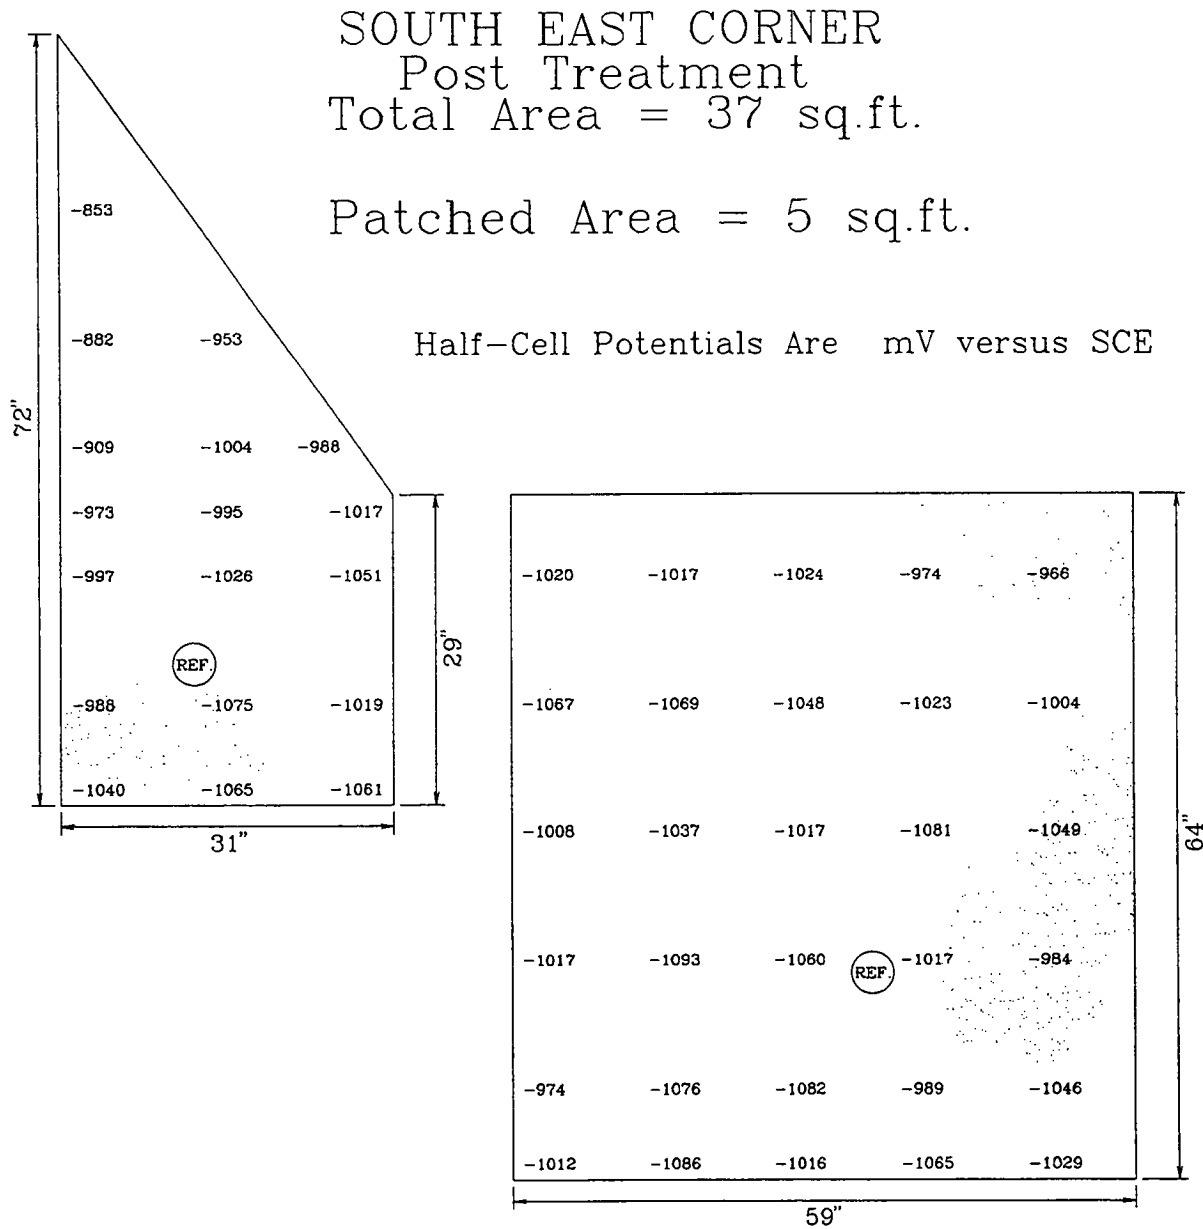
The purpose of this potential survey was to determine the uniformity of polarization, and therefore, the uniformity of current distributed to the steel during treatment. The potential survey is shown being taken in figure 5-22. All potentials were taken using a saturated calomel reference electrode (SCE). The post-treatment potential survey is shown on figures 5-18 through 5-21. These figures show the polarization, and therefore current distribution, to be relatively uniform over most of the treatment area. The exception is the small triangular area on the sides of each corner. These areas were consistently polarized to a less negative value, indicating a lower current density. This was probably due to poor electrolyte circulation, creating a dryer condition in this area, and less current would be passed.
