# Appraisal of Guardrail Installations by Car Impact and Laboratory Tests

WILLIAM G. CICHOWSKI, PAUL C. SKEELS, AND WILLIAM R. HAWKINS, *Respectively, Project Engineer and Head, Experimental Engineering Dept.; and Road Design Engineers, Plant Engineering Dept., General Motors Proving Ground, Milford, Mich.*

This paper describes the guardrail tests conducted at the General Motors Proving Ground since the previous paper, "Full-Scale Appraisals of Guardrail Installations by Car Impact Tests," was presented in January 1959 (HRB Proc., 38:353). Approximately 105 tests have been conducted since that time, including tests of improved end sections, chain link fence and cable type barriers, rail mounting and spacing from post, post strength, beam strength, special posts and mounting on superelevated curves.

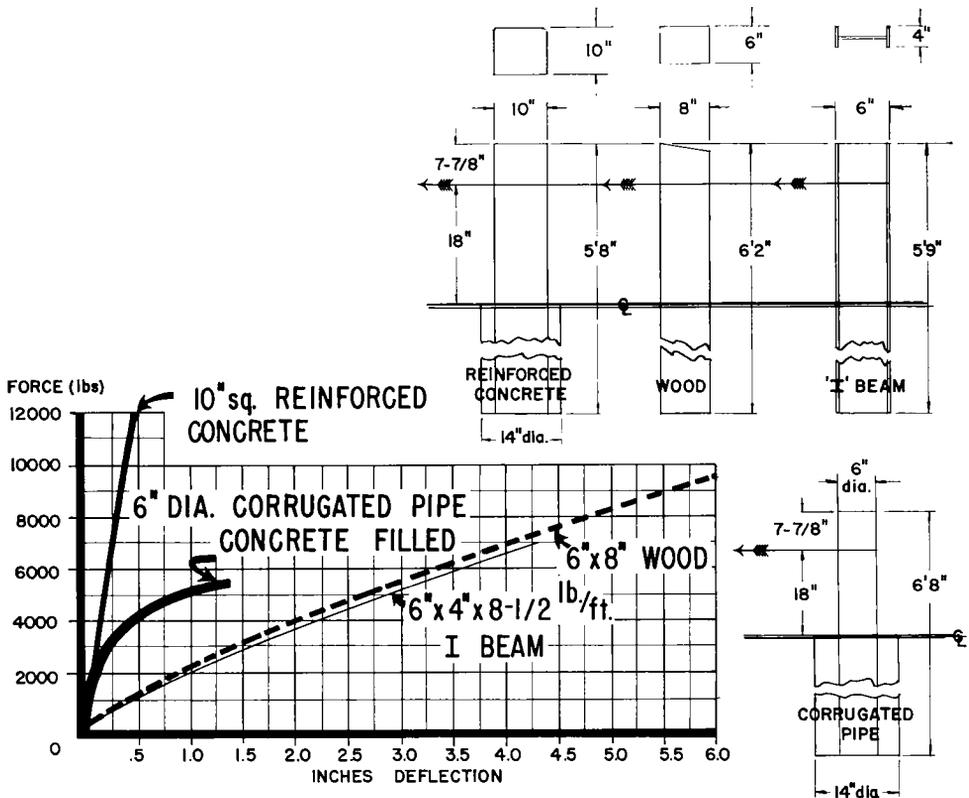
Figure 1. Post soil bearing strength by static pull test; post mounted in dry glacial till for at least 2 months, load applied 18 in. above ground surface.

Figure 1 shows that the 10-in. x 10-in. reinforced concrete post with a 14-in. diameter base was very solidly in the ground as indicated by the steep load vs deflection curve. This undesirable rigidness was verified by an actual test on a guardrail installation using these posts. A 6-in. diameter spirally-wound corrugated steel pipe, concrete filled, mounted in a 14-in. diameter concrete base gave

fair results. However, the post was weak and the base's soil bearing was too strong. The 4-in. x 6-in. x 8½-lb per ft steel I-beam post performed quite satisfactorily in the soil until the post rotated and bent just below the ground line. The 6-in. x 8-in. post, 6 ft 2 in. long, either new wood or precast concrete, has given the most satisfactory soil bearing results to date. This size post produced the long gentle load versus deflection soil bearing curve (Fig. 1).

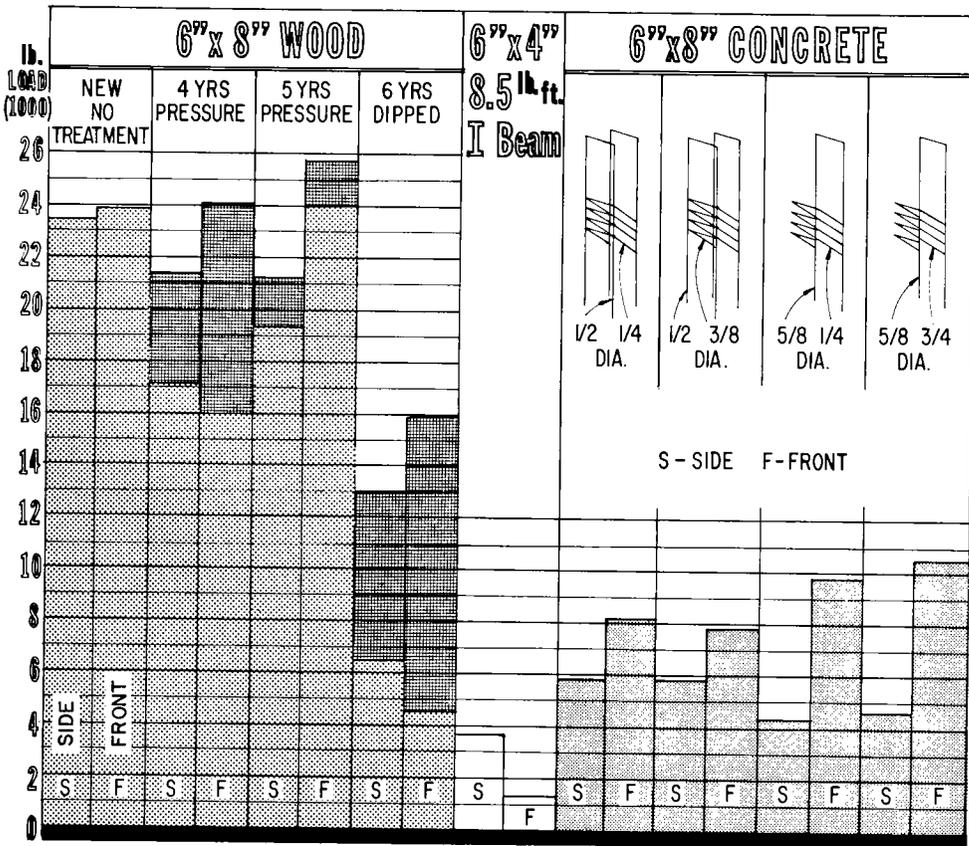
Figure 3. Post breaking strength.

was applied by a testing machine 18 in. above and parallel to a simulated frozen ground condition. This load was applied to both the traffic face and the side of the post. The 6-in. x 8-in. wood posts gave good to poor results depending upon their age and type of preservation (Fig. 3). The

open box areas at the tops of the columns indicate the variation of strength among the posts tested. The 6-in. x 4-in. x 8½-lb per ft I-beam post indicated poor strength during this test. Finding that a 6-in. x 8-in. x 6-ft 2-in. post gives a desirable load vs deflection soil bearing curve, it was attempted to construct a concrete post which would be more durable than the wood post. Figure 3 shows that the strength of the wood post has not been duplicated although many variations of reinforcing rod and stirrup rod location have been tried. Figure 4 shows some of the construction details of this type of post.

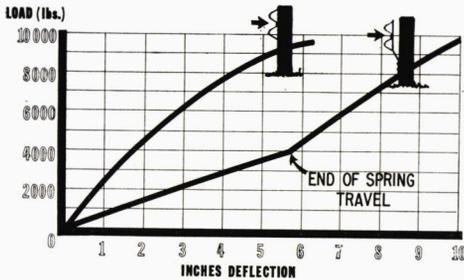
Figure 6. Effect of spring bracket for load 18 in. from ground surface.

The 4-in. block out of a guardrail ribbon is usable space to lessen the shock of a guardrail impact. Experiments with a spring bracket type of ribbon mounting having a spring rate of 1,000 lb per in. have been conducted. These spring brackets are made of AISI 5160 steel and are 4 in. wide and 7/16 in. thick. The effective arm of this cantilever spring bracket is 15 in. By combining this spring rate with the load vs deflection soil bearing curve of a 6-in. x 8-in. x 6-ft 2-in. post, desirable results are produced. Figure 6 shows the low rate of load buildup until the bracket contacts the post, and then the increase of load rate until the post finally yields rapidly in the soil. This 4-in. lateral flexibility provided by the spring mount plus the post movement reduce the car damage greatly, and lower the lateral acceleration on accidents of 35 mph and less. In

higher speed accidents, this added flexibility seems to do no harm. The deflection afforded by the spring brackets is not affected by ground condition.

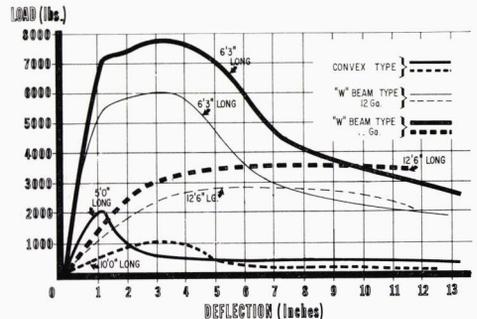
Figure 10. Beam strength of guardrail ribbon.

Figure 10 shows the results of these tests. These data confirmed the previous conclusion that it was not economically possible to strengthen the existing proving ground convex ribbon satisfactorily by closer post spacings. The gage thickness of the beam-type ribbon

and the simulated post spacings, all had a pronounced effect.

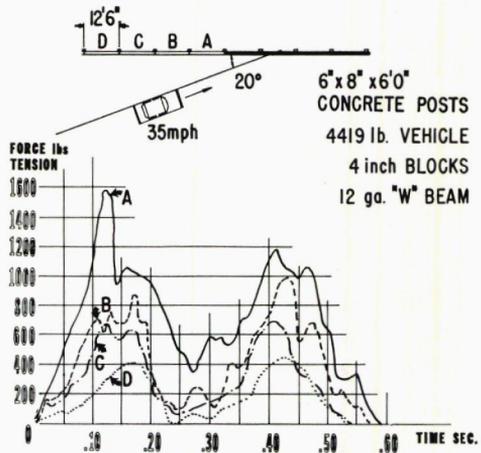
Figure 13. Guardrail ribbon tension.

mph and at a 20-deg included angle to evaluate the tensile forces produced in the sections of guardrail ribbon. This was also the beginning of an attempt to solve the problem of the minimum length of a guardrail. Figure 13 shows that the forces are not too high considering the ultimate tensile strength of 80,000 lb for the 12 gage ribbon. The two pronounced families of peaks in the curves are caused by the front of the vehicle hitting the rail first—then being deflected and the rear of the vehicle swinging around and contacting the

rail. As yet no guardrail ribbon tension failure has occurred at the proving ground even in higher energy level bus impact tests. The 12½-in. overlap of the ribbon sections at their joints and the eight splice bolts appear to be sufficient. On this basis the 12-gage W-beam galvanized-steel guardrail ribbon does appear to have adequate cross-sectional area to withstand the impact tensile loads applied to it by passenger cars when the proper end treatment is used.

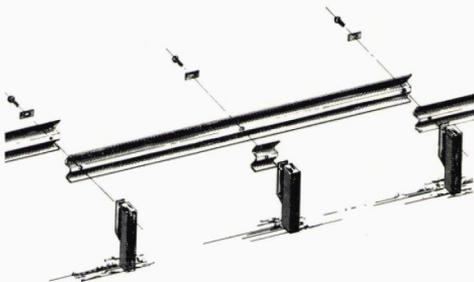
Figure 12. Reinforcement of guardrail installation.

One weakness that appeared in the beam-type guardrail ribbon was the ease with which it flattened out and lost its section modulus. This was particularly evident when spring brackets were used with a 6-ft 3-in. post spacing (Fig. 11). To reinforce the section and prevent the ribbon flattening at the non-splice post mounting, a short 12-in. piece of W-beam is now mounted behind the guardrail ribbon (Fig. 12).

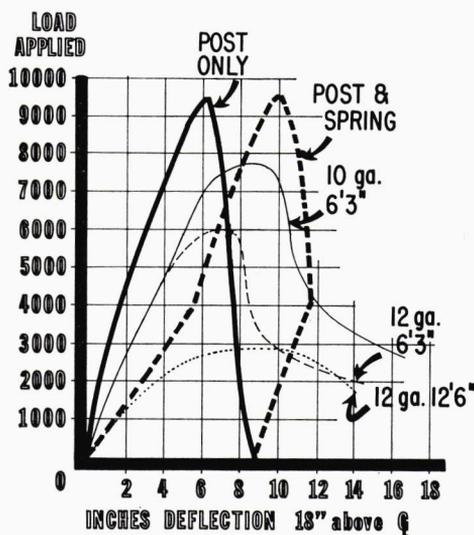
Figure 14. Total strength of guardrail with 6-in. by 8-in. wood posts.

From the data derived from the post soil bearing test and the beam strength test, curves were drawn (Fig. 14) to evaluate various configurations in terms of load vs deflection. It was assumed that the load was applied normal to the axis of the guardrail ribbon. In determining the values used to establish these curves, the interdependence of a continuous guardrail installation was disregarded. These curves are based on a 12-ft 6-in. long guardrail installation. If the load was applied at the post location, the load vs deflection curve represented by a heavy solid line would result. If a spring bracket was used on the post, a curve

represented by the dashed line would result. If the impact point was midway between the posts, the other curves would result depending upon the post spacing and the thickness of the guardrail ribbon. During an actual impact, the car usually slides along the rail. There is a difference between the load vs deflection curve for the post soil bearing strength and the load vs deflection curve for the ribbon strength. This will result in a lumpy type of lateral reaction to the car impacting the guardrail. This has been verified by oscillograph recordings of the lateral and longitudinal accelerations and decelerations experienced by a vehicle impacting a 12-gage ribbon with a post spacing of 12 ft 6 in. Figure 15 is an oscillographic record of a 39-mph, 20.4-deg impact, and shows the lump experienced in the transverse acceleration curve after impact. The load vs deflection curve for any point along the guardrail should be the same. Therefore, in terms of this graphic analysis of a guardrail's strength, it appears that the posts are either too strong or the ribbon

is too weak in bending. The posts should not be weakened because post failures do occur from time to time. It appears that in order to achieve a more balanced guardrail design, the beam-type guardrail must be made stronger in bending, or the post spacing must be reduced accordingly.

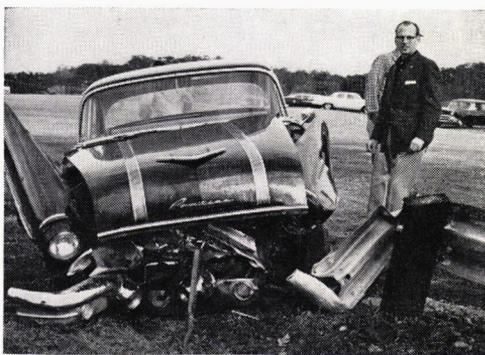
Figure 16. Standard guardrail end impact.

One phase of the guardrail testing program was to determine the best type of end treatment for guardrail installations. This testing was prompted by reports and pictures of cars striking the ends of guardrail installations on public highways. Tests indicated that the standard terminal section (27½-in. long) was extremely dangerous (Fig. 16). Also tested were installations using an end treatment consisting of a standard 12.5-ft length of guardrail curved to 10- and 50-ft radii (Fig. 17). Both

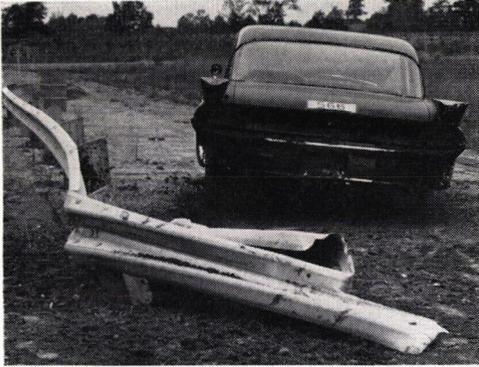
Figure 17. Impact on guardrail end with 50-ft radius.

tests produced unsatisfactory high deceleration rates to the vehicle.

The most satisfactory solution found to date is to slope the guardrail into the ground and anchor it in concrete. The length of the sloped-end treatment can vary with speeds driven at these sites. A 37.5-ft length, three 12.5-ft sections of rail, is satisfactory for most locations but not on rural freeways at 65+ mph. Posts are 6 ft 3 in. on centers (Fig. 18). This end treatment has the advantage of using standard materials which all guardrail contractors can supply. Several full-scale tests have been run on this type of installation. Figure 19 is a picture of a vehicle during a 65-mph, 3-deg impact. Vaulting of the vehicle is still a problem; how-

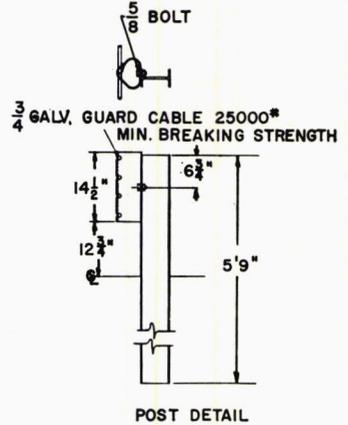
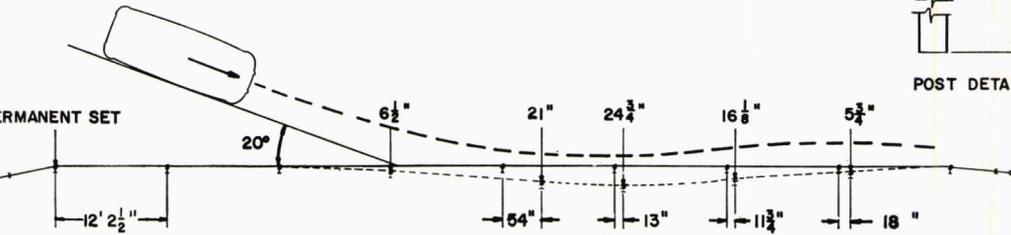
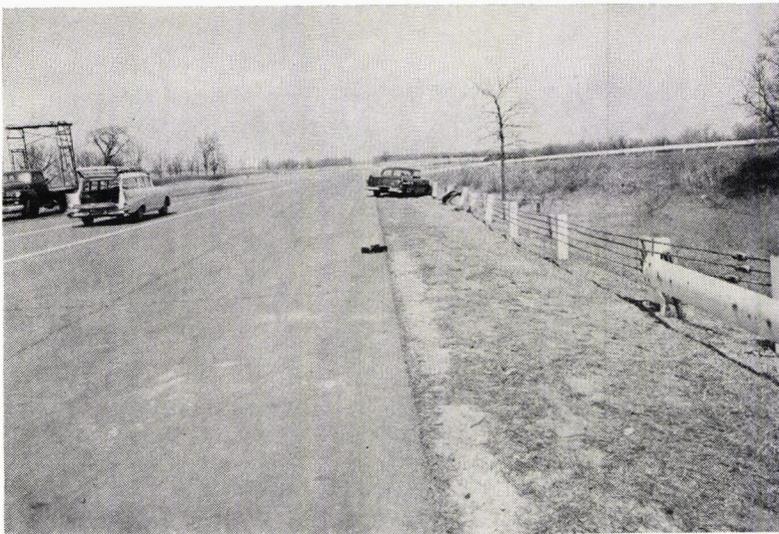
Figure 29.

Guardrail Damage - 4 posts  
4 cables stretched

Deceleration: Transverse (vehicle) 5.8 G's  
Transverse (dummy-right front) 4.0

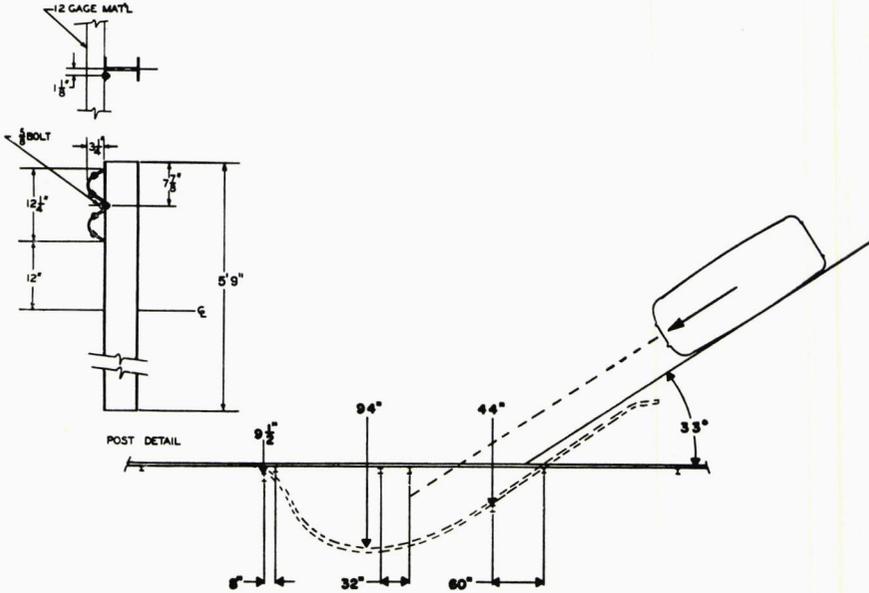
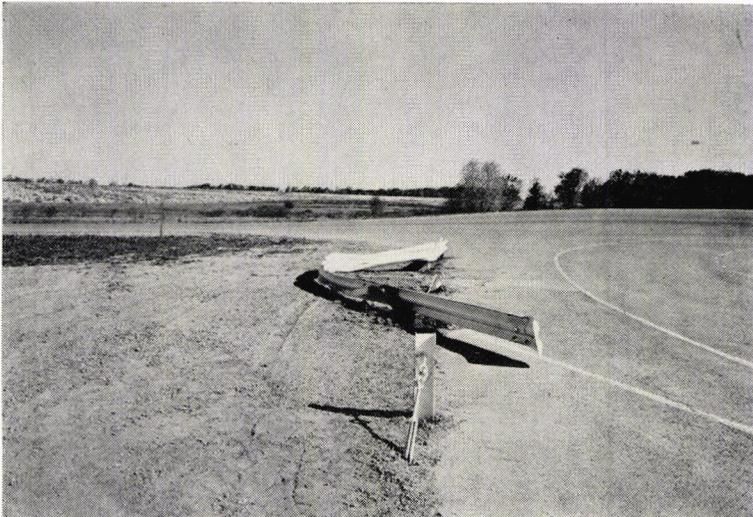
Figure 31.

Guardrail Damage - three posts  
three sections of rail

Vehicle - 1956 Pontiac 4 Dr. Hr. - Wt. 4163 lbs.  
Estimate of Damage: \$175.00

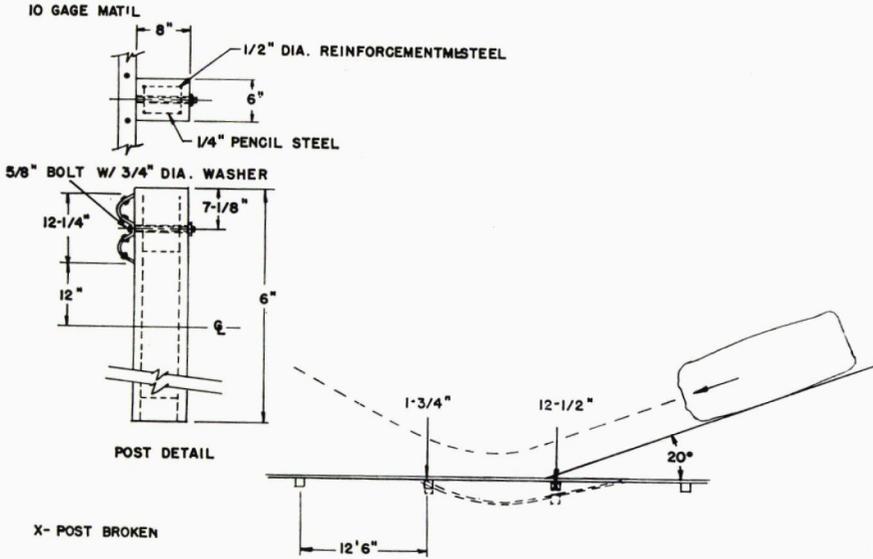
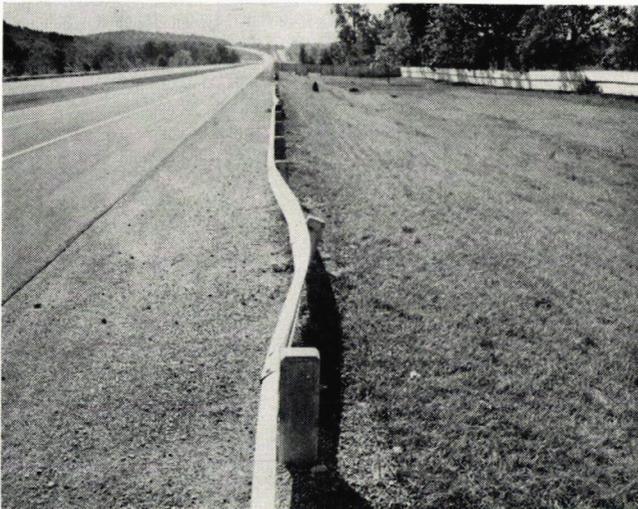
Figure 39.

Guardrail Damage - one post  
two sections of rail

Vehicle - 1957 Pontiac 2 Dr. - Wt. 4058 lbs.  
Estimate of Damage: \$150.00

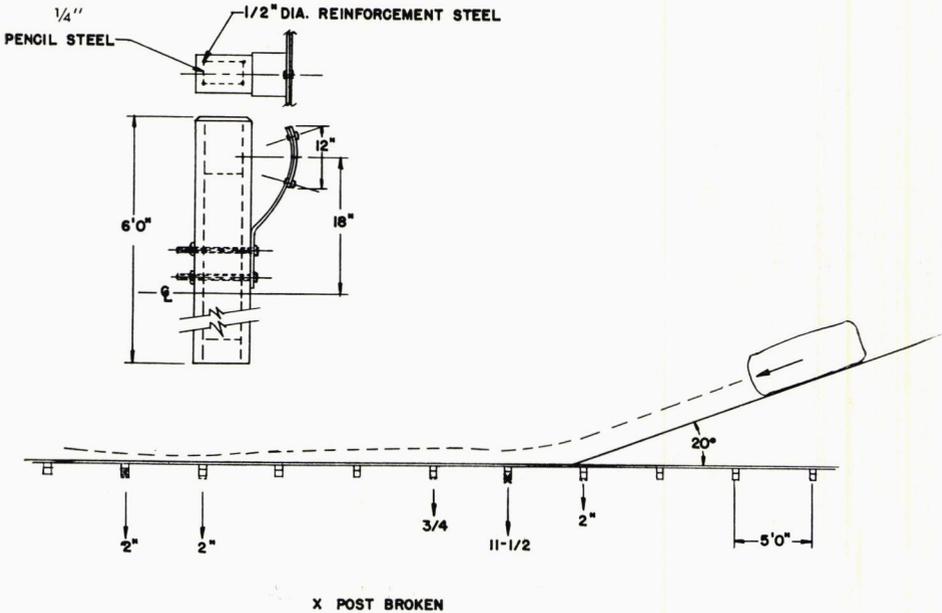
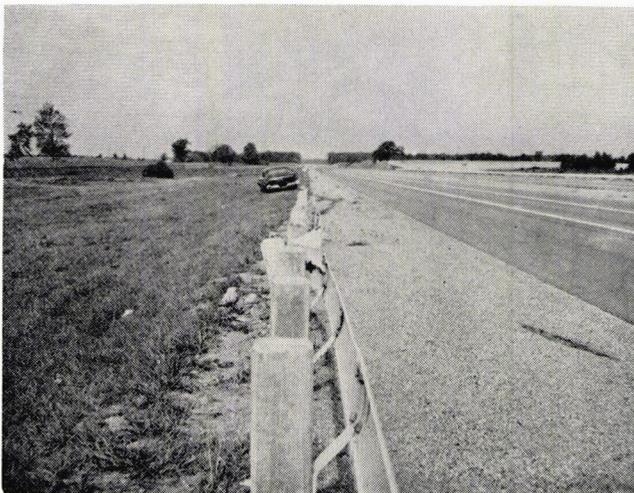
Figure 43.

Guardrail Damage - two posts  
one section of rail

Vehicle - 1957 Pontiac 4 Dr. Ht. - Wt. 4058 lbs.  
Estimate of Damage: \$150.00

Ground Condition - Glacial Till; Dry

Vehicle Brakes Applied after Impact

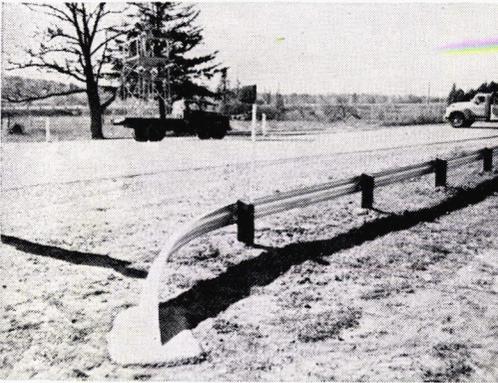
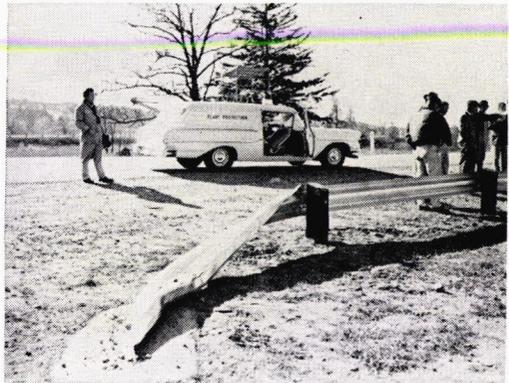
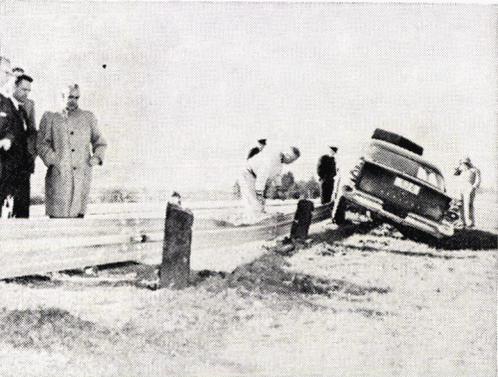
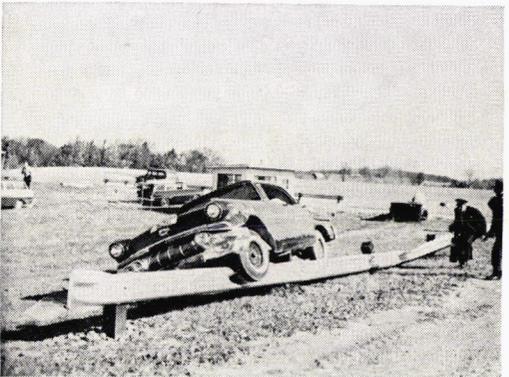
Figure 45.

Guardrail Damage - two sections of rail

Vehicle - 1957 Pontiac 4 Dr. Ht. - Wt. 4058 lbs.  
Estimate of Damage: \$300.00

Ground Condition - Glacial Till: Dry

Vehicle Brakes Applied after Impact

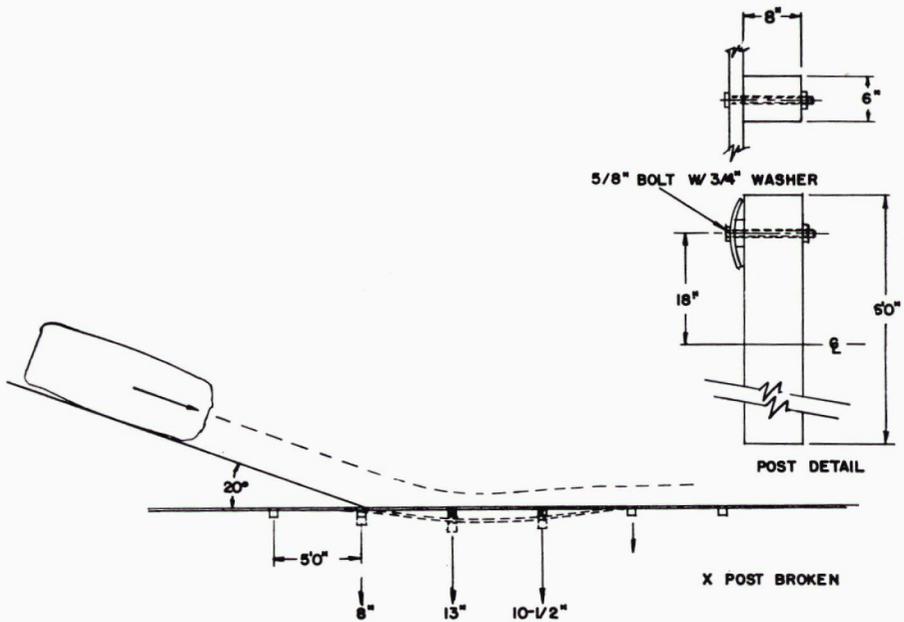
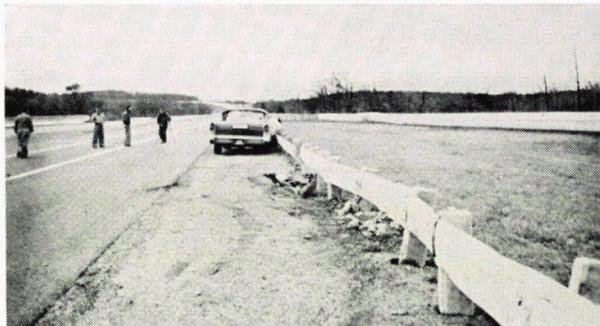
Figure 46.

Tutthill Guardrail - mounted directly on post	Dummy Injury - none used
Posts - 6" x 8" Pre Cast Concrete 6' 0" long	Guardrail Damage - two posts three sections of rail
Speed - 32.4 mph, Impact Angle 20°	Vehicle Deceleration - Longitudinal: 16.5 G's Transverse: 11.7 G's
Vehicle - 1957 Buick 4 Dr. Ht. - Wt. 4317 lbs. Estimate of Damage: \$200.00	Ground Condition - Glacial Till; Dry
Vehicle Brakes Not Applied	Run No. 538

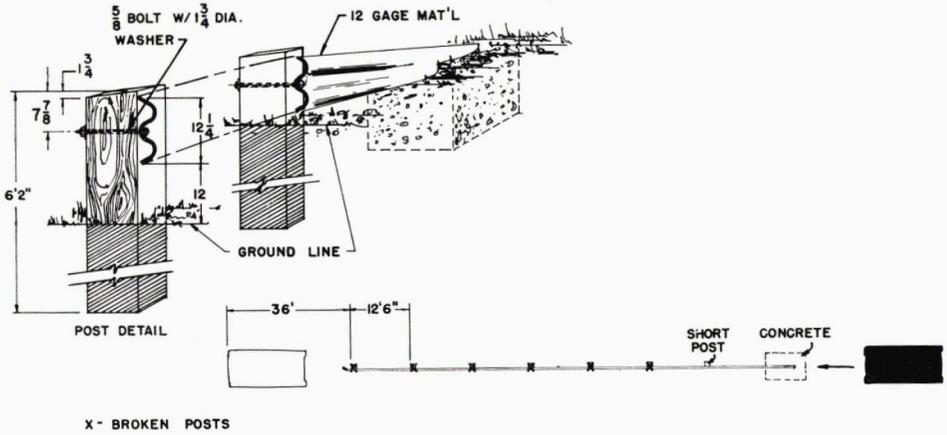
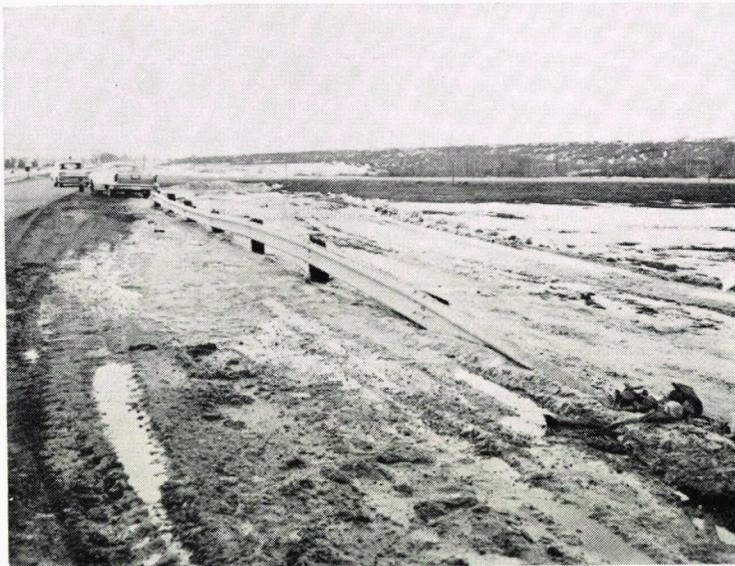
Figure 50.

Guardrail Damage - six posts

Vehicle Deceleration - instrument failure

Vehicle - 1958 Oldsmobile 2 Dr. Ht. - Wt. 4528 Lbs.  
 Estimate of Damage: \$300.00

Ground Condition - Glacial Till - 18" frozen layer  
 1" below surface

Vehicle Brakes Applied after Impact

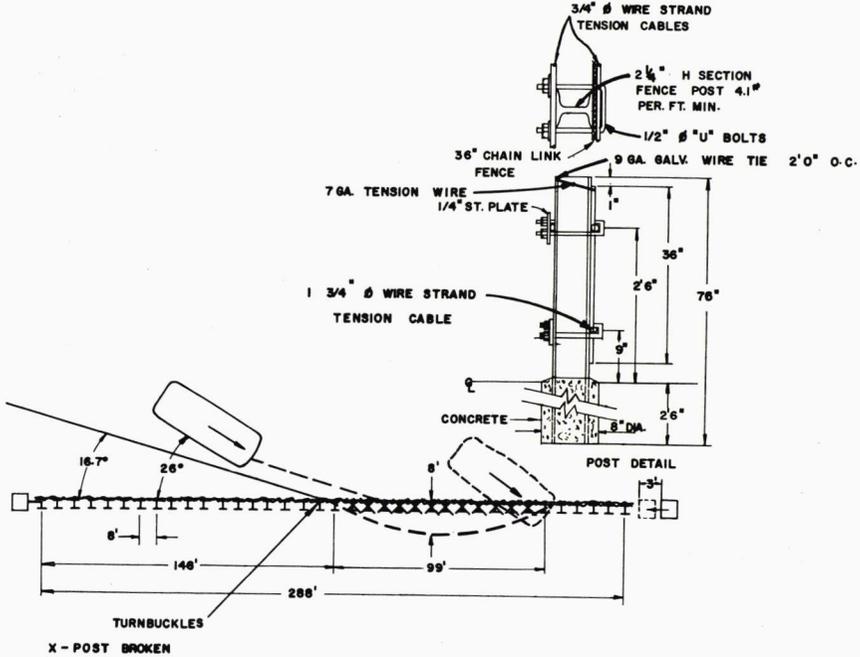
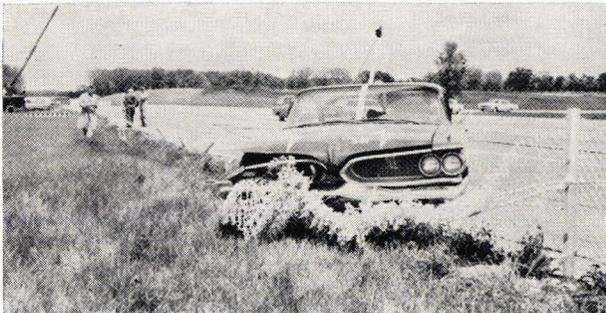
Figure 51.

rier. The barrier again retained the vehicle and brought it to a mild stop. For this last test the entire barrier installation was placed 3 in. higher than in the previous tests, which were at California specifications, and it was noted that the vehicle penetrated the upper tension cables up to the passenger compartment. Details of these impacts are given in the Appendix, Run Nos. 591 (Fig. 51), 593 (Fig. 52) and 596 (Fig. 53).

Guardrail Damage - 14 Posts  
 100 ft. Fence  
 1 Concrete Deadman

Vehicle - 1960 Pontiac 2 Dr. Hr. - Wt. 4190 lbs  
 Estimate of Damage: \$500.00

Ground Condition - Glacial Till; Dry

Vehicle Brakes Not Applied

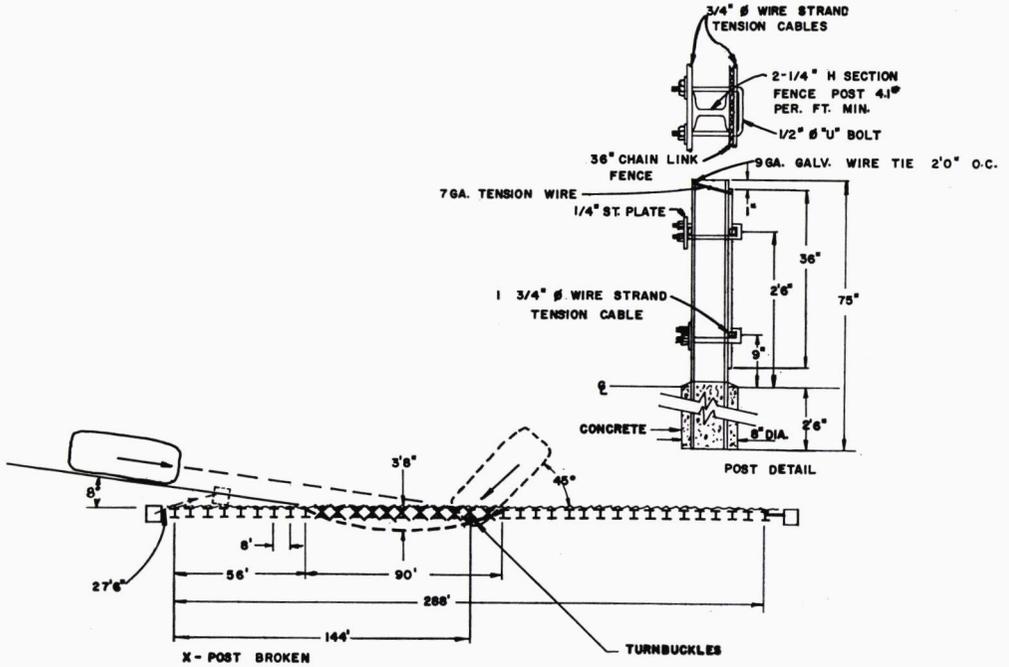
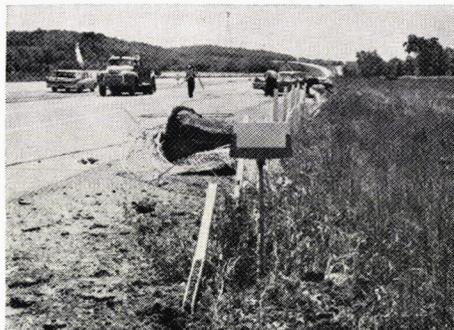
Figure 52.

Chain Link Cable Type Guardrail	Dummy Injury - No Dummies Used
Posts - 2-1/4 in. H Section 4.1 lb/ft	Guardrail Damage - 13 Posts -90' of Fence 1 Deadman
Speed - 65 mph, Impact Angle 8.0°	Vehicle Deceleration Peak g Average g Longitudinal 34 1.5 Transverse 4.5 2
Vehicle - 1957 Cadillac 4 Dr. Ht. - Wt. 4922 lbs. Estimate of Damage - Total Loss	Ground Condition - Glacial Till: Dry

Vehicle Brakes Not Applied
