## PROGRESS REPORT ON BRICK ROAD EXPERIMENTS IN OHIO

## SYNOPSIS

DESCRIPTION OF THE FILLERS AND THEIR  
PRESENT CONDITIONS, AFTER  
ONE YEAR'S SERVICE

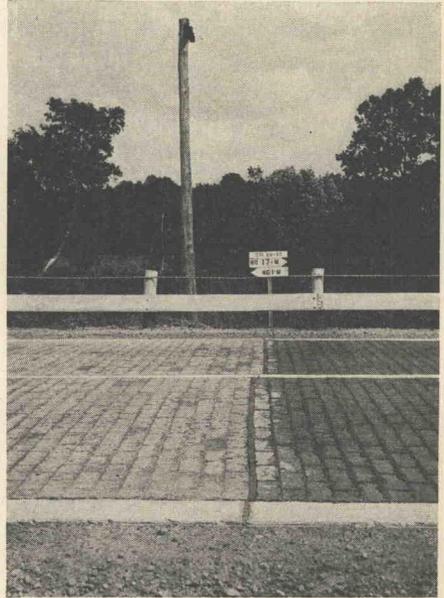
Figure 22. Fillers 1 and 17

brick is badly broken. Although at the present time the section is in serviceable condition, these broken areas are increasing in extent with the result that the test section as a whole is considered unsatisfactory. (Fig. 1)

1: Portland cement grout (one part cement and four parts sand by volume). While most of the section is in a very satisfactory condition, numerous small areas exist in which the bond of grout to

has been sufficient to show that, in their present form, the two grout fillers, the Natural Lake Asphalt and the asbestos filled pitch are not satisfactory, and they will be removed from the test road as a maintenance step. The Ohio State Highway Department, basing their selection on satisfactory behavior in the test road for one year, have designated Fillers 4, 5, 6 and 16 for more extended use and further trial in brick pavement projects.
