THE STABILITY ANALYSIS OF A FOUNDATION FAILURE

BY DONALD W. TAYLOR

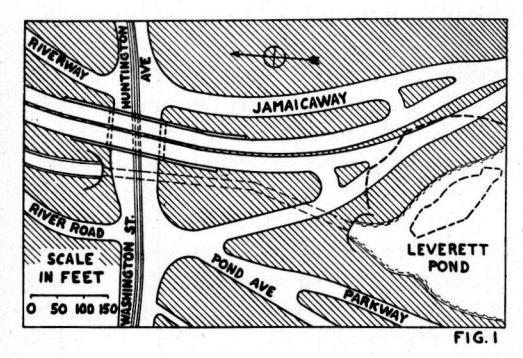
Figure 1. Plan of Overpass and Approach Fill

The overpass and approach fill are shown in plan in Figure 1. The slide is indicated by a broken line and occurred where the southbound roadway, to the south of the overpass, skirts Leverett Pond. For a length of 250 ft. along this roadway and an entering lane, there was
