EFFECT OF EXPERIMENTAL SUBGRADE TREATMENTS ON PAVEMENT FAULTING AND PUMPING

By E. A. HENDERSON, *Graduate Assistant*

Joint Highway Research Project, Purdue University

SYNOPSIS

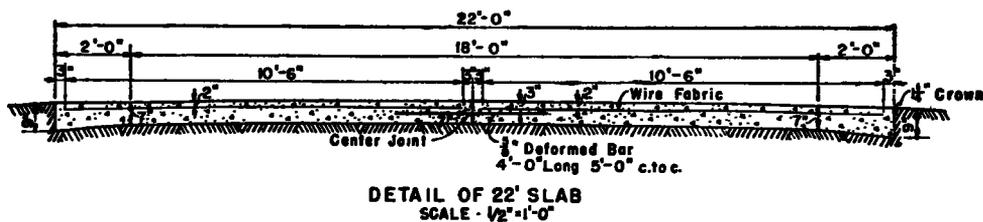
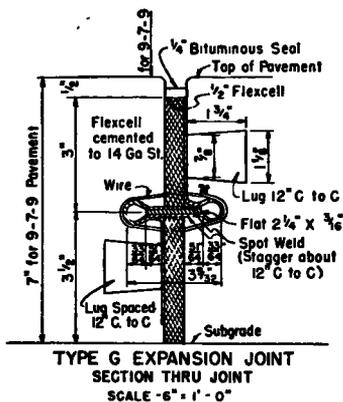
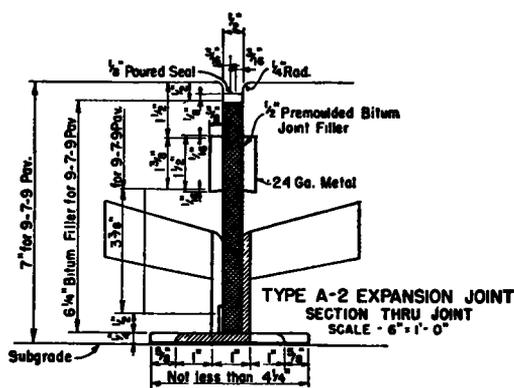
Figure 2. Slab and Expansion Joint Details

Two major types of expansion joints were installed, namely, A-2 and G joints. Figure 2 shows cross-sections of both types. The type G joint is no longer used by the State Highway Commission of Indiana. Type G joints were used between Station 15+00 to 125+00, and Type A-2 joints in the remaining portion of the area surveyed. At intersections a few type D-1 and 1-in. cork joints were used.

Two types of expansion joints, A-2 and G, were used on the portion of U.S. Highway No. 30 considered in this survey. Figure 2 shows cross-section views of these joint types including the design of the load transfer devices. Type G joints were used in both lanes from Station 15+00 to Station 125+00. Type A-2 joints were used in both lanes for the remainder of the section surveyed. To compare the effect of the two different load transfer devices in these expansion joints it is necessary to consider areas where similar subgrade and traffic conditions exist. Since the natural

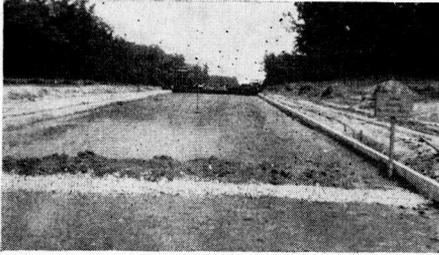
The subgrade was excavated to grade by a scraper and sand spread to a loose depth of 7 in. and thoroughly wet before paving. Figure 4 shows a view of the sand subgrade being prepared for paving. This section handled easily during construction and held

Six-inch subsurface lateral drains (Fig. 4) were installed approximately every 300 ft beginning at Station 145+00 to insure drainage of this course.

Figure 4. Sand Subgrade Ready for Paving.
Lateral Drain in Foreground

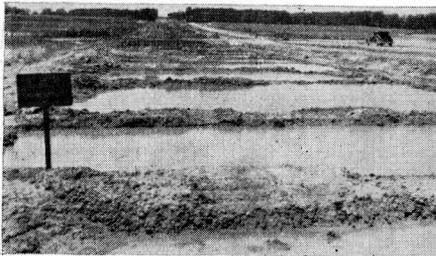
This treatment consisted in thoroughly wetting the subgrade to a depth of 12 in. The subgrade was scarified to a depth of 12 in. and ponded with water for three or four days.

Figure 5. Ponded Subgrade—Water Saturation Treatment

Figure 5 shows a view of the ponded subgrade. After ponding, 3 in. of dry dirt were added to

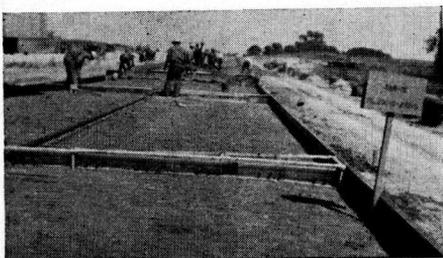
Figure 6. Tar Treated Road Ready for Paving. Type A-2 Expansion Joint in Foreground

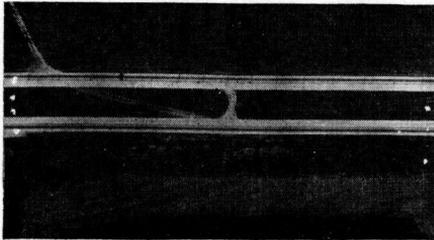
Figure 11. Aerial Strip Map of a Portion of the Test Section with a 3-in. Limestone Dust Subgrade treatment. The eastbound lane, which contains the subgrade treatment, is at the bottom of the photograph. The westbound lane is untreated.

However, at the present time the untreated eastbound lane is in poorer condition than the opposite untreated westbound lane. From performance surveys made in 1946 on other primary highways leading to Chicago, the same is generally found to be true; that is, the south or eastbound lanes, as the case may be, are in worse condition than the north or westbound lanes. Measurements of the faulting in the outside slabs over approximately 4.3 miles in both lanes, where neither lane has received subgrade treatment, show 204 in. of faulting in the eastbound lane and only 95 in. in the westbound lane. A count of the number of patched joints for approximately 10 miles where neither lane has received subgrade treatment shows 179 patches in the eastbound lane and only 27 patches in the westbound lane. Based on these facts, it is believed that

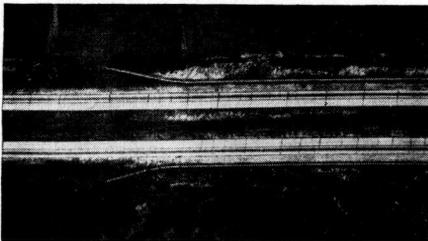
Figure 13. Aerial Strip Map of a Portion of the Test Section with a 3-in. Tar Subgrade Treatment. The eastbound lane, which contains the treatment, is at the bottom of the photograph. The westbound lane is untreated.

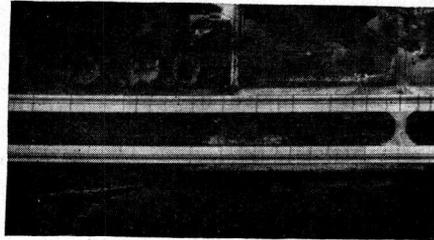
Figure 14. Aerial Strip Map of a Portion of the Test Section with a 2-in. Emulsified Asphalt Subgrade Treatment. The eastbound lane, which contains the treatment, is at the bottom of the photograph. The westbound lane is untreated.

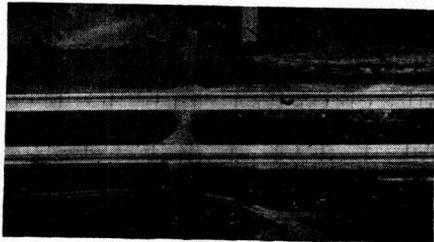
Figure 15. Aerial Strip Map of a Portion of the Test Section with a 3-in. Liquid Asphalt (MC-1) Subgrade Treatment. The eastbound lane, which contains the treatment, is at the bottom of the photograph. The westbound lane is untreated.

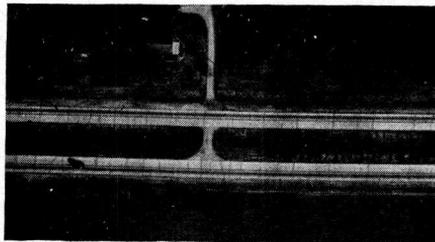
Figure 16. Aerial Strip Map of a Portion of the Test Section with a 3-in. Stabilized Material Base Course. The eastbound lane, which contains the base course, is at the bottom of the photograph. The westbound lane is untreated.
