# TREATMENT OF PUMPING PAVEMENTS WITH CEMENT-SLURRY MIXTURES

By F. H. GREEN, *Research Engineer, Joint Highway Research Project, Purdue University*

This is a report of experimental treatments for correction of pumping pavements on three test sections in Indiana, using a mixture of portland cement and calcium aluminate cement as a filling material. The experimental use of a mechanical pavement jack, in connection with the slurry treatments to correct faulted joints, is also reported. Cost records were maintained on most of this work.

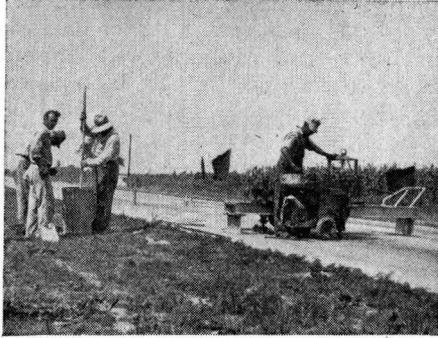
Figure 4. General View of Treatment Operations

When it is decided that a faulted joint is to be re-aligned before the treating material is placed, the pavement jack is used. The expansion anchors are placed in the 2-in. holes, and connected to the cross-bar extending between the two holes. The jack frame is then placed over the lower slab, with one end supported by the higher slab immediately adjacent to the joint, and the lower end supported by the pavement at a point 10 ft. ahead of the joint. The hydraulic jack, which rests upon the frame, is then fastened to the cross-bar, and the entire assembly is tightened. The hydraulic pump is then operated, and the lower slab is lifted into alignment. Usually a pressure of 10 to 12 tons is sufficient, but occasionally pressures as high as 18 tons have been used. This pressure represents the differential lifting force required to re-align the joint, plus a relatively small force which represents the actual weight of the slab. These large forces indicate the resistance offered by the internal structure of the joint, as the damaged load transfer devices come into play in reversed stresses. (Figs. 4 and 5.)
