REPORT ON EXPERIMENT WITH CONTINUOUS REINFORCEMENT IN CONCRETE PAVEMENT—NEW JERSEY

WILLIAM VAN BREEMEN, *Engineer of Special Assignments, Research, New Jersey State Highway Department*

This paper reports the observed behavior and performance of two sections of continuously-reinforced concrete pavement constructed in New Jersey in 1947. These sections, which are each approximately one mile long, carry relatively heavy truck traffic. Some of the significant observations are as follows:

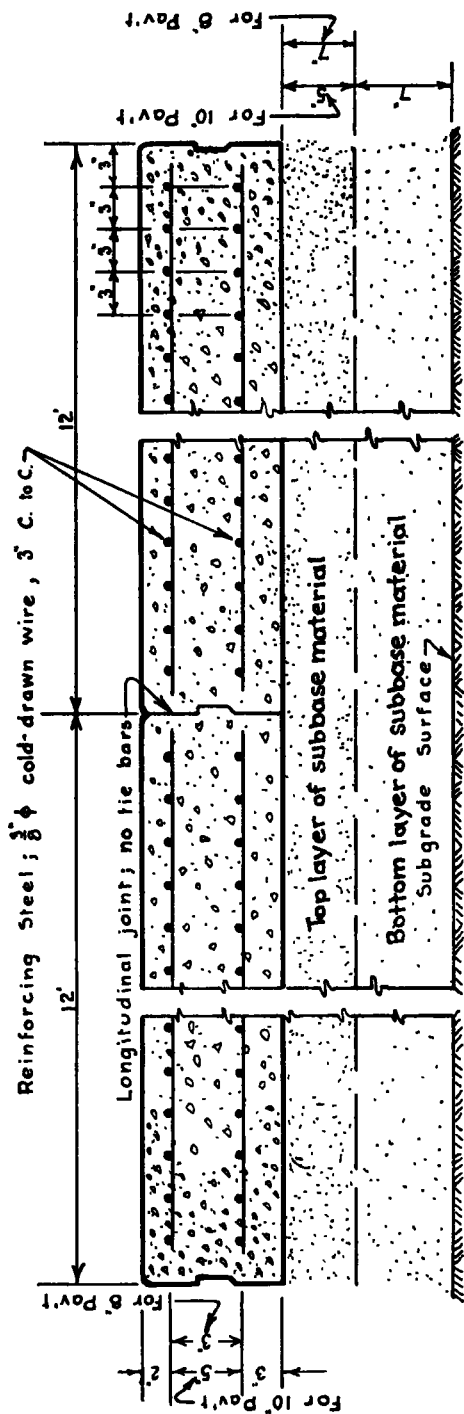
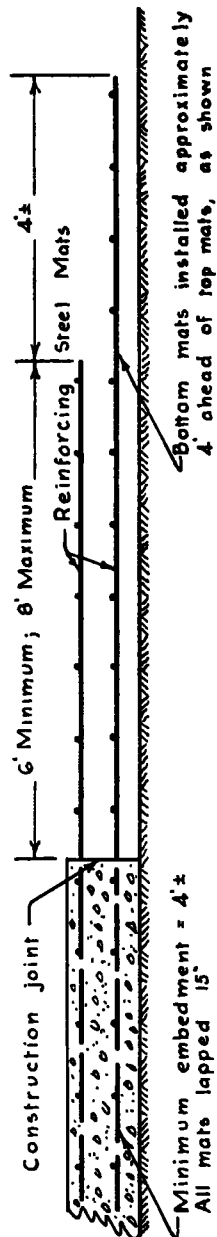
Figure 1

A typical cross section of the pavement and incidental construction details are shown in Figure 1.

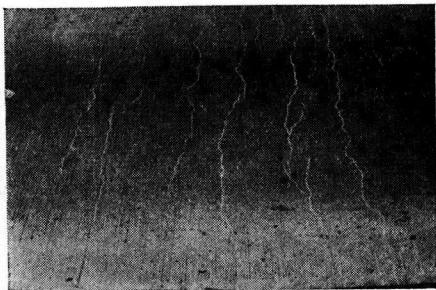
Figure 8

In order that this report would show the true nature of the cracking, detailed crack surveys were made in four locations. The crack patterns in these locations are shown in Figures 4, 5, 6 and 7. Figures 8 to 11 are pictures of various typical crack patterns. Of particular interest is the cracking shown in Figure 11, which is in the inside lane of the 10-in. section, at station 897 + 33. As will be

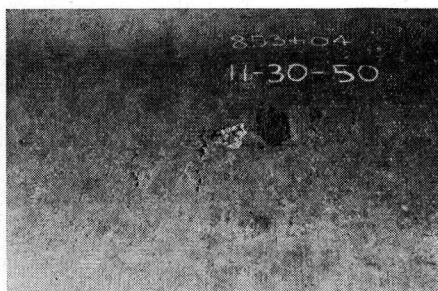
Figure 24. November 30, 1950

With the exception of the previously described severe cracking adjacent to some of the construction joints, there is at present only one other location which appears likely to undergo this form of failure. This is in the outside lane of the 8-in. section, 494 ft. from the southerly end. The present conditions at this point are shown in Figure 24. Except for a slow progressive enlargement of the cold-patched area, the conditions at this point have remained essentially unchanged during the past year.
