THE PERFORMANCE OF CONCRETE RESURFACING IN INDIANA

D. W. LEWIS, *Research Engineer, Joint Highway Research Project, Purdue University*

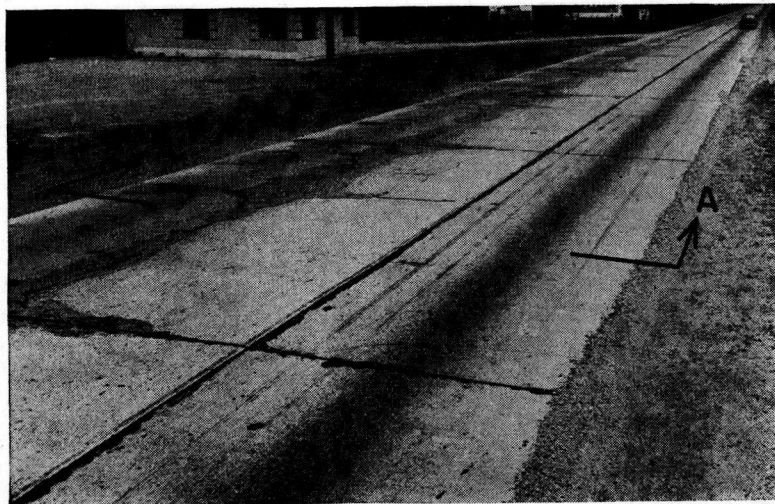
in the concrete resurfacing than in the adjacent full-depth pavement. Figure 6 shows the appearance of one of the projects, FA 13 F, built in 1937. This difference was not as pronounced as in some of the older projects discussed above, probably because of the shorter time of exposure. Considering all of the projects inspected, one-third of those 8 to 14 years old show accelerated deterioration

Figure 6. Typical Appearance of Project FA13F After 13 Years
Project FA13F—U. S. 40, Sec. M
Date Built—1937
