DEPARTMENT OF MAINTENANCE

Field Experimentation with Bituminous Undersealing Materials

W. E. CHASTAIN, SR., *Engineer of Physical Research*, and
JOHN E. BURKE, *Assistant Engineer of Physical Research*
Bureau of Research and Planning, Illinois Division of Highways

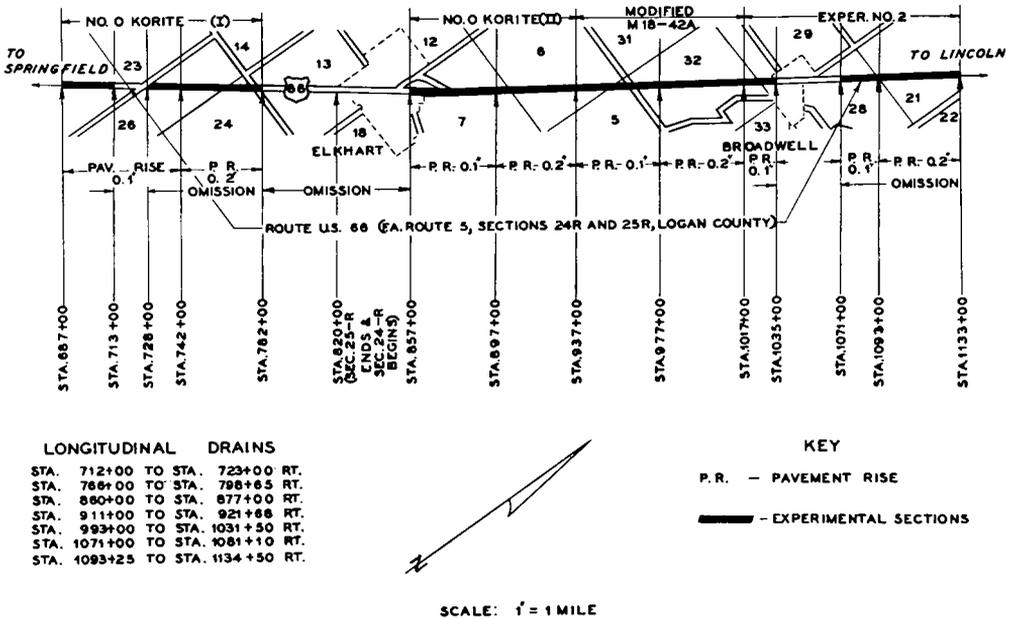
Figure 2. Location and layout of bituminous-underseal test project.

Lincoln. Figure 2 shows the location of the experimental project, together with the stationing of the test sections and of longitudinal drains installed during construction. The test sections are not continuous, because omissions were made where the pavement had been placed on granular subbase or where it had been previously undersealed or mud-jacked. Of some interest is the fact that no pumping was noted in the areas where the granular subbase had been used.¹

Two of the excavations were carried down to the longitudinal drains that parallel the pavement at the edges through much of the test area (see Fig. 2). Pumping was found at both locations at the time the excavations were made. Although the backfill material ($\frac{3}{4}$ in. to $1\frac{1}{2}$ in.) was clean and the tile open,

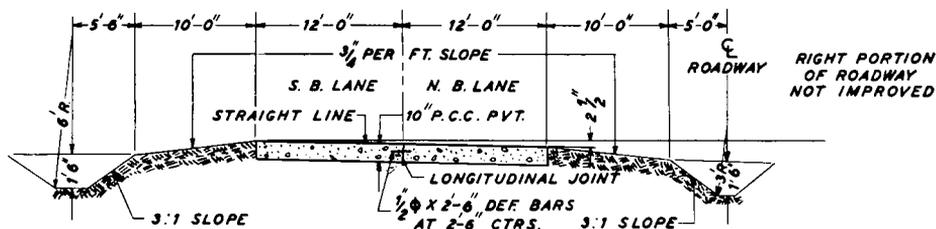
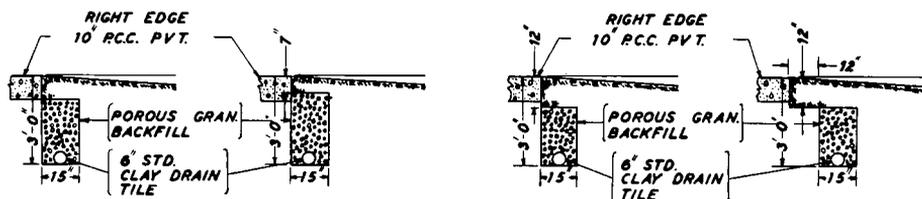
TYPICAL CROSS SECTION OF ROADWAY

pavement is in good structural condition with very few cracked panels, but evidence of pumping had been increasing prior to undersealing. There is also a considerable amount of light faulting at the transverse joints. A typical roadway cross section is shown in Figure 3.
