REPORT OF COMMITTEE ON CHARACTER AND USE OF ROAD MATERIALS

REPORT ON GUARD FENCE RESEARCH

H S MATTIMORE

Engineer of Materials, Pennsylvania Department of Highways

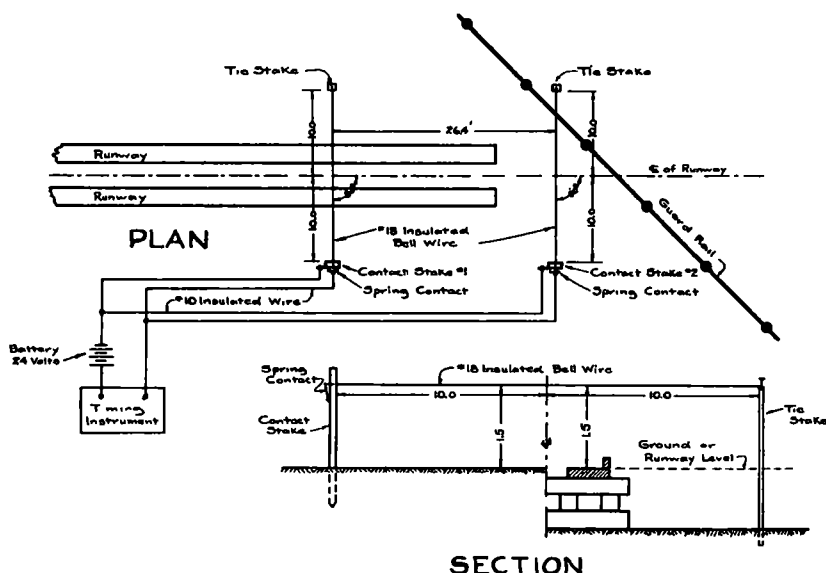
Figure 1. Timing Apparatus for Guard Rail Tests, Pennsylvania Department of Highways

actual field conditions. The 1924 tests were run on a flat field so it was decided to run additional tests to find the weakness of this new design under actual service conditions. The guard fence was constructed on a terraced fill with a total drop to the lower slope of 8.3 feet, as in the previous tests a five ton truck having a gross weight of ten tons and an average weight automobile were used. These traveled on a wooden runway constructed on an 8.5 per cent grade. An electric contact device was used to determine the speed of the truck (Figure 1).

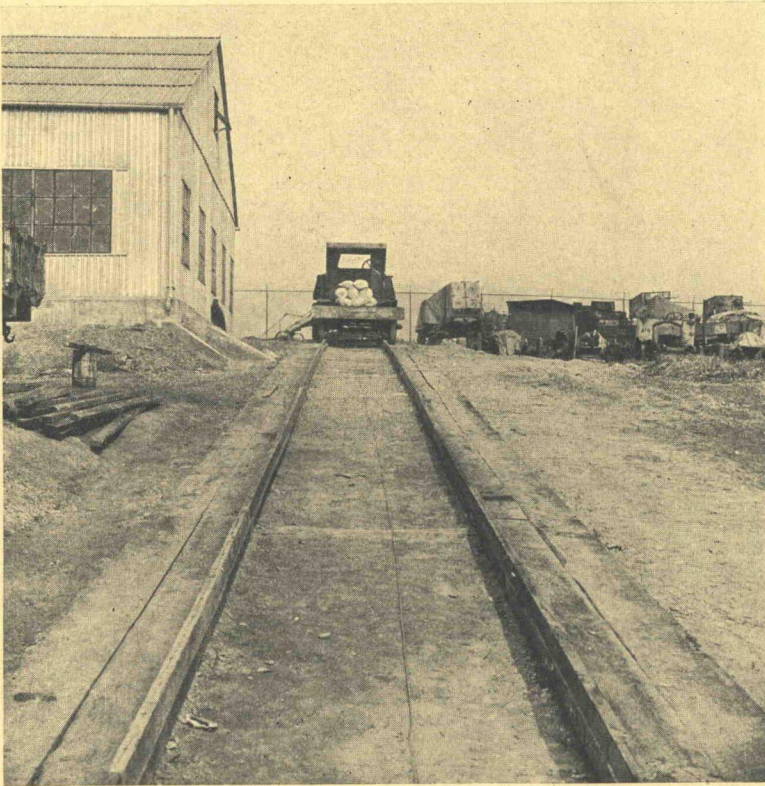
Figure 2 illustrates the truck on the runway prior to starting of a test.

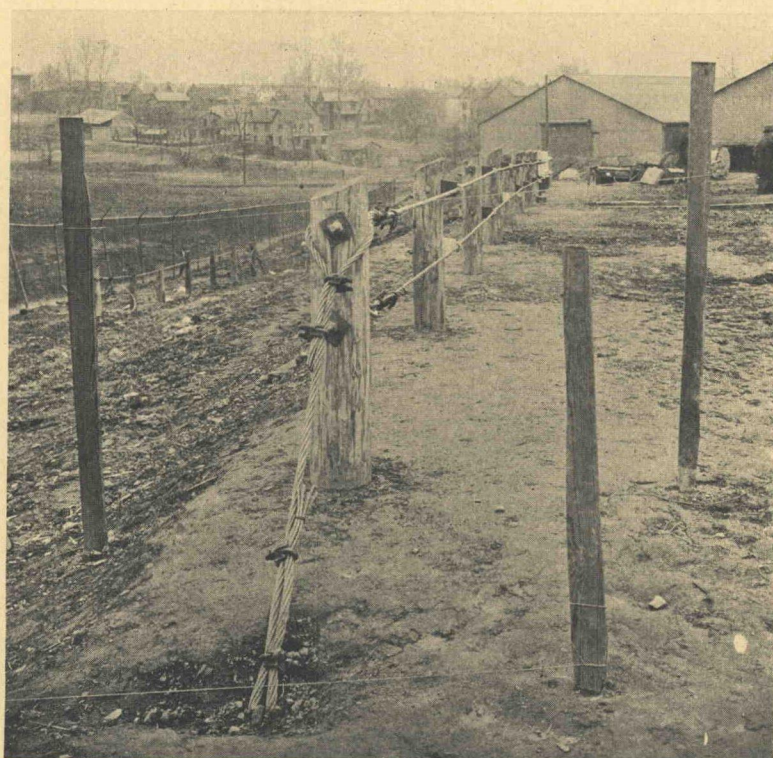
Figure 13 illustrates the guard fence now used as a standard. The basic principal of wooden posts and wire rope are the same as the original guard fence, but corrections were made to overcome the weakness found

as a result of the series of tests. Note that the rope is offset 4 inches from the post. This accomplishes two purposes; it gives the full efficiency of the post under impact, and in cases illustrated in other figures it prevents the hub of an automobile from coming in contact with the post, thus reducing the damage to the car and the tendency for the driver to loose control of the machine. See Figures 22 and 23.

The efficiency of the type of guard fence now used as a standard on Pennsylvania highways, Figure 13, depends on proper installation. Posts must be in stable ground, connections must be of adequate quality, and all connections and splicing must be done so as to give full effectiveness of the ropes

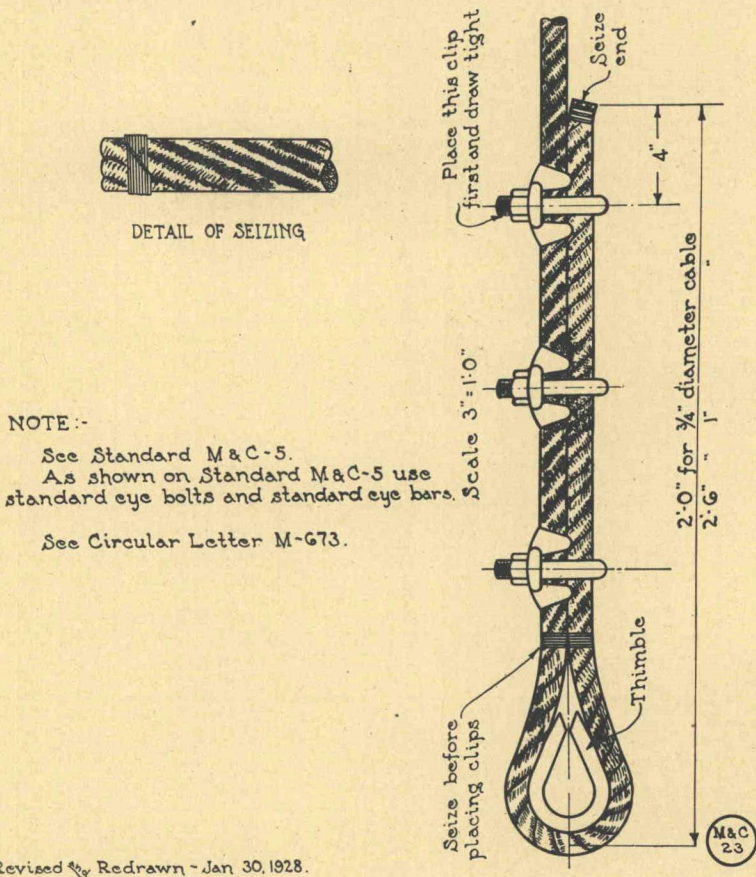
Figure 18. Standard Cable Fitting for Guard Fence, Pennsylvania Department of Highways

very efficient in service. In the few cases where trucks or busses have been reported to have left the road through the guard, a detailed investigation has determined that this was entirely due to negligence in following the standard methods of construction, viz, improper form of splicing on a long line, or insufficient number of clips used at the connection of the end posts, or in the guy rope to the anchors. It was also found that there is a tendency to connect these clips the wrong way. Figures 18 and 19 illustrate the proper method of placing clips

Figure 18 and 19 illustrate proper method of placing clips.

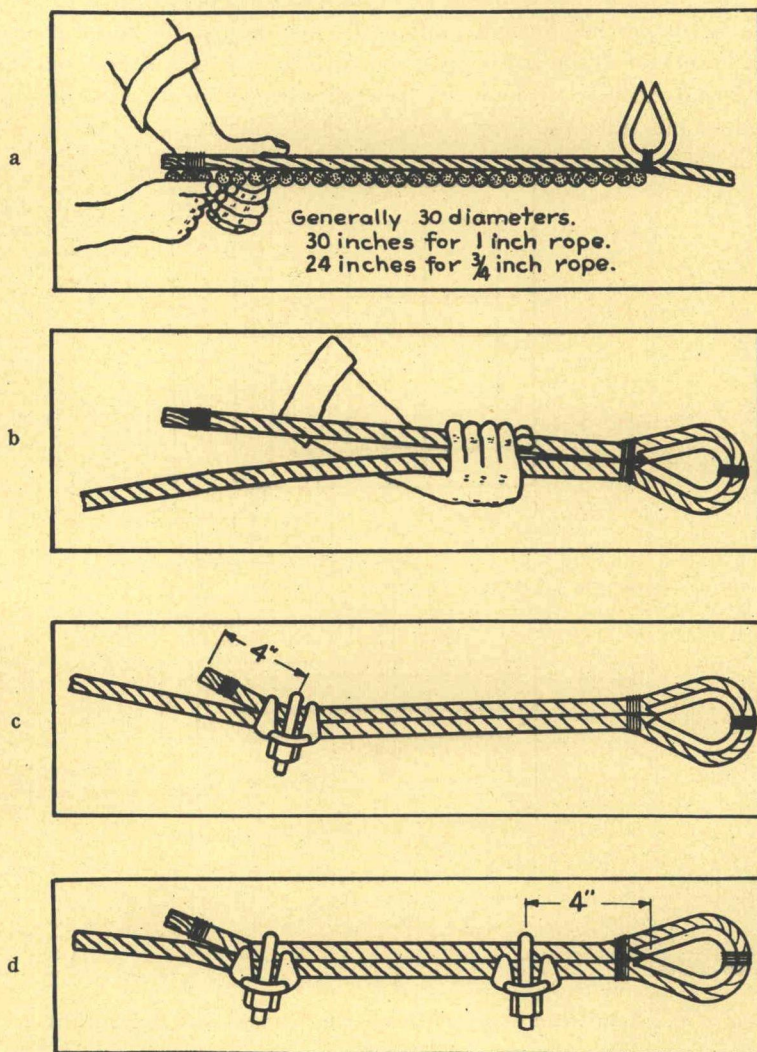
Figure 19. How to put Clips on Wire Rope, Pennsylvania Department of Highways
a. Measuring to ascertain proper length of short end. b. Loop temporarily wired in place. c. First clip correctly put on. d. Second clip correctly put on.

(Third clip when used, to be half way between other two; see Figure 18)

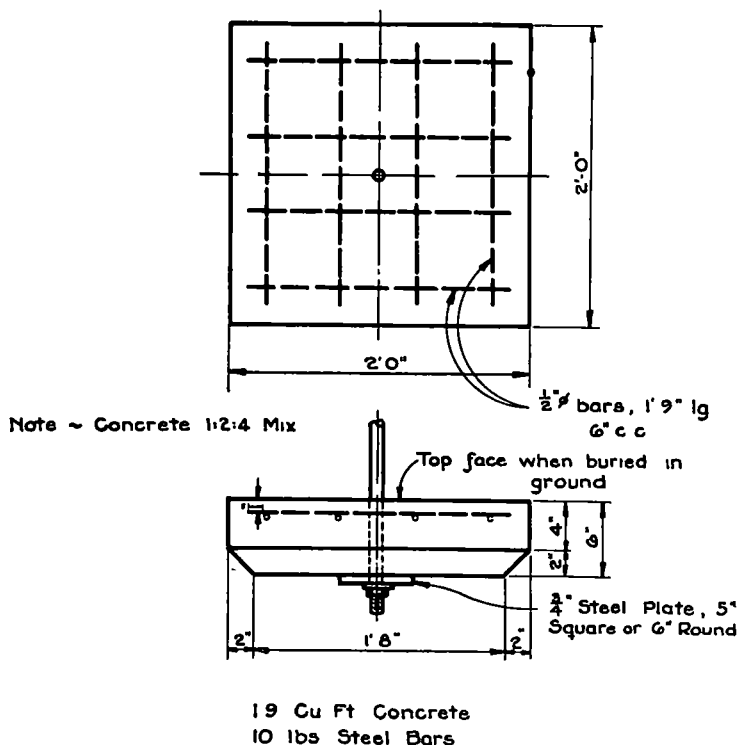
Figure 20. Reinforced Concrete Deadman, Pennsylvania Department of Highways

Figure 11 shows a failure of the anchorage, which detailed examination disclosed was due to the shattering of the plain concrete block used as a deadman. This was corrected by using a reinforced concrete deadman, and also by increasing the size of the bearing plate in the eye bolt connection to the deadman, as illustrated in Figure 20. The speed of the truck was fifteen miles per hour.

Figure 20 shows standard deadman
