## TESTS on RUTTING of SHOULDERS

R. S. DuBois  
Principal Highway Design Engineer  
Bureau of Public Roads

## SYNOPSIS

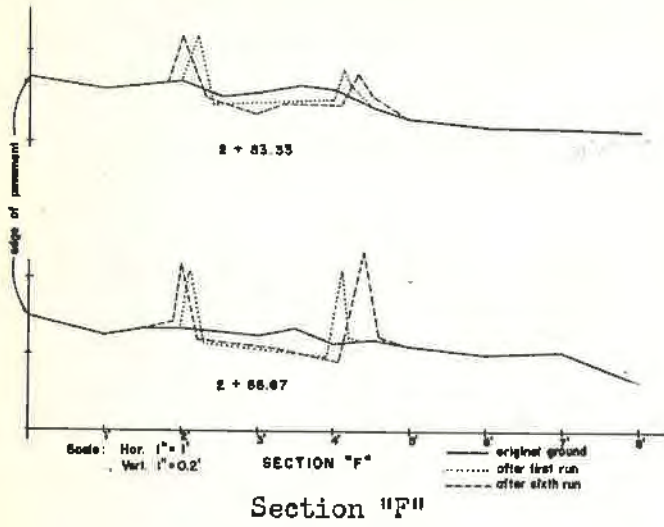
RUTTING TESTS ON STABILIZED SHOULDER PLOTS  
HENRY G. SHIRLEY MEMORIAL HIGHWAY

Table 1 shows the test results of investigations of the surface layer of the shoulder material at the time of the rutting tests, and the depth of rutting. The large scale cross sections show the rutting and extrusion caused by the tests.
