Dynamic Tests of Short Sections of Corrugated Metal Beam Guardrail

ERIC F. NORDLIN, ROBERT N. FIELD, and J.J. FOLSOM,
California Division of Highways

The results of six full-scale vehicle impact tests into anchored short sections (less than 100 ft) of 27-in. high blocked-out corrugated metal beam guardrail are reported. Tests were performed on three free-standing sections using two different end anchorage systems. Tests were also performed on three simulated bridge approach guardrail flares using a cable anchor assembly on the upstream or approach end and a rigid attachment to the concrete bridge rail end post at the other end. The tests were conducted at speeds ranging from 56 to 63 mph and approach angles varying from 24 to 33 deg, using 1964 to 1966 sedans weighing approximately 4500 lb.

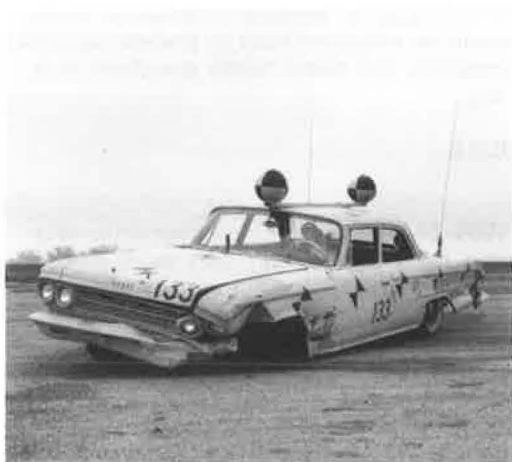
Figure 2.

The test vehicle impacted near the center of the barrier at 56 mph and 30 deg and remained in contact for about 35 ft before being effectively redirected at an exit angle of 7 deg (see Plate A, Appendix). Vehicle dynamics through impact were considered good, with the vehicle sustaining moderate front end damage (Fig. 2). The permanent deflection of the guardrail beam was 2.8 ft horizontally (back) and 6 in. vertically (up).

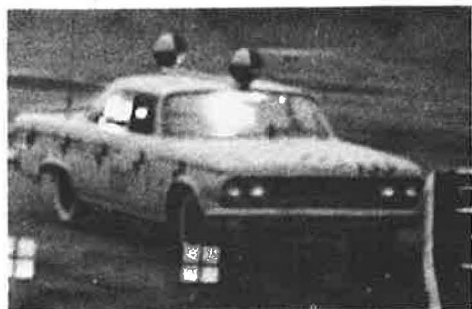
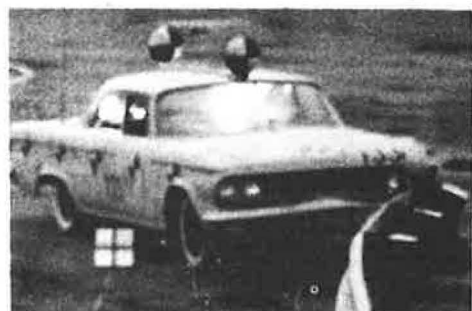
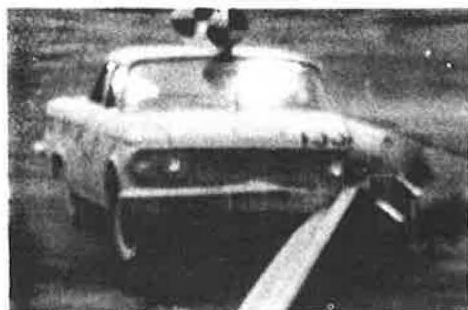
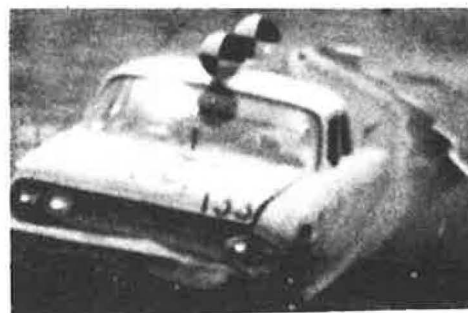
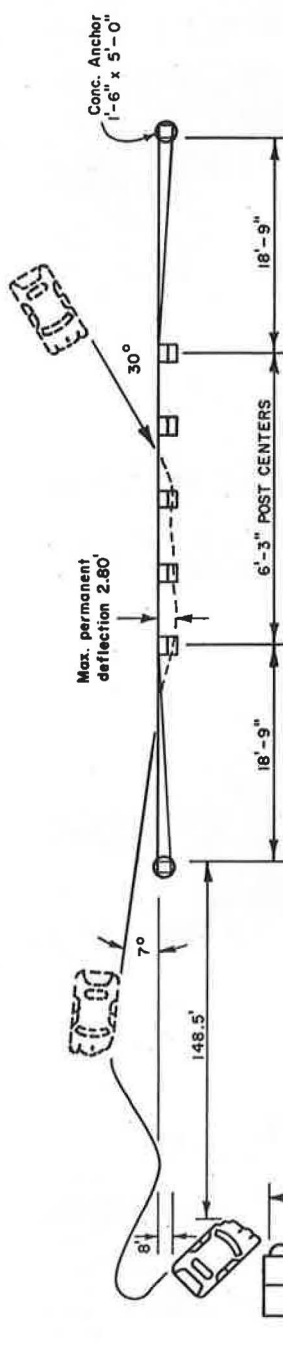
PLATE A TEST 133

TEST	133
VEHICLE	1964 Dodge Sedan
VEHICLE WEIGHT	4540#
(W/DUMMY & INSTRUMENTATION)	
IMPACT SPEED	56 m.p.h.
IMPACT ANGLE	30°
EXIT ANGLE	70°
DUMMY RESTRAINT	Lap Belt

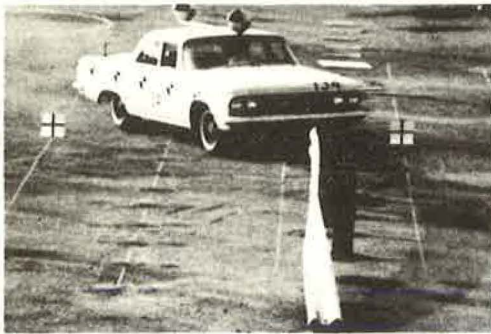
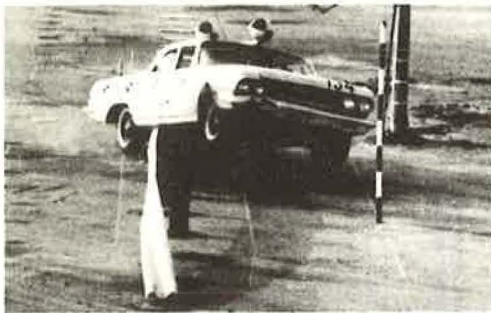
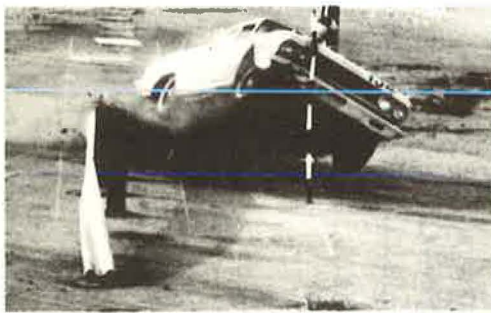
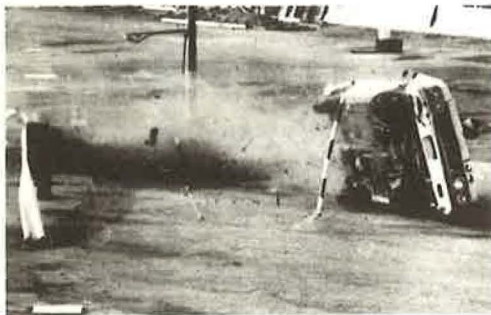
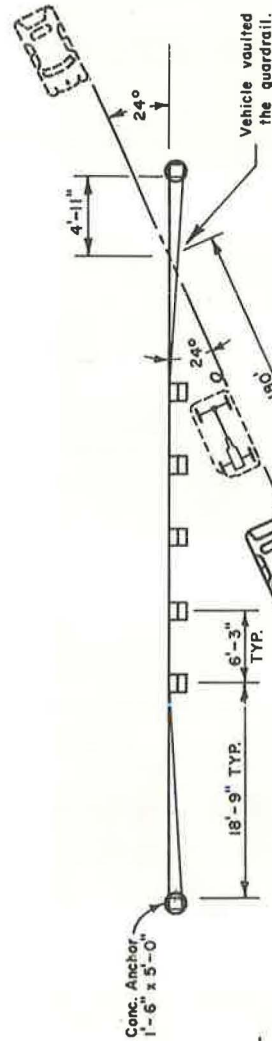
PLATE B TEST 134

Test 134—Although Test 133 demonstrated that the "Texas twist" anchorage system was structurally adequate, it was felt that the geometric characteristic of the sloping beam end anchorages presented a potentially hazardous condition. The sloping beam could form a ramp upon which an impacting vehicle might climb and vault the barrier. Therefore, in Test 134 (installation identical to Test 133), the point of impact was shifted upstream, with the vehicle impacting the barrier within the sloping beam portion, 4.9 ft from the concrete end anchor, at 63 mph and 24 deg. The beam at this point was too low to effectively resist the vertical downward force of the impacting left front wheel, which deflected the beam down, permitting the front wheel to ride up and over the beam. This reaction of the beam imparted a rolling moment to the vehicle, which completely overturned as it vaulted the barrier. The vehicle came to rest 180 ft beyond impact in a regained upright position (Plate B). The end section of beam was flattened and one post and block-out block was shattered (Fig. 4). The vehicle sustained major front, side, and top damage and was considered a total loss (Fig. 5). These test results were later substantiated by a test on a sloped-end anchorage design by the Ontario Highway Department (5) in which similar vehicle reaction was observed.

2. Although Test 133 demonstrated the structural adequacy of the "Texas twist" design in providing effective anchorage for short sections of guardrail, Test 134 showed that a hazardous condition exists when vehicle impact occurs at the upstream sloping beam end anchorage.

DATE	1-18-67
TEST	134
VEHICLE	1964 Dodge Sedan
VEHICLE WEIGHT	4540#
(W/DUMMY & INSTRUMENTATION)	
IMPACT SPEED	63 m.p.h.
IMPACT ANGLE	24°
EXIT ANGLE	24°
DUMMY RESTRAINT	Lap Belt
BEAM RAIL	12 ga. Galv. Steel x 13'-6.5"
BEAM RAIL END SECTIONS	12 ga. Galv. Steel x 26'-0"
POST	8" x 8" Rough D.F. x 5'-4"
POST EMBEDMENT	36"
POST SPACING	18'-9" TYP.
LENGTH OF INSTALLATION	62'-6"
GROUND CONDITION	Damp

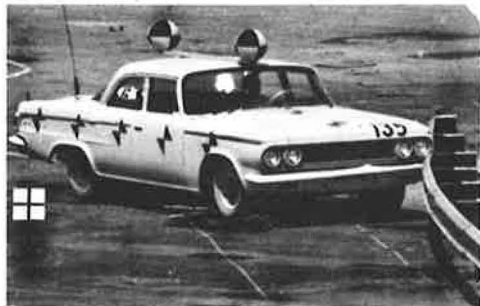
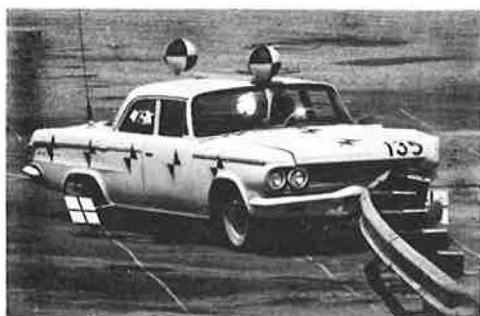
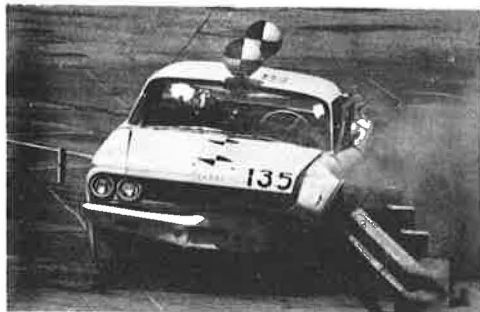
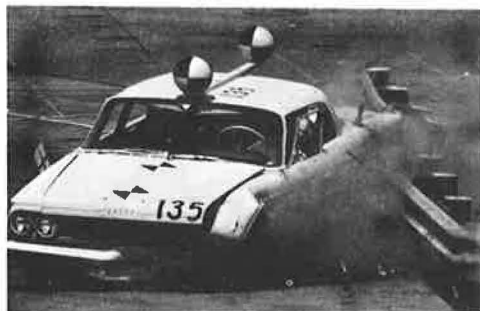
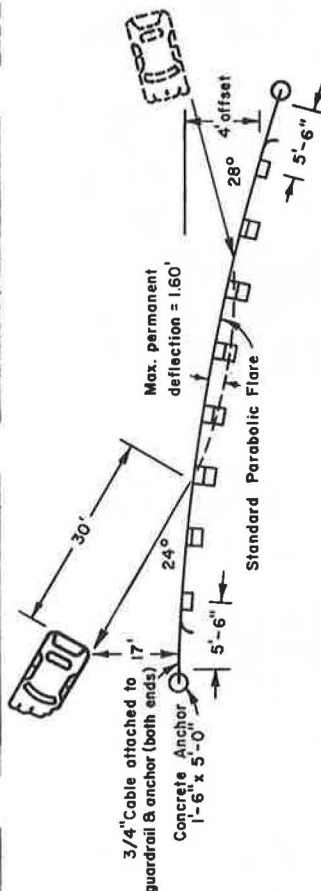
PLATE C TEST 135

mately 22 ft before being effectively redirected at an exit angle of 24 deg (Plate C). All beam sections were damaged and both anchors were displaced approximately $\frac{5}{8}$ in. toward impact (Fig. 9). The test vehicle sustained moderate front-end damage (Fig. 10).

Although vehicle dynamics and barrier reaction were considered satisfactory through impact, deceleration forces were fairly severe, as there was a tendency for the vehicles to pocket the beam. Analysis of high-speed film revealed that this pocketing was due, at least partially, to the parabolic configuration of the barrier, since the curved beam had to deform through a straight line before the restraining force of the anchor was effectively developed. As a result, it has been recommended that all short sections of guardrail be flared and placed on a straight line between anchor points, even though there is a possibility of increasing the collision impact angle by doing so.

4. Test 135 indicated that a parabolic layout line for an anchored guardrail section will increase the likelihood of pocketing over that of a straight section between the same two end anchor points under similar conditions of impact.

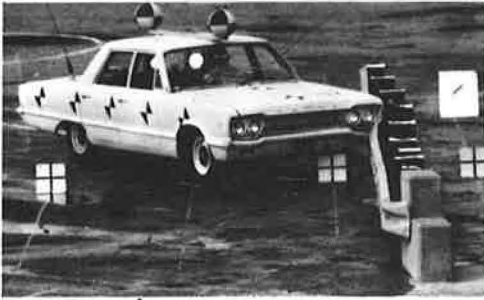
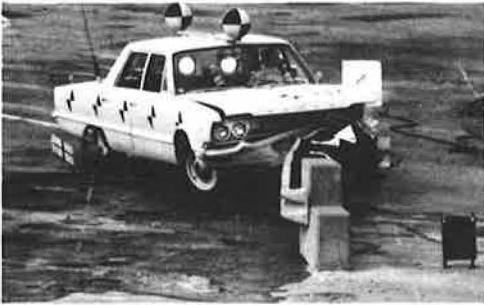
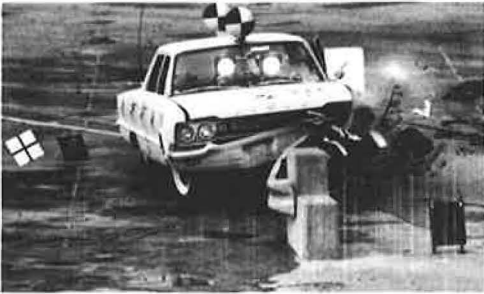
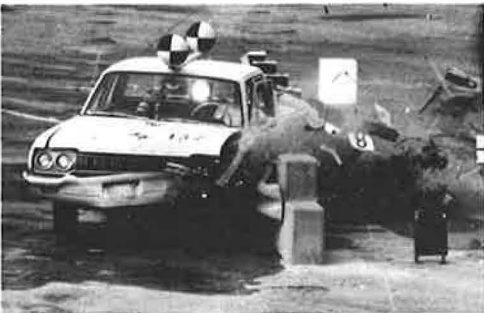
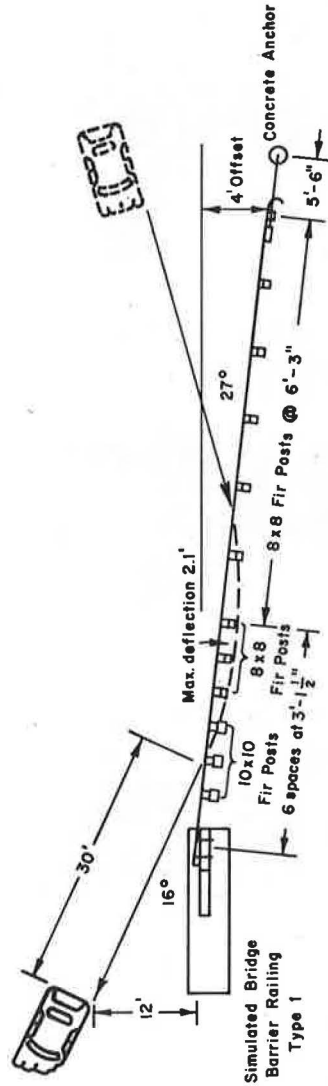
PLATE E TEST 137

The guardrail beam sustained a permanent deflection of 2.1 ft (Fig. 17). Although vehicle dynamics in this high-speed oblique angle collision were considered good through impact, the left front wheel was torn off and the vehicle sustained major front-end and undercarriage damage. The vehicle was considered a total loss (Fig. 18).

TEST.....137
 VEHICLE.....1965 Dodge Sedan
 VEHICLE WEIGHT.....4540#
 (W/DUMMY & INSTRUMENTATION)
 IMPACT SPEED.....61 m.p.h.
 IMPACT ANGLE.....27°
 EXIT ANGLE.....16°
 DUMMY RESTRAINT.....Lap Belt
