Disintegration of Concrete in Foundation and Anchorage Blocks for an Aerial Mast

G. M. IDORN and P. NEPPER-CHRISTENSEN, Concrete Research Laboratory, Karlstrup, Denmark

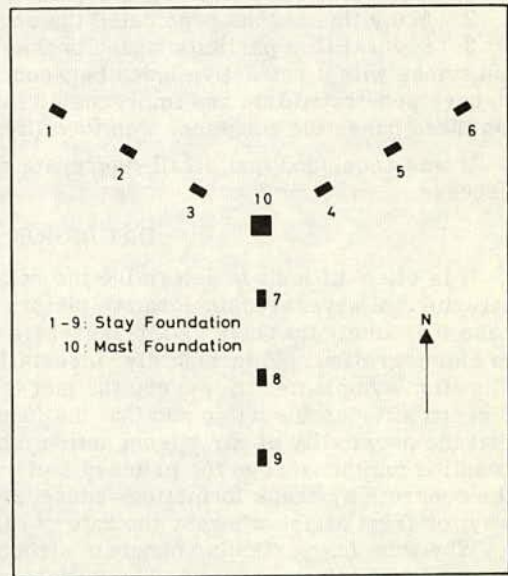
Figure 2. Arrangement of anchorage blocks and foundation (not in scale).

foundations. After 5 years of service, the foundations were extensively cracked, with map-cracking, single coarse cracks, and pop-outs (Figs. 1 and 3). Disintegration was most pronounced in foundations 7, 8, and 9 (Fig. 2).
