Dynamic Field Test of Wooden Signposts

FOSTER C. SANKEY, Bureau of Materials, Testing, and Research, Pennsylvania Department of Highways

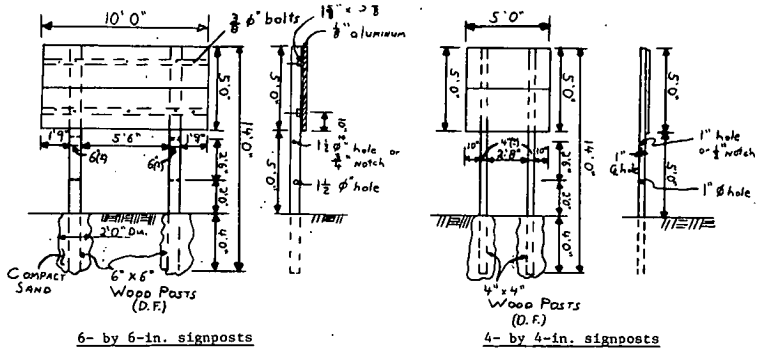
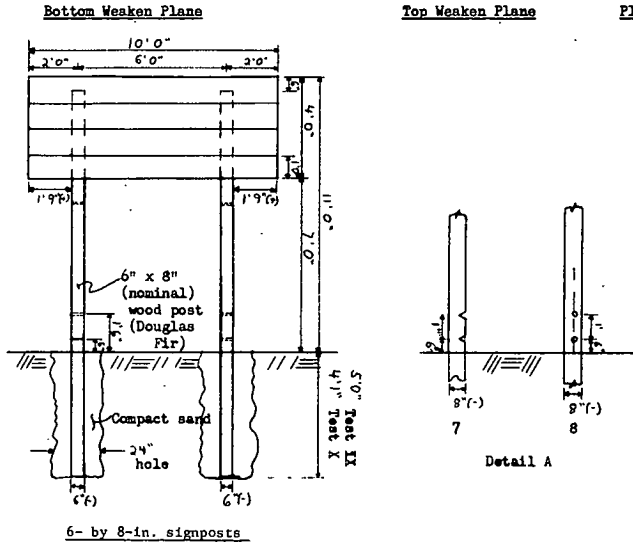
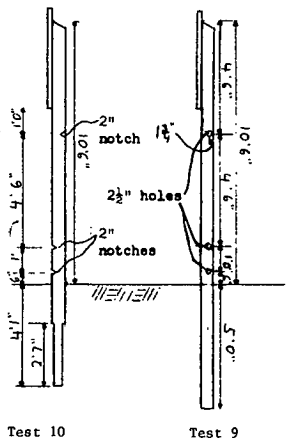
Figure 4. Signpost installations.

The 10 signpost installations are shown in Figure 4 and their measurements and characteristics are given in Table 1.
