In-Place Roadway Foundation Stabilization

Richard P. Murray

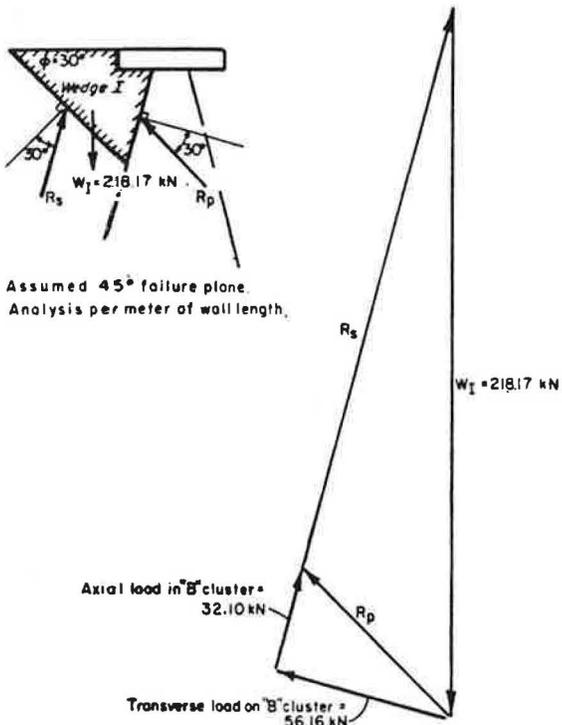
Figure 9. Design analysis: resolution of forces from wedge 1.

The forces exerted on the piles by the earth above the failure plane were resolved (see Figures 9 and 10) into axial and transverse loads on the two pile clusters. The transverse loads acting on the piles were distributed increasing linearly with depth. A rigid-frame analysis

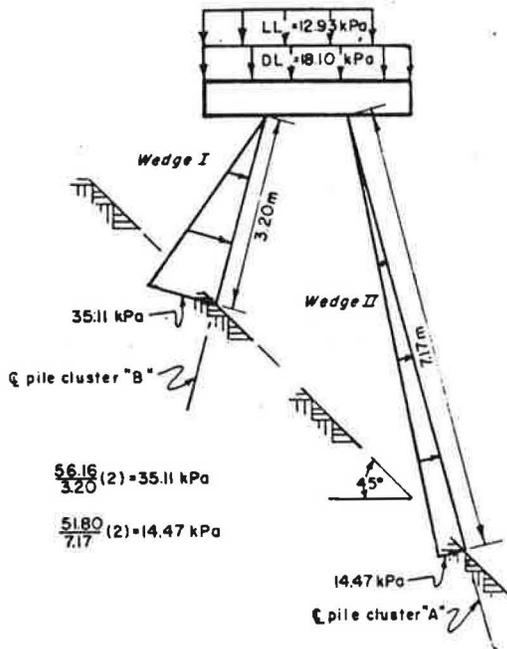
Figure 11. Design analysis: forces acting on rigid frame.

with sidesway was performed for the geometry and loading shown in Figure 11. The resulting moments and shears are shown in Figure 12. The axial loads from the bending moments were added to those obtained in the steps shown in Figures 9 and 10. The allowable pile loads were calculated as shown below ($1 \text{ kN/m} = 0.222 \text{ lbf/ft}$ and $1 \text{ kN} = 224 \text{ lbf}$):
