## The Malibu Landslide

RAYMOND A. FORSYTH AND MARVIN L. McCAULEY

A case history of one of the most highly publicized landslides in the history of the California Department of Transportation is presented. In the spring of 1979, the recognition of an incipient and potentially dangerous massive slide above steep sandstone bluffs adjoining the Pacific Coast Highway (CA-1) between Malibu and Santa Monica necessitated closure of this vital transportation link. The installation of an extensive and unique warning system plus a rock fall catchment area permitted partial reopening one month later while the slide investigation proceeded. The correction ultimately selected involved a partial unloading and slope reinforcement. The four-way warning system proved to be extremely useful in permitting the partial reopening of the highway while providing for the general safety of the traveling public and adjacent home owners. The use of rock dowels for slope reinforcement reduced the required excavation to achieve stability by more than 1 million yd<sup>3</sup> in extremely difficult terrain.

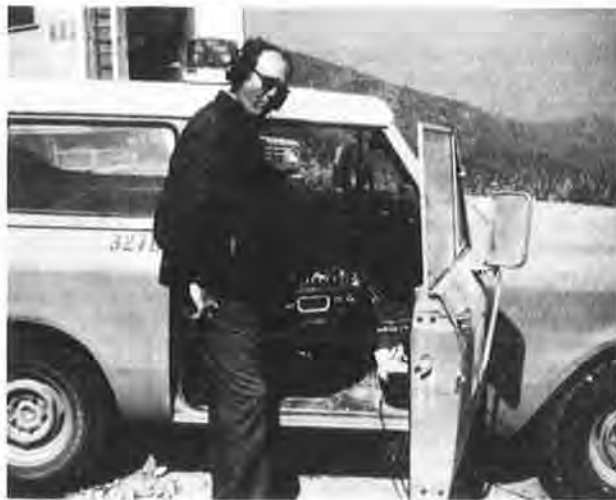
ing of April 25, three of the six stations then in operation indicated a sudden acceleration in count rate, which prompted closure of the pedestrian walkway along the highway. A plot of counts per minute versus time for one such station (PATH) is shown in Figure 6. Three days later, noise levels dropped to the original background level so that reopening of the walkway was permitted.

Figure 6. SARN measurements for Malibu slide.

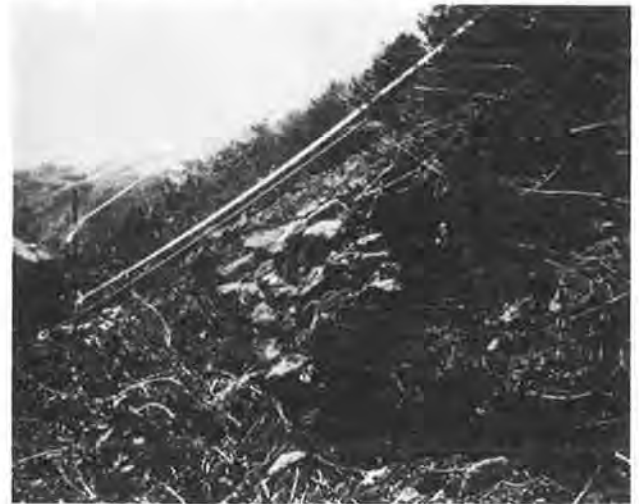
The two monitoring systems described required the presence of surveyors or geophysicists on a continuing basis. It was deemed extremely hazardous for personnel to work on the unstable and very steep bluff at night for monitoring purposes. With this in mind, a third warning system was installed that would automatically trigger an alarm at roadway level in the event of significant slope movement. These devices, designated as "surface extensometers", were installed across selected zones of high activity based on previous survey measurements. They consisted of wire several feet long connected to two steel pins 3-4 ft above the ground surface (see Figure 7). A constant tension was maintained by a spring mounted in a metal housing attached to the system. Movements exceeding 0.15 ft closed an electrical contact, which in turn would trigger a battery-driven alarm system at roadway level. The alarm itself consisted of a flashing yellow light and an air horn (see Figure 8).

Figure 8. Surface extensometer alarm system.

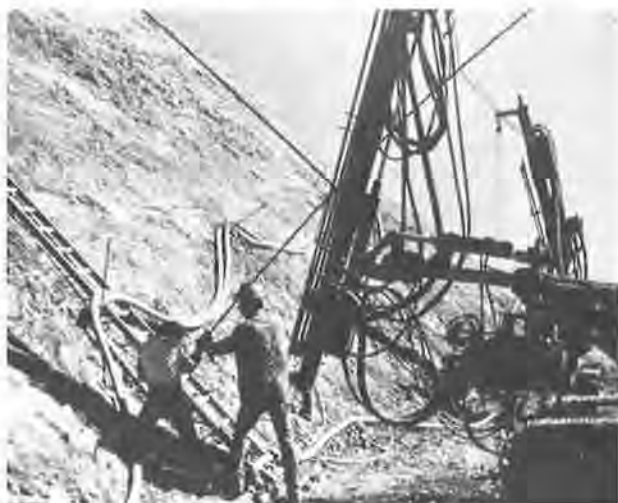
Figure 13. Dowel placement.

On approval of the contract, the existing H-pile catchment system was strengthened and, at key locations, increased in height. Excavation of the slide mass and rock doweling of the underlying material began in early October. Excavated material was pushed down the face of the slope into the catchment area on a work schedule of 12 h/day, 6 days/week. Hauling from the catchment area was performed 10 h/night, 5 days/week. Disposal of most of the debris was accomplished by construction of a buttress fill along another portion of the bluff face adjacent to the Pacific Coast Highway about 5 miles east. Slide removal proceeded at an average rate of 2000 yd<sup>3</sup>/day, and maximum production was 5000 yd<sup>3</sup>/day. Dowel installation (see Figure 13) was accomplished by using two air-actuated pressure drills on a continuous basis. The construction operation was significantly benefited by the rainfall pattern in the immediate area. In contrast to normal conditions, rainfall was relatively light during the months of November and December, which permitted a period of almost three months of uninterrupted unloading and slope reinforcement. In January and
