Evaluation of Two Geotextile Installations in Excess of a Decade Old

BARRY R. CHRISTOPHER

Many erosion-protection installations for roadway embankments were designed and constructed by using geotextiles during the 1960s. Two such installations constructed in 1969 were studied to evaluate the long-term field performance of the facilities and the geotextile material. These projects were the 79th Street Causeway in Miami Beach, Florida, and the Bahia Honda Bridge in Bahia Honda Key, Florida. The 79th Street Causeway was constructed with a woven geotextile as a filter in a rip-rap revetment-type seawall to protect one of the bridge abutments and a segment of the causeway. The geotextile design was used in place of a conventional granular filter design to prevent erosion of the subgrade soils through the rip-rap. The protected section was designed for 3-ft waves and a 3-ft tidal variation. The Bahia Honda Bridge project was constructed with a woven geotextile as a subgrade-protection filter beneath sand-cement rip-rap-constructed bridge abutments, drains, and seawalls at both ends of the bridge. In this system, a geotextile was used to act as a filter between the rip-rap and underlyin

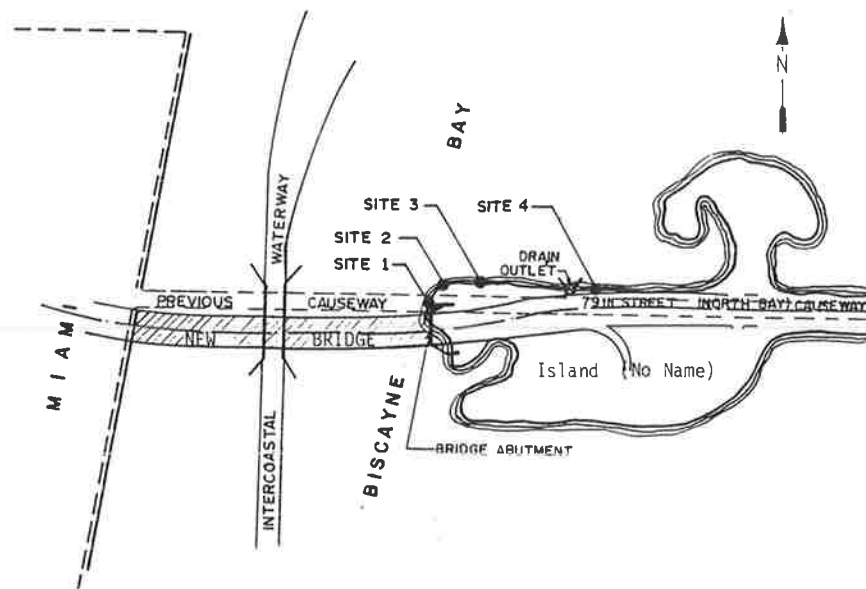
Figure 1. Location diagram for 79th Street Causeway.

Four sites were selected for further examination of the soil-geotextile system, as indicated in Figure 1. Site 1 was located approximately 3 ft north of the north corner of the causeway bridge abutment. The north corner of the concrete abutment and the location of site 1 are shown in Figures 3 and 4. This area was selected due to the relatively smaller size of rip-rap covering the area and the location in reference to protection of the bridge abutment. Also, due to a relatively flat slope in this section, the majority of the excavation could be performed above the water level at low tide.

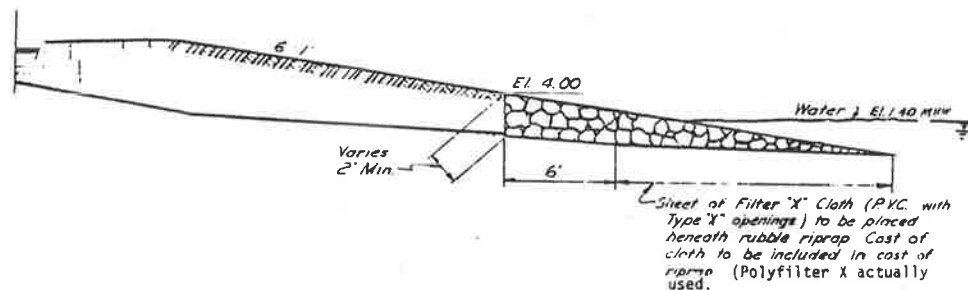
Figure 2. Proposed design of seawall.

A geotextile was used as a reverse filter beneath the limestone rip-rap for the design of the seawall. The actual proposed design of the seawall is shown in Figure 2. The original design drawings did not include details for fabric placement or the head or toe of the slope. At that time proper fabric anchorage was not well understood. The actual design was found to be somewhat different than the proposed design, as will be subsequently discussed.

Beneath the large surface rip-rap a 1-ft layer of 6- to 12-in.-diameter rip-rap was encountered. Beneath the total depth of rip-rap a 3-in. layer of coarse sand and gravel was underlain by approximately 0.25 to 0.50 in. of fine to medium sand. Note that the 3-in. cushion layer of sand and gravel was not shown in the proposed design (Figure 2). The sand was located directly on the surface of the geotextile and was probably the result of sand being washed down from the upper slope above the protec-

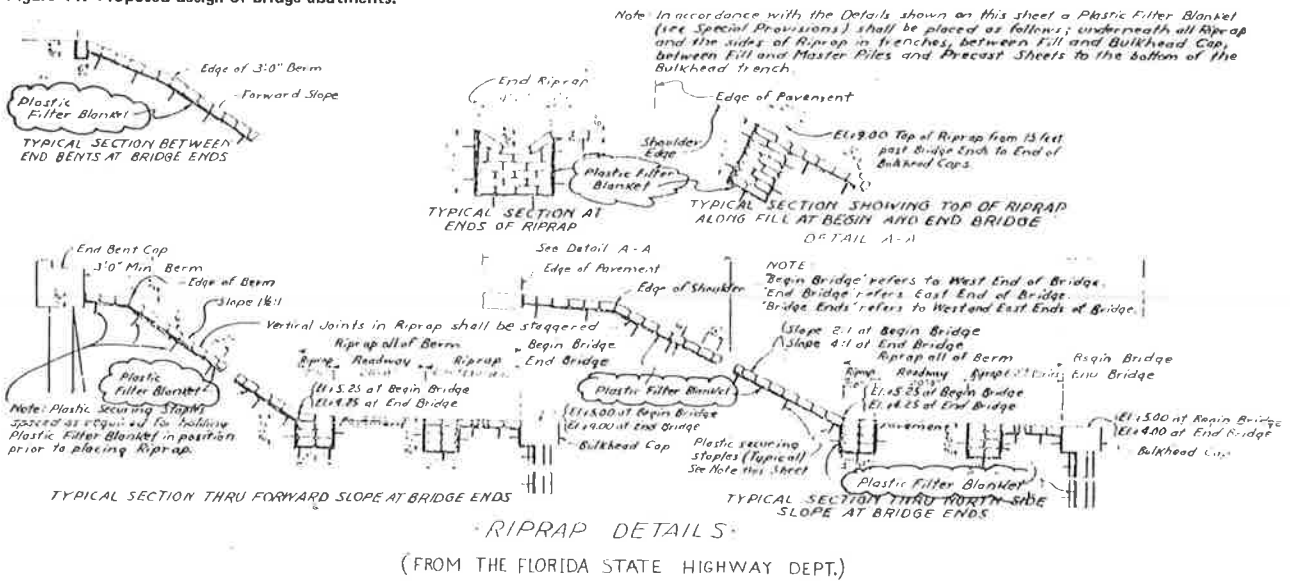
Figure 11. Proposed design of bridge abutments.

Both bridge abutments of the new bridge were constructed with a monofilament geotextile (Poly-Filter X) as a protection filter beneath sand-cement rip-rap-constructed abutment slopes, drains, and seawalls. The proposed designs for each of these sections are shown in Figure 11. The fabric in this system acts as a filter between the erosion-control armoring and the underlying soil to prevent loss of soil due to weathering or wave action through cracks or holes in the rip-rap. Sand-cement armoring construction consists of laying successive courses of burlap or jute sacks, which generally contain a mixture of one part cement to five parts sand. The sandbags are placed with broken joints. Header courses are used to tie the units together. The sacks are rammed or packed against each other so as to form a molded contact after the cement and sand mixture has set up.

stability of the sand-cement constructed facilities, as shown in Figures 12 and 13. No erosion problems were apparent at any of the drains, slopes, and seawalls protected by the sand-cement armoring system, which indicated that the installation was functioning as designed. The armoring, in most cases, has held up completely. Some surface wear was noticeable; however, no washouts of the rip-rap were observed.
