## Post-Construction Evaluation of the Fremont Bridge

MICHAEL J. KOOB, JOHN M. HANSON, and JOHN W. FISHER

#### ABSTRACT

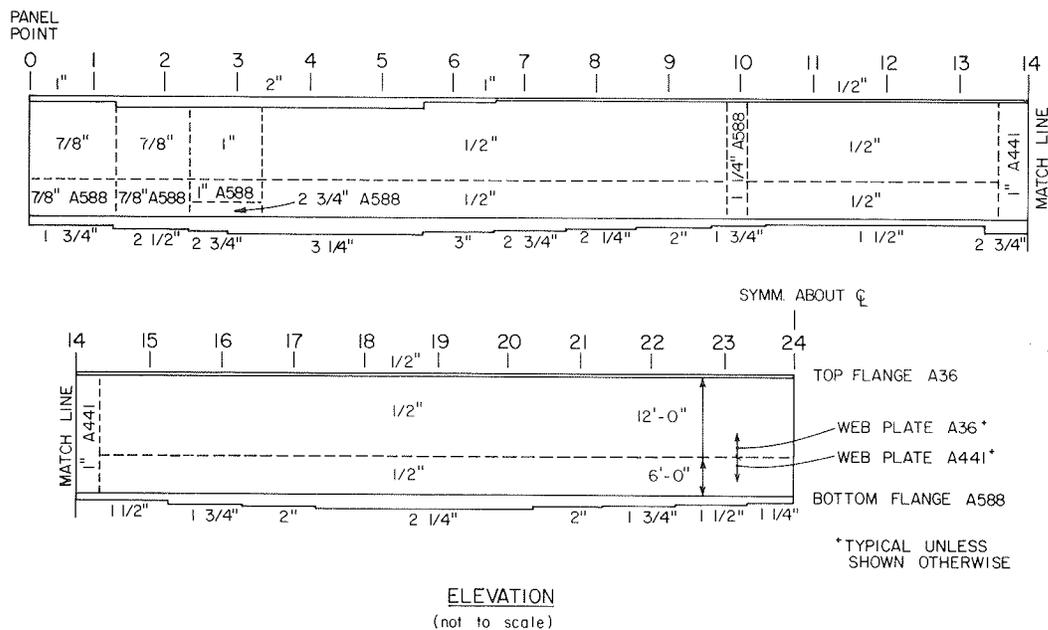
FIGURE 6 Diagram showing location and thickness of plates in tie girder.

A diagram that shows the location of various thicknesses and types of steel plates in the tie girders is presented in Figure 6. From review of the available mill reports and the shop drawings, information was compiled relating to the heat number and the physical and chemical properties of about 90 percent of the steel plates. The mill reports for the ASTM A588 plates in the bottom flange included values of material toughness obtained from Charpy V-notch (CVN) specimens tested at +40°F in accordance with ASTM E23.

plates. There was substantial variation in the toughness values. At three locations the values did not meet the AASHTO Guide Specifications for Fracture Critical Non-Redundant Members (4) requirements of 25 ft-lb, or 30 ft-lb for welded material more than 2 to 4 in. thick, at 40°F for zone 2. Minimum service temperature for zone 2 is from -30° to -1°F. The A588 steel at these locations came from 1.25- and 3-in.-thick material. According to the mill reports, the CVN values of the two 3-in.-thick plates were 18, 16, and 17 ft-lb at 40°F. CVN values for the 1.25-in. plate were 15, 16, and 15 ft-lb.
