Shoreline Stabilization To Protect Louisiana Highway 82

BABAK NAGHAVI AND PETER A. ALLAIN

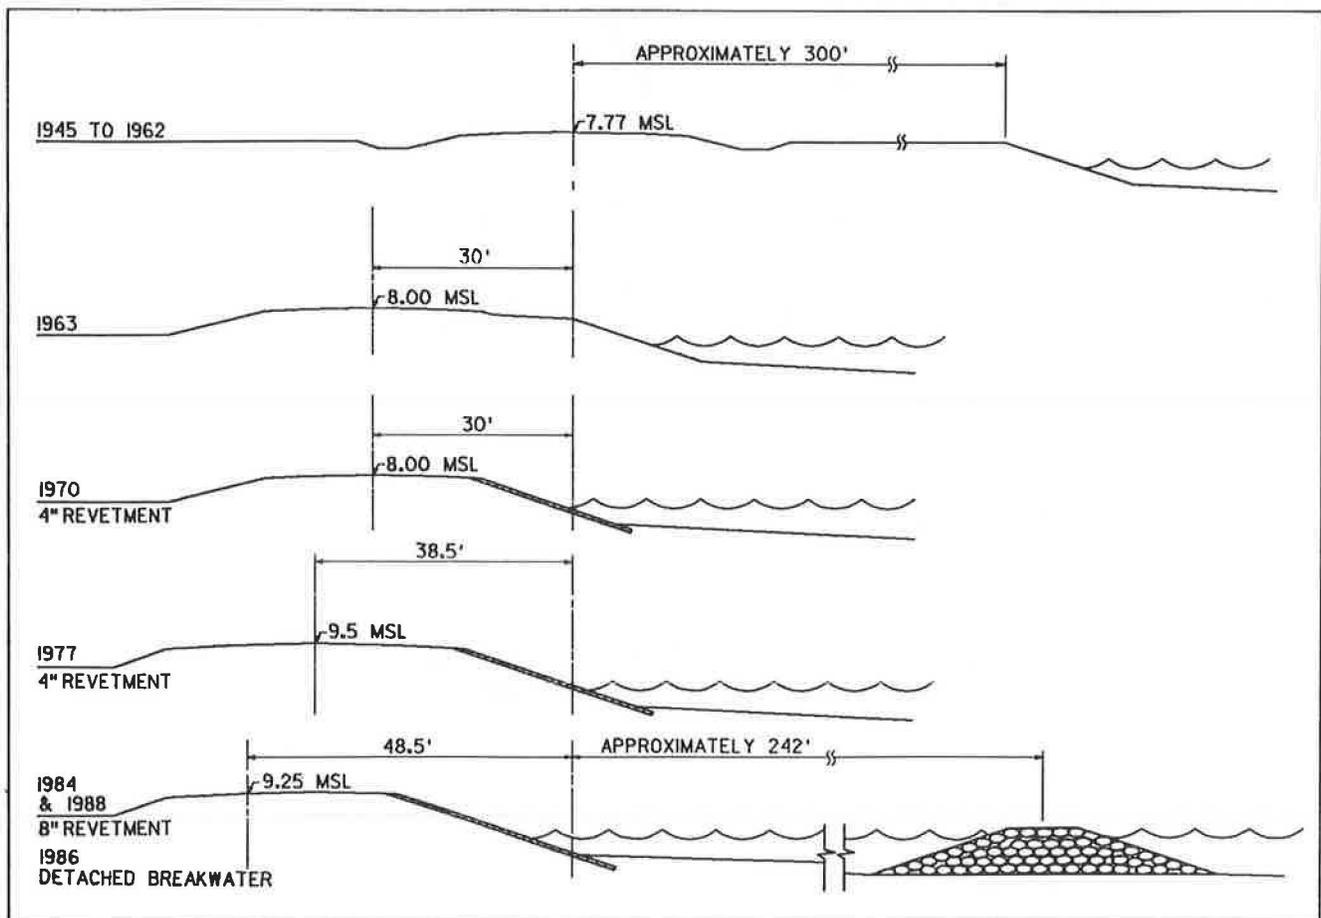
chenier. At this location, the highway was well protected from the gulf by at least 300 ft of beach and dunes. The highway became increasingly exposed to wave damage as the beach diminished and had to be relocated inland several times. Figure 3 shows the regression of the shoreline and the corresponding relocation of the highway. As further relocation of the highway became unsuitable, various revetment projects were initiated by the Louisiana Department of Transportation and Development. The project limits for these projects are shown in Figure 4.

FIGURE 3 Regression of shoreline and corresponding relocation of LA-82.

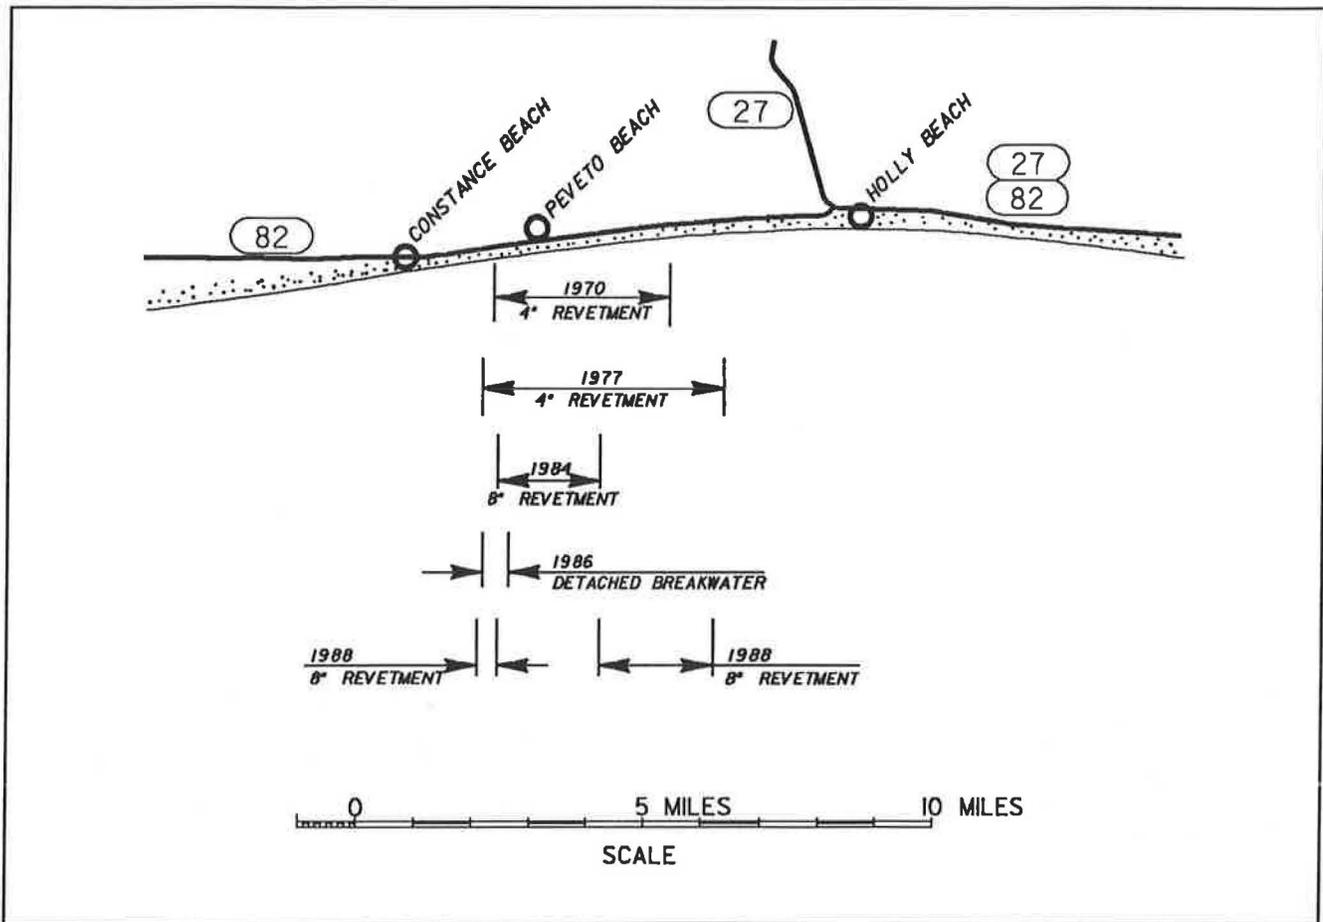
FIGURE 4 Limits of coastal erosion protection projects.

cost of \$423,000. The use of different designs also provided the opportunity to evaluate the performance of each breakwater and to identify the shoreline responses. The use of detached breakwaters to dissipate most of the wave energy through turbulence has been successfully implemented in Japan and other countries. However, their use as a coastal erosion control tool requires a detailed study of the waves, currents, sediment supply, and sediment transport in the region (7). The design and performance of the 1986 detached breakwaters are discussed in detail by Nakashima et al. (4). Even though the detached breakwaters provided additional protection, the relatively short length of the breakwaters, as shown in Figure 4, had a minimal effect on the overall performance of the recent revetment projects.

the limits of the 4-in.- and 8-in.-thick revetment projects overlapped (see Figure 4).
