Field Performance of Large-Stone Hot Mix Asphalt on a Kentucky Coal Haul Road

KAMYAR MAHBOUB, AMY SIMPSON, PAUL ODUROH, AND
JOHN FLECKENSTEIN

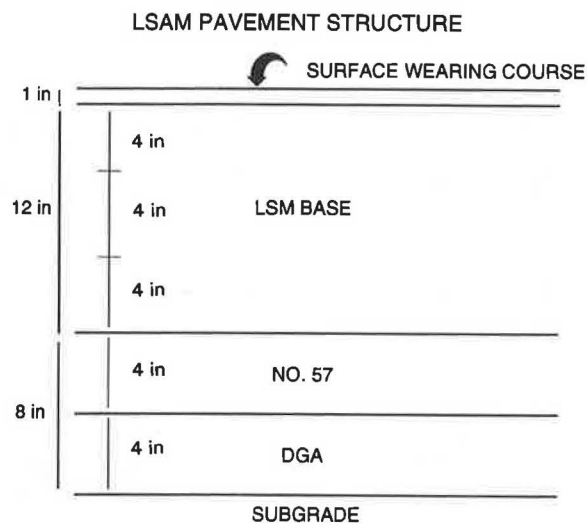
FIGURE 1 Pavement cross section, US-23–Louisa Bypass.

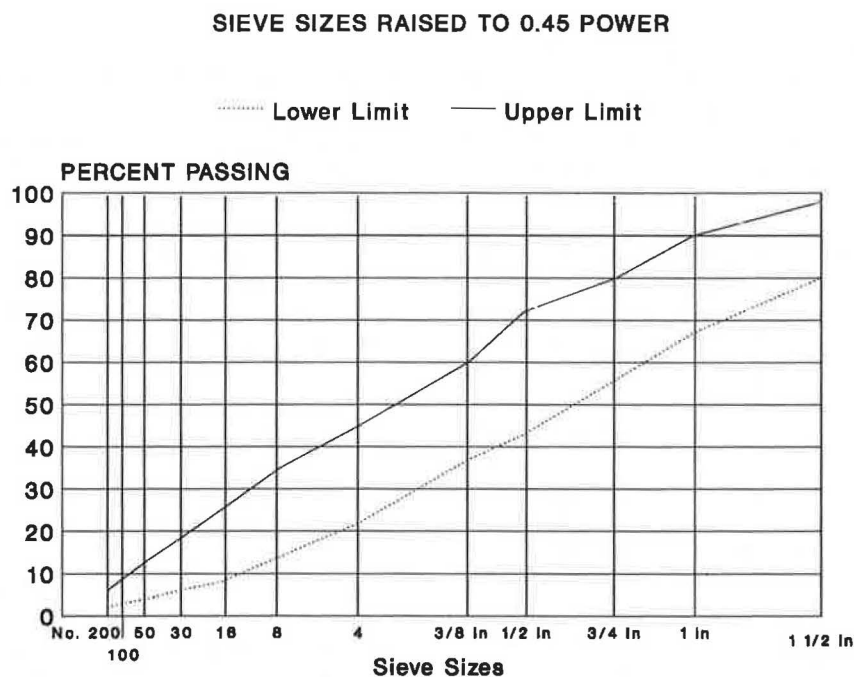
Kentucky Class K was selected through a cooperative effort between state agencies and the asphalt industry in Kentucky to address the severe rutting problem in some coal haul regions of Kentucky. The gradation of this mixture is shown in Figure 2. On the basis of previous work (1), mixture properties such as Marshall stability (Table 1), resilient modulus, and creep were shown to be superior to those of the conventional mixtures. This was true for both laboratory-

FIGURE 2 Gradation distribution for Kentucky large-stone Class K.

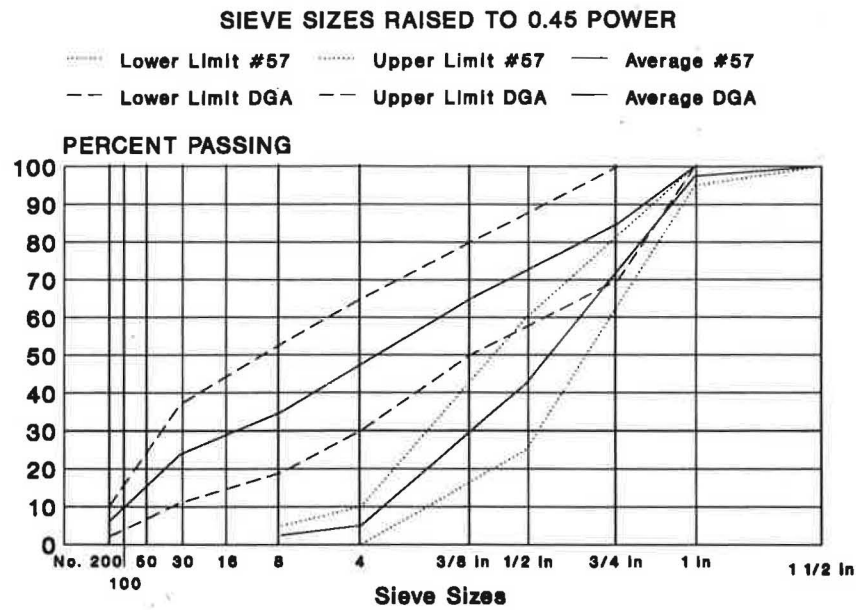
FIGURE 5 Gradation distributions for DGA and No. 57 aggregate.

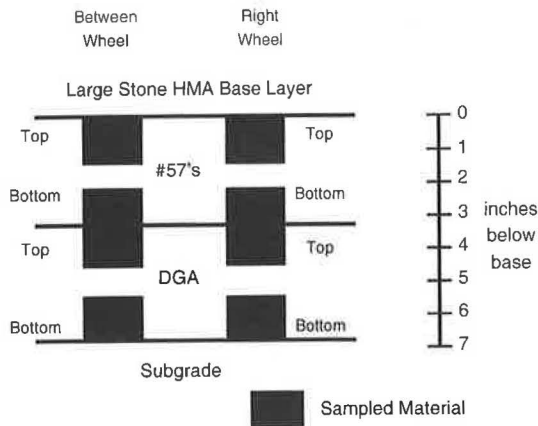
FIGURE 7 Sampling locations for DGA and No. 57 subbase material.

there has been some intrusion of small particles into the No. 57 layer, pushing parts of the gradation distribution of the No. 57 materials outside of the specification limits (Figures 8 and 9). This phenomenon was more severe at the under-the-wheel location. Water-associated migration of DGA fines into the No. 57's is possible. Load-associated forcing of the No. 57's into the DGA may also cause the thinning. This seems plausible because of the gradation differences of the between-the-wheel and under-the-wheel samples. Obviously, more work is needed before the actual cause is determined.
