# Slope Failure Risk Mapping for Highways: Methodology and Case History

ROY E. HUNT

**CASE STUDY: HIGHWAY BR 116, BRAZIL**

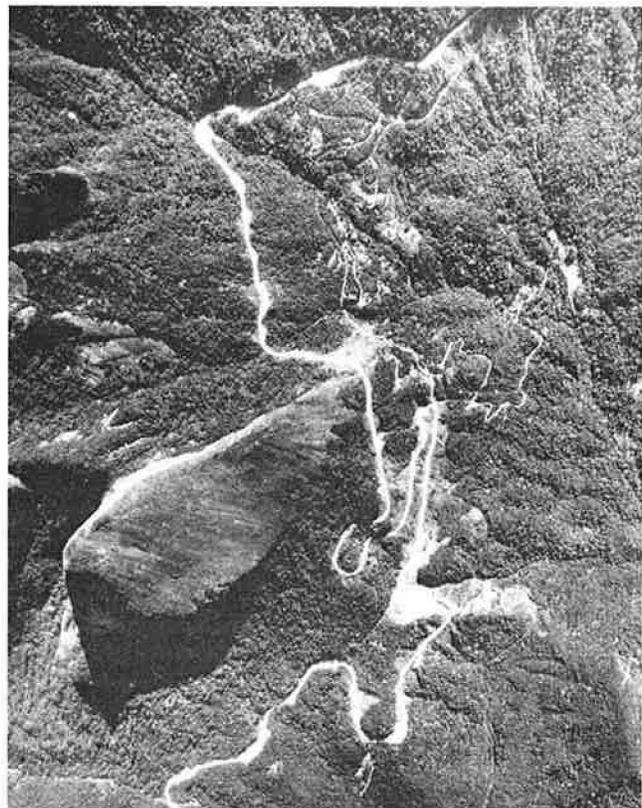
pairs of aerial photographs at a scale of 1:20,000, which were dated 1973. Enlarged to a scale of 1:10,000, the photographs provided base maps of the roadway on which cuts, fills, and retaining structures (as of 1973) were illustrated. Slide, avalanche, and erosion scars; drainage paths; and geologic data (including surface exposures of rock and soil types classified by origin) were plotted on the base maps during stereoscopic interpretation of the photographs. An aerial photograph of a portion of the higher roadway elevations is shown in Figure 1.

**FIGURE 1** Aerial photograph, Km 91-95, BR 116 (scale: 1 cm = 200 m).
