Pavement Evaluation and Development of Maintenance and Rehabilitation Strategies for Illinois Tollway East-West Extension

ELIAS H. RMEILI, KURT D. JOHNSON, AND MICHAEL I. DARTER

The procedures used in the field evaluation and development of maintenance and rehabilitation strategies for the Illinois Tollway Authority's 70-mi, four-lane East-West Extension are presented. The extension consists of 14-in. portland cement concrete (PCC) placed directly on the silty clay subgrade with random joint spacing varying between 12 and 17 ft. Although the pavement is only 17 years old, it is experiencing rapid decrease in serviceability. The field evaluation consisted of a visual condition survey, non-destructive deflection testing including void detection and transverse joint load transfer efficiencies, coring, soil evaluation, determination of slab and soil properties, and petrographic analysis of the PCC. After the pavement evaluation was completed, several maintenance and rehabilitation strategies were developed for different life expectancies varying from 2 to 20 years. All of the strategies were evaluated using EXPEAR (EXpert system for Pavement Evaluation And Rehabilitation).

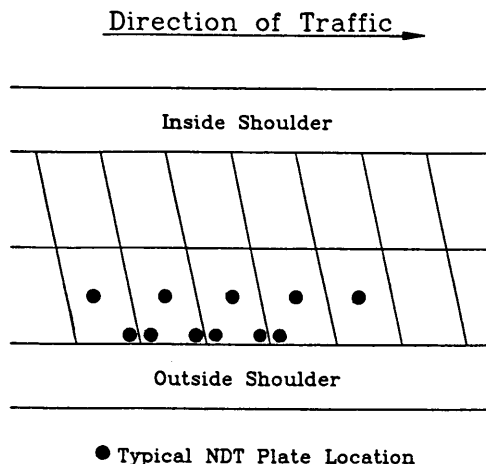
FIGURE 5 FWD testing pattern.

The initial pattern called for each test site to have five center slab tests, three lead corner tests, and three lag corner tests as shown in Figure 5. However, after 3 days of testing with very little variability between test readings, the pattern was changed to four center slab, two lead corner, and two lag corner tests.

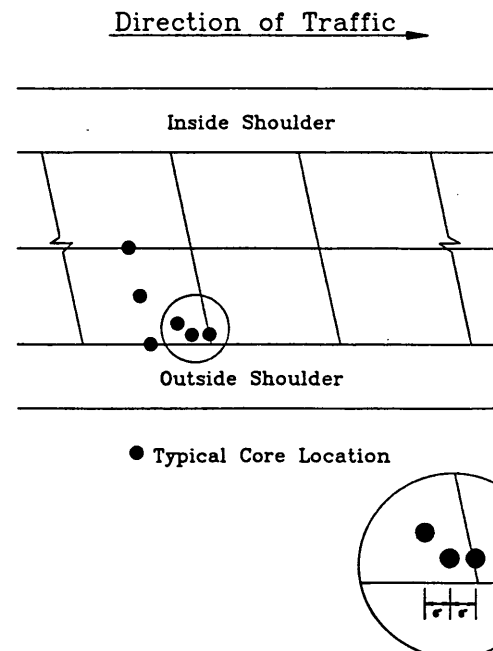
FIGURE 6 Concrete coring locations.

The coring pattern called for a core to be taken at the longitudinal, transverse, and lane/shoulder joints, center slab, and corner slab. Additional cores were taken at approximately 6 in. from the longitudinal joint, on the shoulders, and in frost heave locations. Figure 6 shows the location of the cores within a site, and Table 1 gives the thickness of the PCC and the aggregate type at specific mileposts.

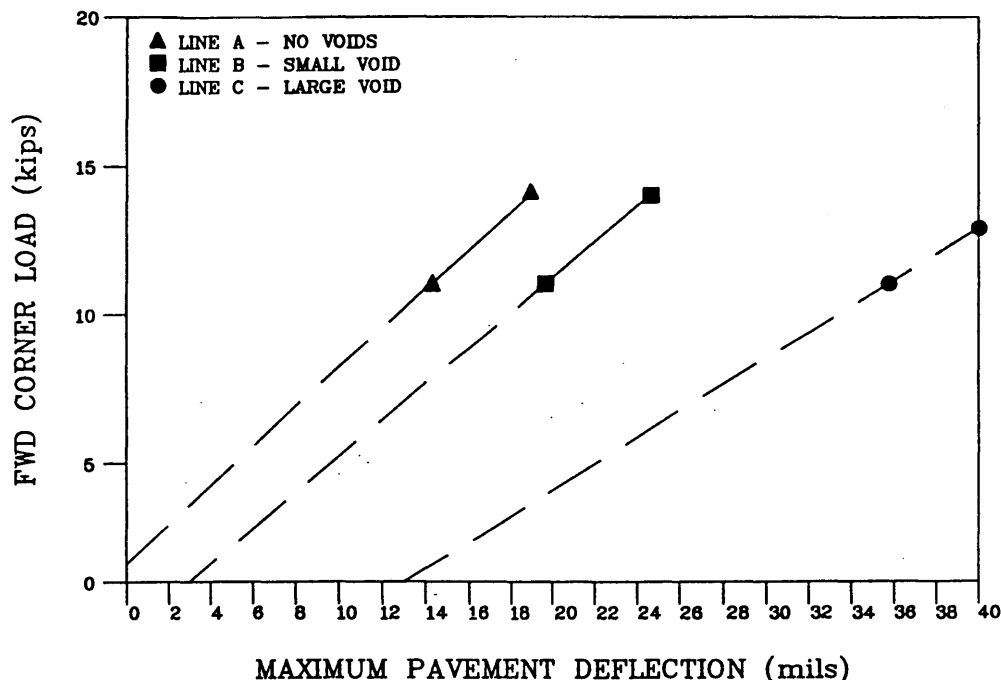
FIGURE 7 Load versus deflection void detection plot.

A void can be described as an area of loss of support beneath the slab corners. This occurs because of heavy loads deflecting the slab corners, causing some pumping of fines with impulse water pressure. Any loss of support, even less than 0.10 in. thickness beneath the slab, will result in greatly increased slab stresses, causing corner breaks or diagonal cracks. The most common location for these voids is slab corners along the lane/shoulder joints. The loss of support can be determined using a procedure developed at the University of Illinois for the FWD (3). An examination of the load versus deflection at a slab corner can provide a rapid and simple indication of the existence of a void beneath the slab corner. The corner of each slab tested was loaded at three load levels and the corresponding deflections measured. Corners that have a load versus deflection plot that crosses the deflection axis near the origin of zero deflection, such as Line A in Figure 7, do not have voids beneath the slab. However, a line that passes significantly to the right of the origin, such as Lines B and C in Figure 7, is indicative of a void or loss of support beneath the slab corner. Figure 8 shows actual data from the East-West Extension.

After reviewing all of the load versus deflection plots, it was concluded that no voids or loss of support existed beneath the slabs tested except at Milepost 62.0153 eastbound. This was probably caused by the full-depth asphalt patch of the shoulder across the joint. Most likely the subgrade soil was disturbed during patching.
