Performance Monitoring of Joint Load Transfer Restoration

KATHLEEN T. HALL, MICHAEL I. DARTER, AND JAMSHID M. ARMAGHANI

The most comprehensive load transfer restoration experiment currently in service was constructed on Interstate 10 near Tallahassee, Florida, in 1986. The performance of this experiment has been monitored continuously by the University of Illinois and the Florida Department of Transportation between 1986 and 1992. Fourteen different load transfer restoration treatments were studied. Retrofit dowel factors studied included number of dowels per wheelpath, dowel length, and dowel diameter. Double-V shear device factors studied included core wall grooving and number of devices in the outer and inner wheelpaths. The results of condition surveys, faulting surveys, and falling weight deflectometer deflection load transfer testing of the project are reported. All of the treatments were effective in limiting faulting increases to much lower levels than the faulting increases of the control sections. In addition, they all improved deflection load transfer significantly, and after 5 years in service, deflection load transfer percentages are still similar to initial postcons

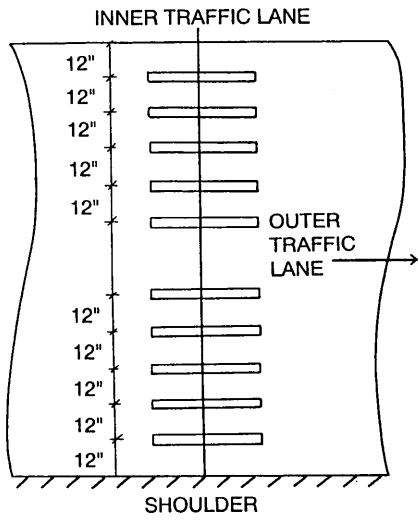
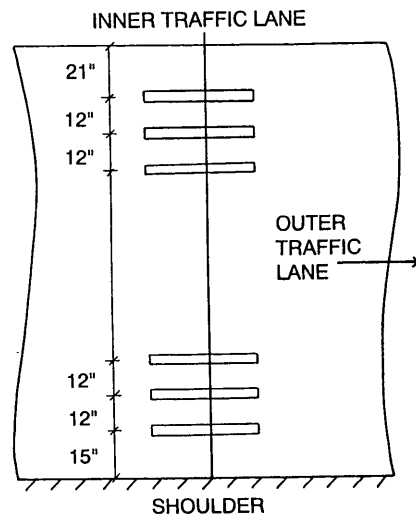
FIGURE 3 Retrofit dowel layouts.

The retrofit dowels were fitted with expansion caps on one end, mounted on chairs in parallel slots sawed across the joints, and backfilled with a concrete patching material (trade-name HD-50) supplied by Dayton Superior. The positions of the retrofit dowels across the traffic lane for the different configurations are illustrated in Figure 3.

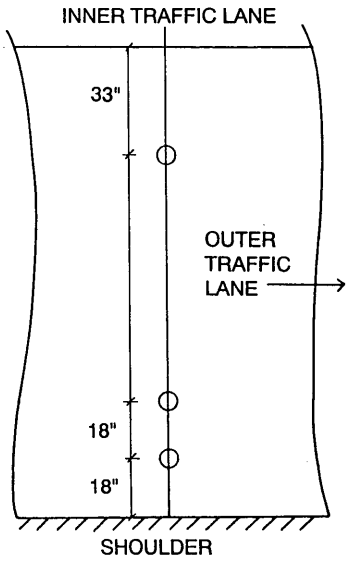
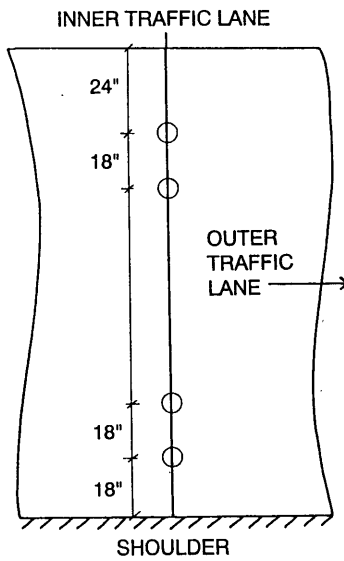
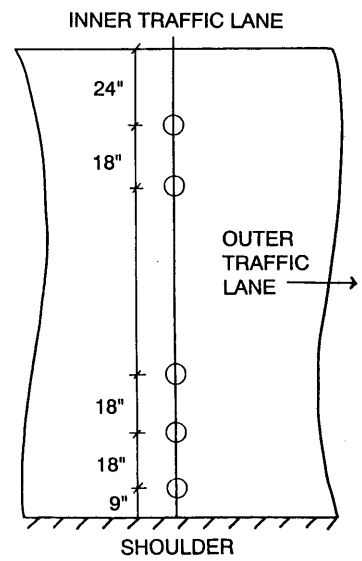
FIGURE 4 Shear device layouts.

The primary components of the LTD + Plus double-V shear device are two v-shaped plates of stainless steel, welded together and flanged. The interior of the device is filled with polyurethane foam, and the double-V's are wrapped in polyvinyl foam. The double-V's are aligned with the transverse joint to permit horizontal movement of the slabs. The positions of the shear devices across the traffic lane for the different configurations are illustrated in Figure 4.
