Liquefaction-Induced Damage to Bridges

T. LESLIE YOUD

Liquefaction-induced lateral spread is a major cause of earthquake damage to bridges built across streams and rivers. Lateral spreads are characterized by horizontally displaced ground with extensional deformations at the head of the feature, shear deformations along the margins, and compressed ground at the toe. Displacements generally range from a few centimeters to several meters and are directed down mild slopes or toward a free face, such as an incised river channel. Such displacements thrust bridge abutments and piers riverward, generating large shear forces in connections and compressional forces in the superstructure. These forces have sheared connections, allowing decks to be thrust into, through, or over abutment walls or causing decks to buckle. In other instances, connections have remained intact with the deck acting as a strut, holding tops of piers and abutments in place while the bases of these elements are displaced toward the river. These actions have inflicted severe damage and even bridge collapse. The performance of bridges during past earthquakes is reviewed to illustrate types of damage as a consequence o

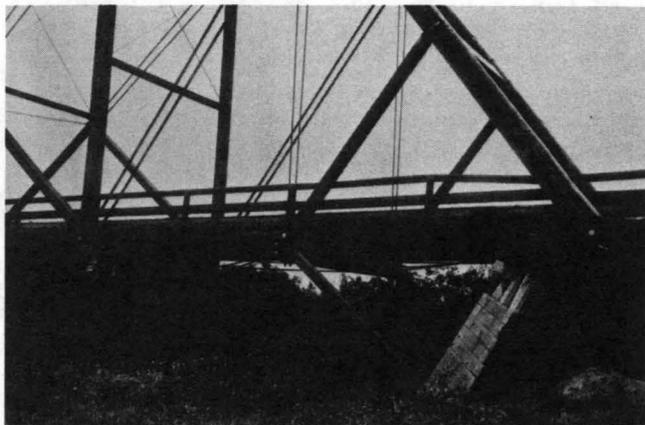
FIGURE 2 Highway bridge over Salinas River south of Salinas, California, that was damaged by lateral ground displacement during the 1906 San Francisco earthquake. The ground displacement physically moved the base of the southern pier 2.8 m toward the river (photograph by J. C. Branner, courtesy of Stanford University Archives).

Lateral displacement of the floodplain physically displaced both ground and pile foundation about 1.8 m northward toward the river channel. The bridge trusses and deck were strong enough to remain intact and were essentially undamaged. The deck, which remained attached to the tops of the piers, acted as a strut, holding the tops of the piers in place while their bases shifted riverward. This motion left the southern pier inclined, with the top of the pier tilted outward, away from the river.
