# Performance Evaluation of a Cement-Stabilized Fly Ash Base

D. H. GRAY, E. TONS, AND T. R. THIRUVENGADAM

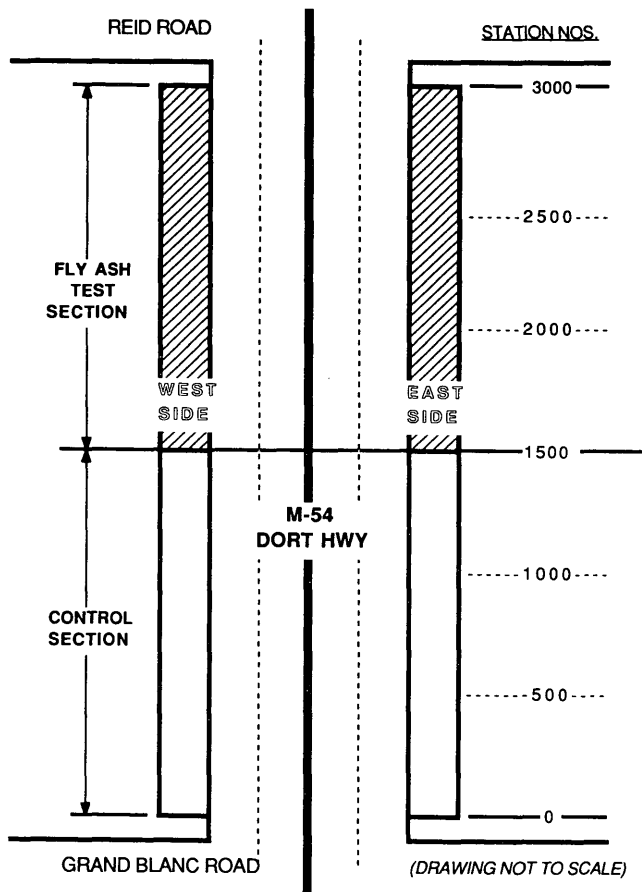
FIGURE 1 Schematic diagram showing plan and layout of road shoulder test.

the project. A new highway construction project on Michigan Route M-54 emerged as the most promising location from a number of candidate sites considered. A 457.5-m- (1,500-ft-) long section between Grand Blanc Road and Reid Road (see Figure 1) was selected for a trial fly ash shoulder. The combined length of the fly ash shoulder on both sides totaled 915 m (3,000 ft). An additional 915-m (3,000-ft) length of shoulder adjacent to the fly ash test section was established as a control section. At present the traffic is of medium intensity, but is expected to grow with time. To accommodate the traffic, the asphalt pavement was made 14.6 m (48 ft) wide with two 3.66-m (12-ft) lanes in each direction. The total width of the roadway, including the 2.7 m (9-ft) shoulders on each side, was 20.1 m (66 ft).

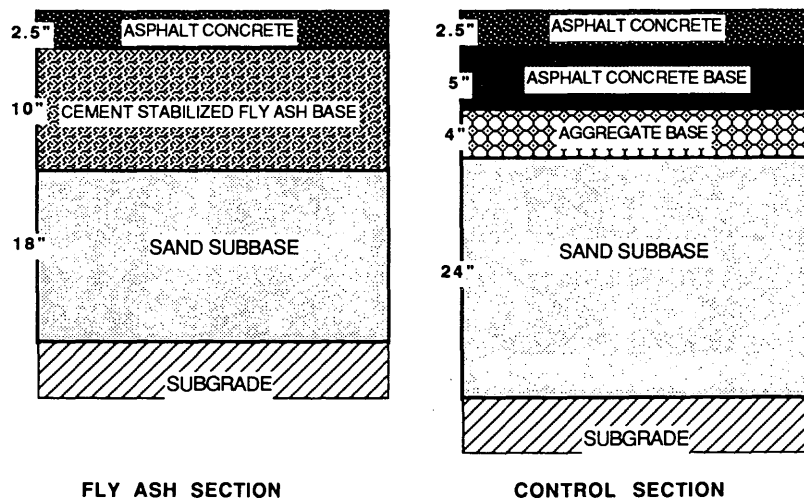
FIGURE 2 Stratigraphic profile of fly ash test section and control section.

The required thickness of the fly ash base was calculated using the American Association of State Highway and Transportation Officials (AASHTO) design equation. The soil support value was assumed to be 3, which is equivalent to a California Bearing Ratio of about 3, and the minimum required sand subbase thickness was taken as 30.4 cm (12 in.). The final thickness of the compacted cement stabilized fly ash base course for the M-54 shoulder was calculated to be about 25.4 cm (10 in.). This design thickness was reasonable, based on previous experience. The adjacent control section had a standard Michigan Class A design with a 12.7-cm (5-in.) asphalt concrete base, 10.1-cm (4-in.) aggregate base and a 6.3-cm- to 7.6-cm- (2.5 to 3-in.-) thick asphalt surface supported on a sand subbase. A stratigraphic profile of both the fly ash and control section is shown in Figure 2.

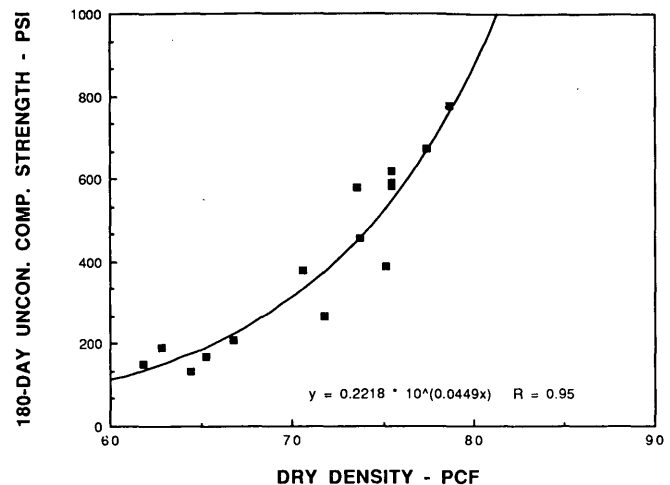
FIGURE 3 Unconfined compressive strength versus dry density: 180-day samples (1 psi = 6.89 kPa).

Correlations were examined among unconfined compressive strength and other soil properties such as density, moisture content, cement content, and Clegg impact readings. The relationship between unconfined compressive strength versus dry density at 180 days is plotted in Figure 3. Fairly good correlations were obtained, with the strength increasing with dry density in an exponential fashion as shown. The coefficient of correlation for 90- and 180-day strength versus dry density was 0.61 and 0.95, respectively.

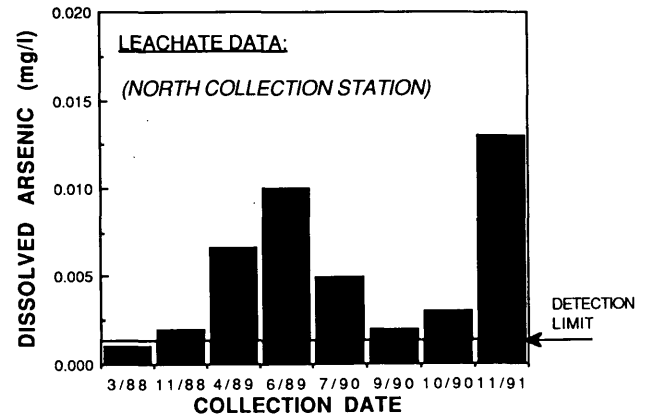
FIGURE 11 Sub drain leachate test results for dissolved arsenic.

wells and no significant differences have been observed to date between the background and test section wells. Leachate samples from the sub drains were analyzed for a number of toxic ions including selenium, arsenic, chromium, and cadmium. Typical results are shown in Figure 11, where dissolved concentrations are plotted versus collection date for arsenic. Results were plotted only for the north collection station, which receives leachate from the fly ash test section. Leachate concentrations for dissolved cadmium and chromium have remained relatively constant over time. On the other hand, selenium and arsenic concentrations have tended to fluctuate over time. The latter trend is particularly noticeable in the case of dissolved arsenic, as shown in Figure 11. Concentrations peaked in June 1989 and again in November 1991. It is important to note, however, that the maximum dissolved arsenic concentration in the leachate is still well below the Safe Drinking Water Standards (SDWS), as shown in the following table:
