ITALIAN MARITIME INVESTIGATIVE BODY ON MARINE ACCIDENTS

MARINE ACCIDENT
INVESTIGATION
C/S COSTA CONCORDIA
13th January 2012

*MSC90
London - May 18th, 2012*

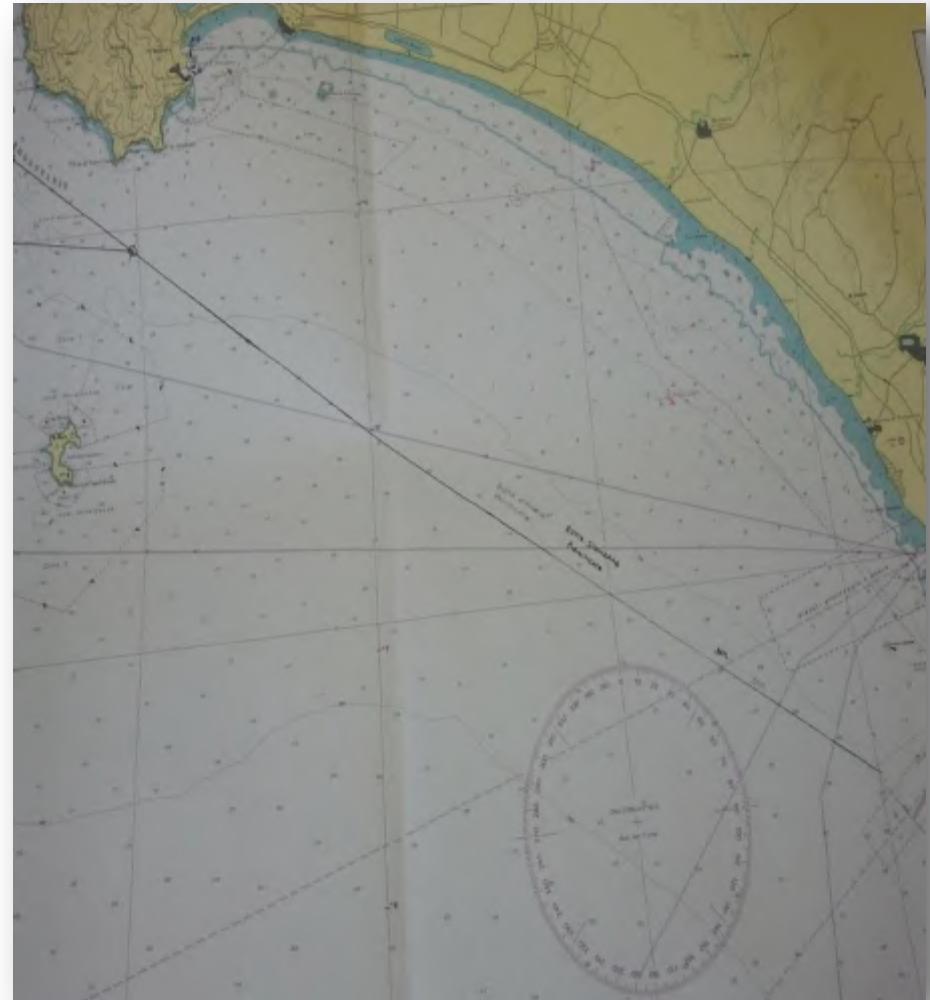
Passage 0,5 miles from the bathymetric limit of 10 meters depth, abeam “Le Scole Reef” (Island of Giglio).

The Ship's **Integrated Navigation System** (Nautical Chart nr. 6 - scale 1:100.000 of Italian Hydrographic Service and the Electronic Cartography – ECDIS) reports the planned course.

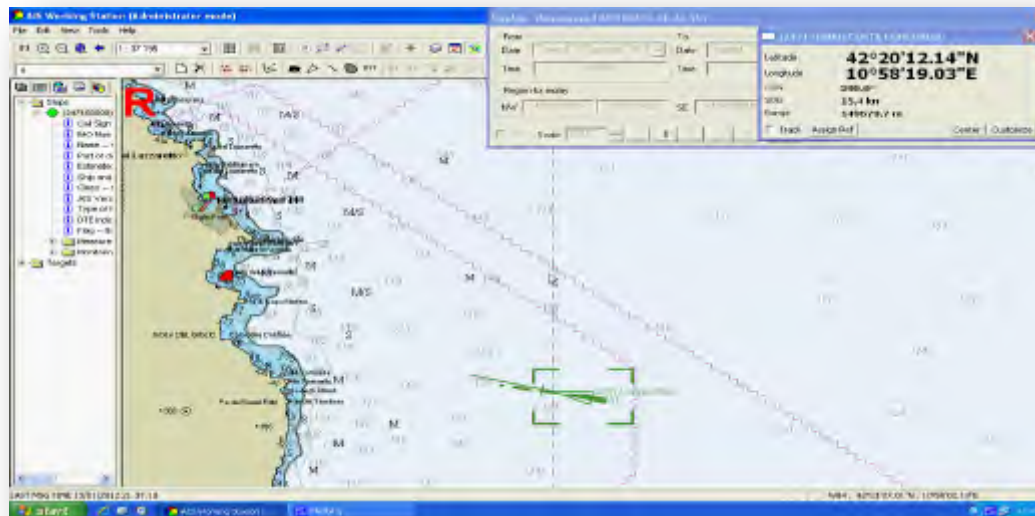
When the Ship is deemed to be sailing too close to the coast the **SEQUENCE OF SHIP MASTER'S ORDERS** is the following:

- 1) "hard to starboard" and the Ship's bow avoids the shallows;
- 2) "hard to port", but the Ship's stern cannot avoid them

09.45 pm : COLLISION between the port side of the hull and the eastern rock of "Le Scole"

- 3) "hard to starboard" and the ship speed reduces instantly up to 8,3 knots, drifting off in headway, on a heading of 350°

IMMEDIATELY the two Ship's main electrical engines lose power

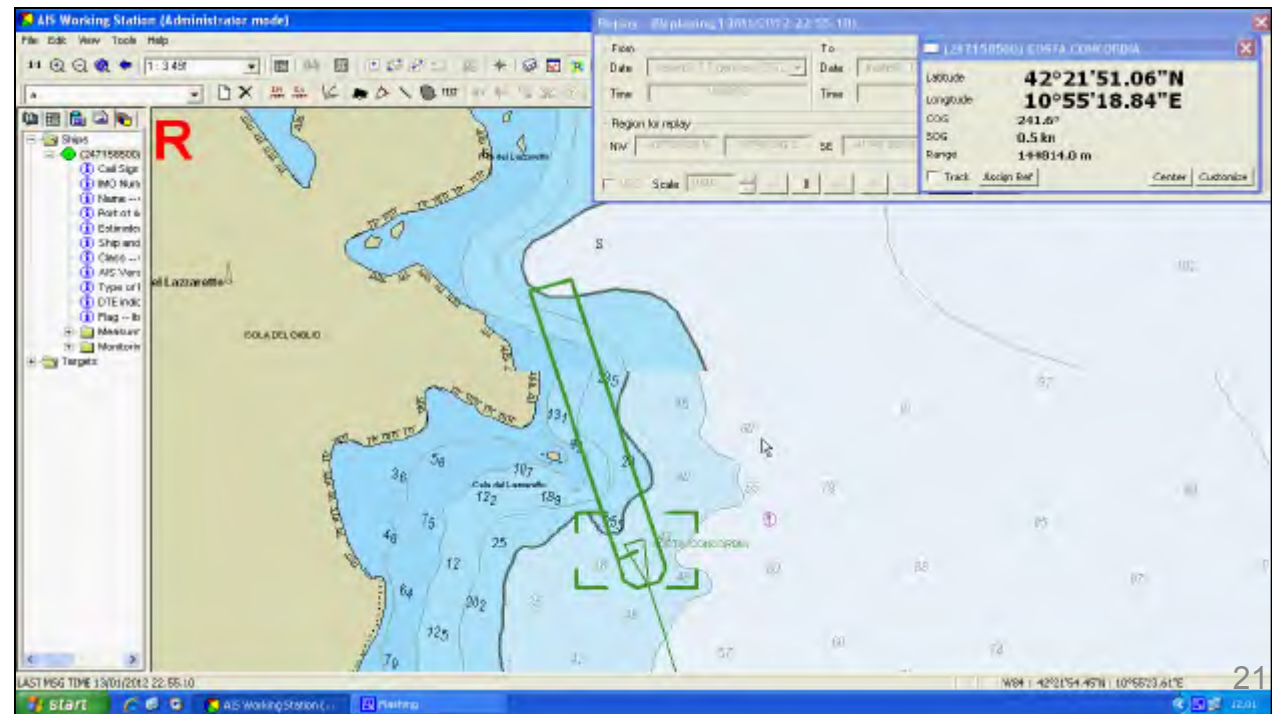
At 10.58 pm

Almost in **final grounded position**, struck, Lat $42^{\circ}21'50''N$ – Lon $010^{\circ}55'18''E$
Island of Giglio – Cala del Lazzereto

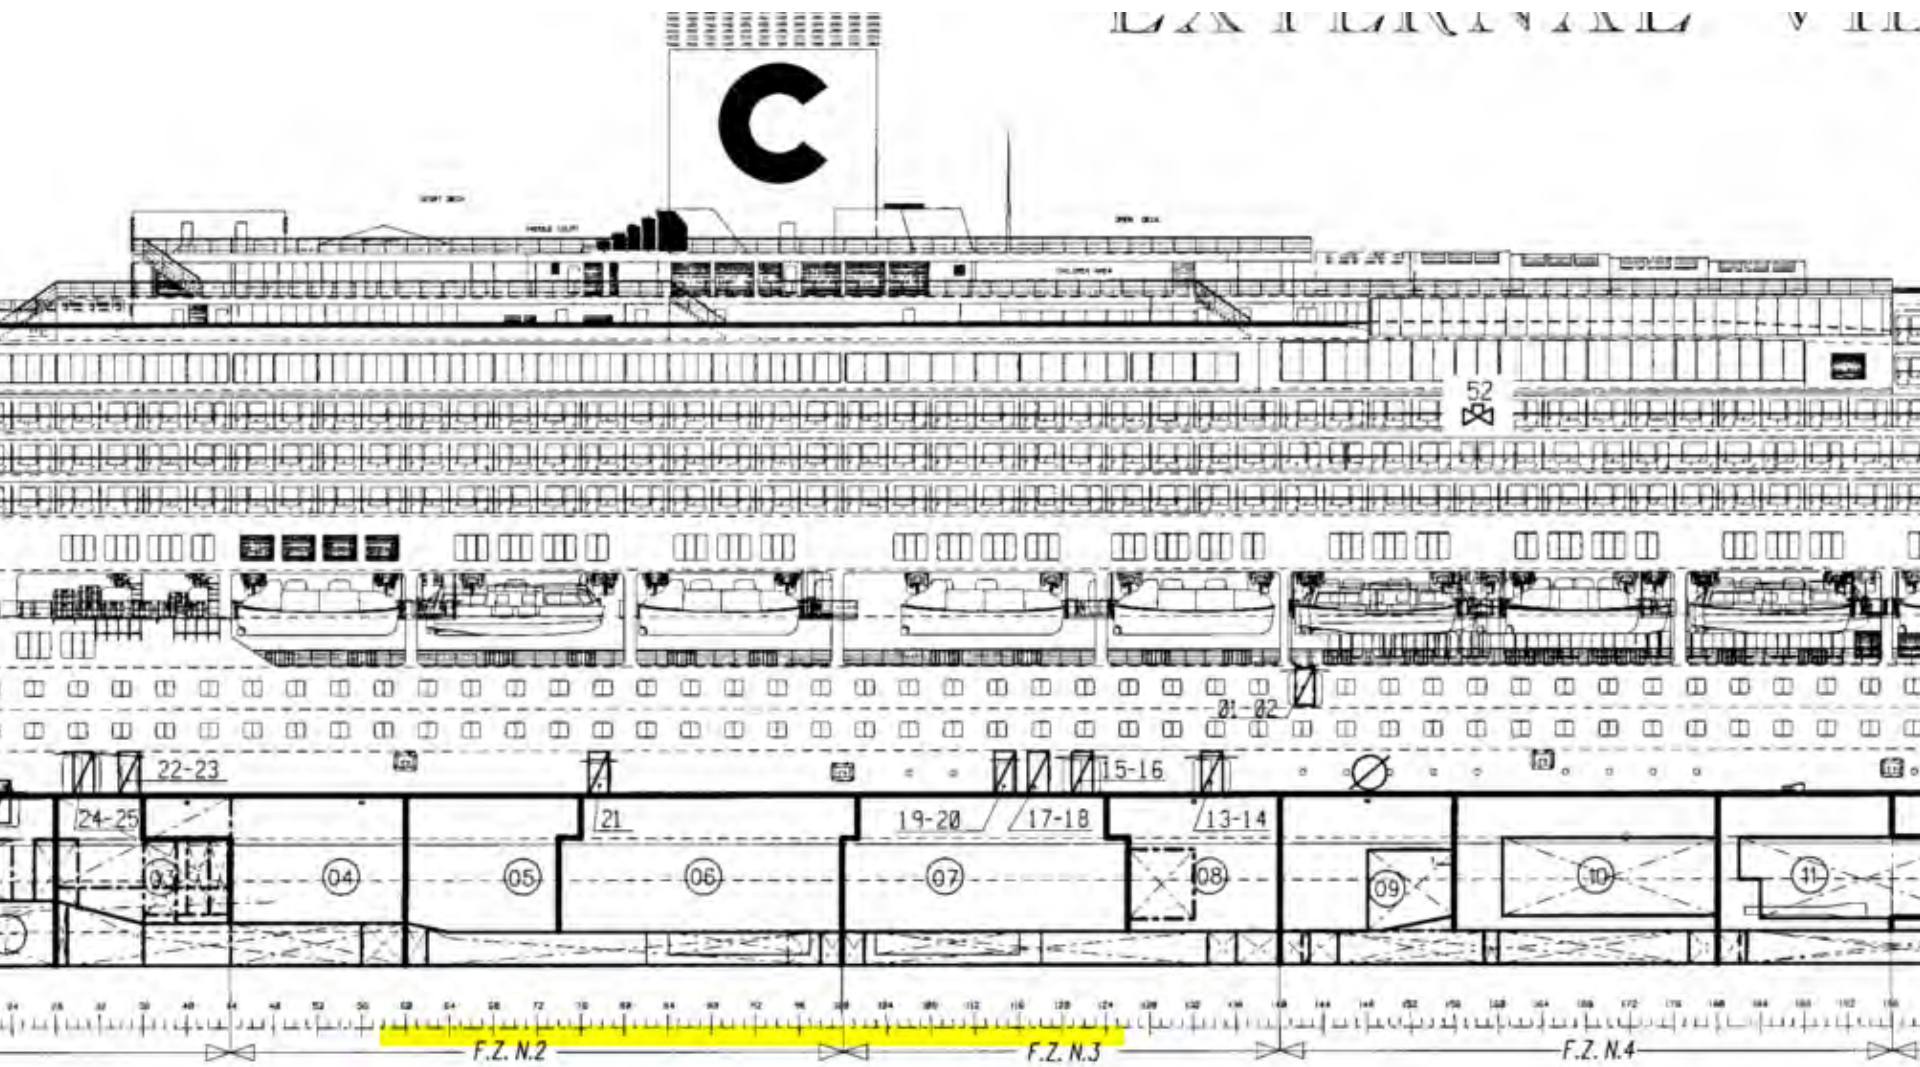
**Damage between frame no. 58 and frame no. 125/128,
creating a 60 meters hole into the hull – portside**

- **The two most affected watertight compartments (contiguous), immediately flooded:**
 - no. 5 (Propulsion Electric Motor)
 - no. 6 (aft generators)
- **Partially flooded at the time of crew inspection (10 minutes after the impact)**
 - no. 7 (forward generators)
 - no. 4 (Galley compressors)
