Guidelines for Dowel Alignment in Concrete Pavements

APPENDIX B FIELD TESTING RESULTS

Prepared for
NATIONAL COOPERATIVE HIGHWAY RESEARCH
PROGRAM (NCHRP)
Transportation Research Board
of
The National Academies

**Shreenath Rao, Senior Engineer
Applied Research Associates, Inc.**

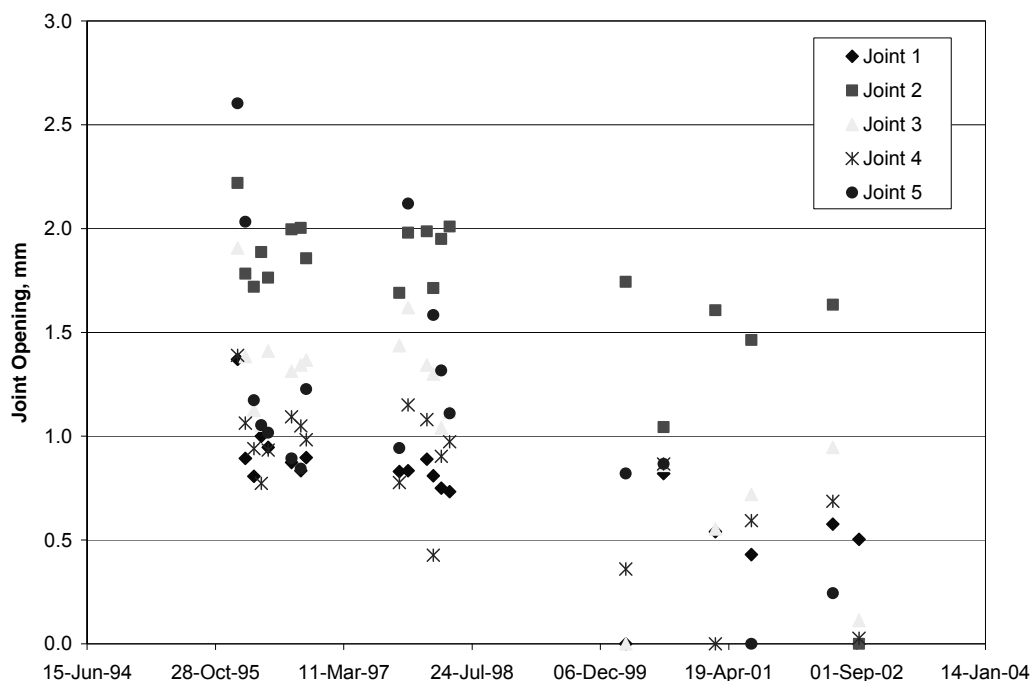
Figure B.2. Joint opening at 1-GA1 (LTPP 13-3019) measured over a 10-year period.

All 11 joints opened and closed (moved) depending on ambient conditions of temperature, moisture, and slab-base friction over the 10-year period. Tables B.12 and B.13 show the maximum joint opening, average vertical translation, average longitudinal translation, average vertical tilt, and average horizontal skew for joints at 1-AZ1 and 1-GA1, respectively. No effects of translations or misalignments can be seen. It should be noted that none of these joints had very high levels of translations or misalignments, and nine joints is a very small sample size; any conclusions should be used cautiously.

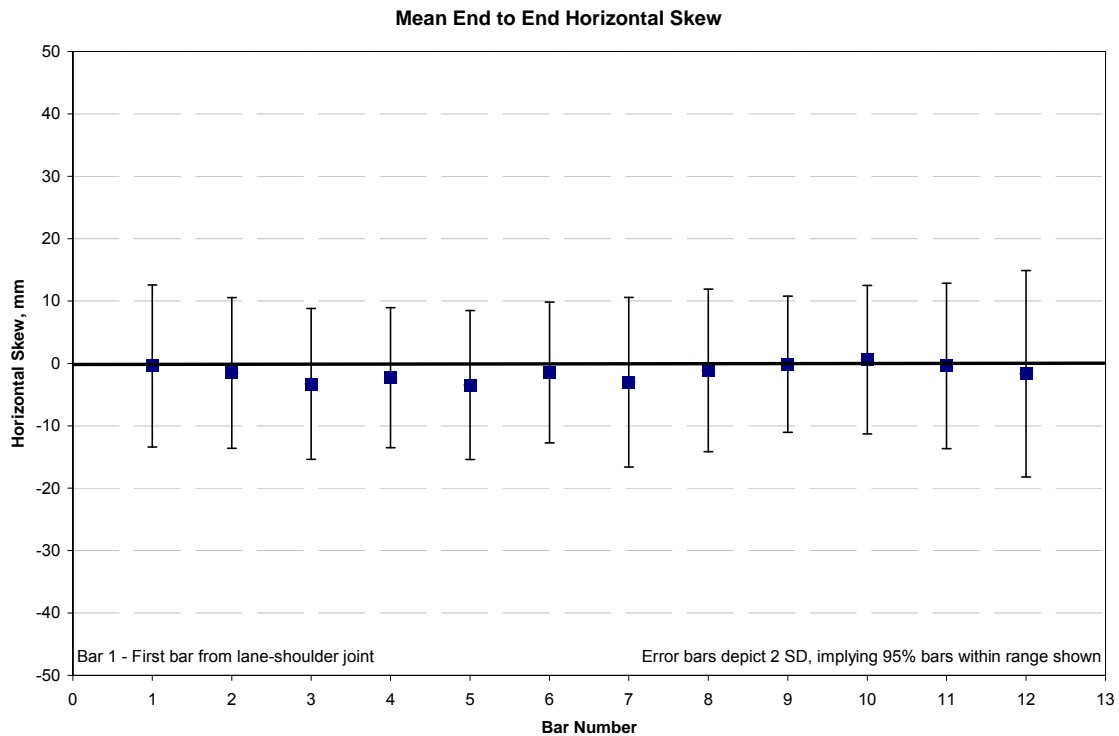
Figure B.4. Mean and range of horizontal skews for each bar position for the 40 scanned joints for 1-IN1 (first and last bar were not used in analysis due to tie-bar effects).

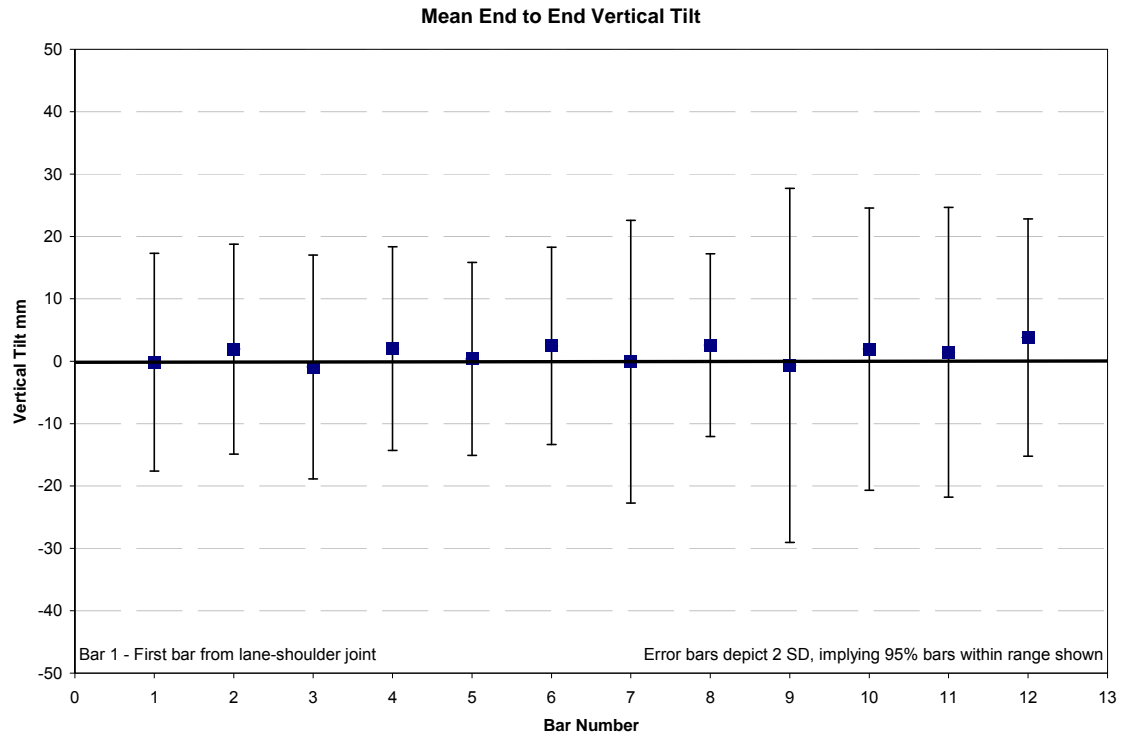
Figure B.5. Mean and range of vertical tilts for each bar position for the 40 scanned joints for 1-IN1 (first and last bar were not used in analysis due to tie-bar effects).

Note that the only mid-panel crack observed on this section was on slab 14, which also coincides with the joint with the highest amount of vertical tilt. Joint 14 has average vertical tilt of 41 mm, which significantly exceeds the project average absolute vertical tilt of 6 mm. The average horizontal skew of joint 14 was 6 mm. Based on the station/date stamp near joint 14, it is surmised that this joint was a construction joint. Overall, the section was in excellent condition, with only two joints showing minor spalling, the single transverse crack on slab 14, and average faulting of 0.005 in. (0.1 mm). Most slabs had faulting less than 0.05 in. (1.3 mm), and many slabs measured minor amounts of negative faulting, likely due to differences in curling between the adjacent slabs.

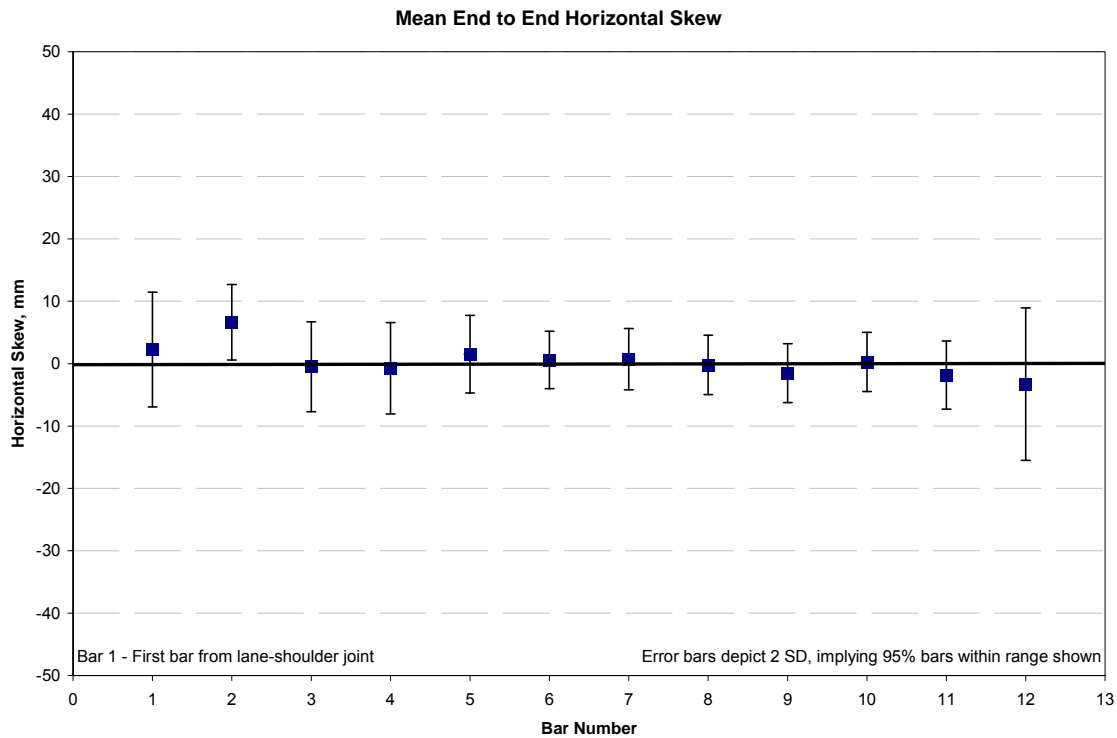
Figure B.11. Mean and range of horizontal skews for each bar position for the 30 scanned joints for 1-WI2.

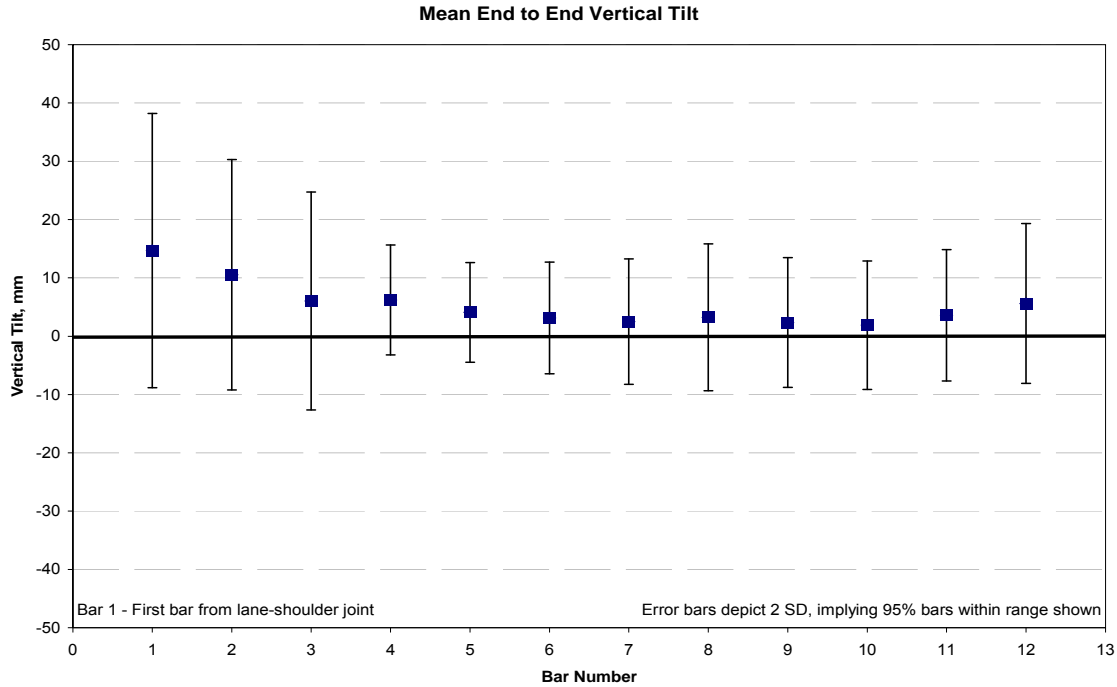
Figure B.12. Mean and range of vertical tilts for each bar position for the 30 scanned joints for 1-WI2.

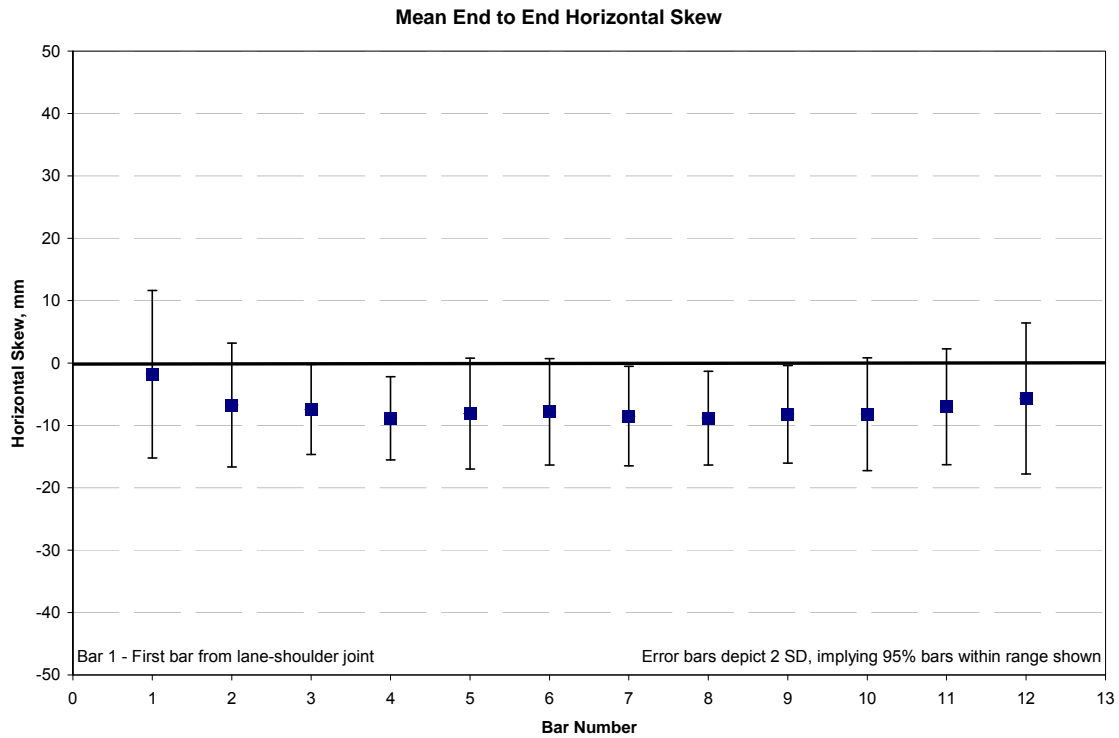
Figure B.18. Mean and range of horizontal skews for each bar position for the 33 scanned joints for 1-OH1.

misalignment and position deviation was in the first and second dowel bars closest to the lane-shoulder joint. Note that this section had AC shoulders and not tied PCC shoulders. Tie bars in tied PCC shoulders can affect the MIT Scan-2 readings, resulting in greater errors for the first two bars, but this was not the case here. The pavement showed excellent performance with no major distresses and only a few joints with very minor surface spalling after 13 years of moderately heavy traffic. The average faulting on this section was 0.03 in. (1 mm).

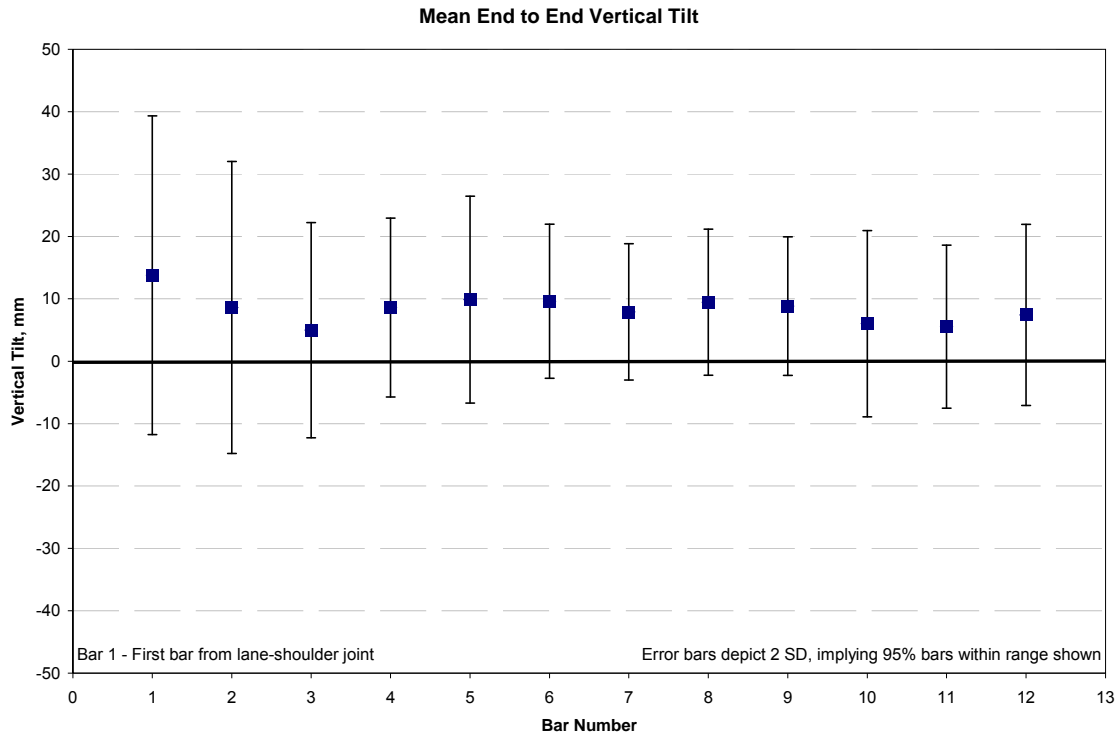
Figure B.19. Mean and range of vertical tilts for each bar position for the 33 scanned joints for 1-OH1.

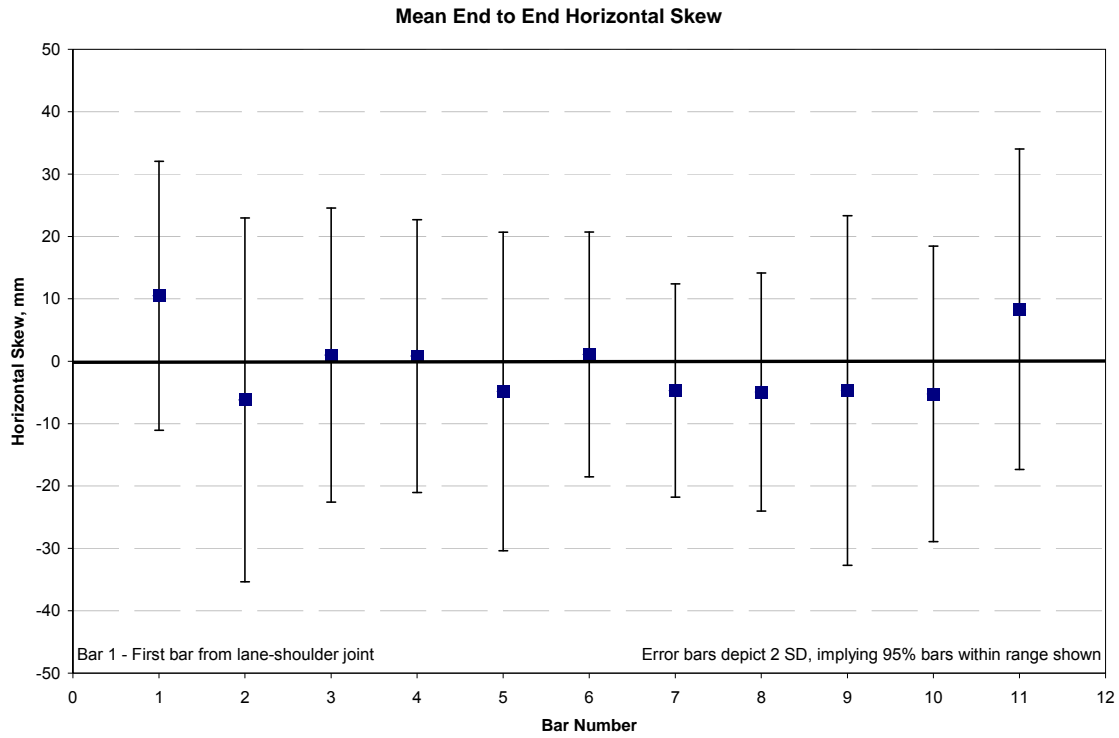
Figure B.24. Mean and range of horizontal skews for each bar position for the 35 scanned joints for 1-IL2.

MIT Scan-2 scanning and analysis showed poor to moderate dowel alignment at some of the joints. Over 27% of the dowel bars had vertical tilt greater than 18 mm, and over 21% of the dowel bars had vertical position shift greater than 25 mm. The pavement also had moderate levels of distresses, with 14% of the slabs exhibiting mid-panel transverse cracking. One slab had longitudinal cracking, and one joint exhibited high-severity spalling. However, the MIT Scan-2 analysis showed that the dowel misalignment and position deviations did not correlate to the observed distresses.

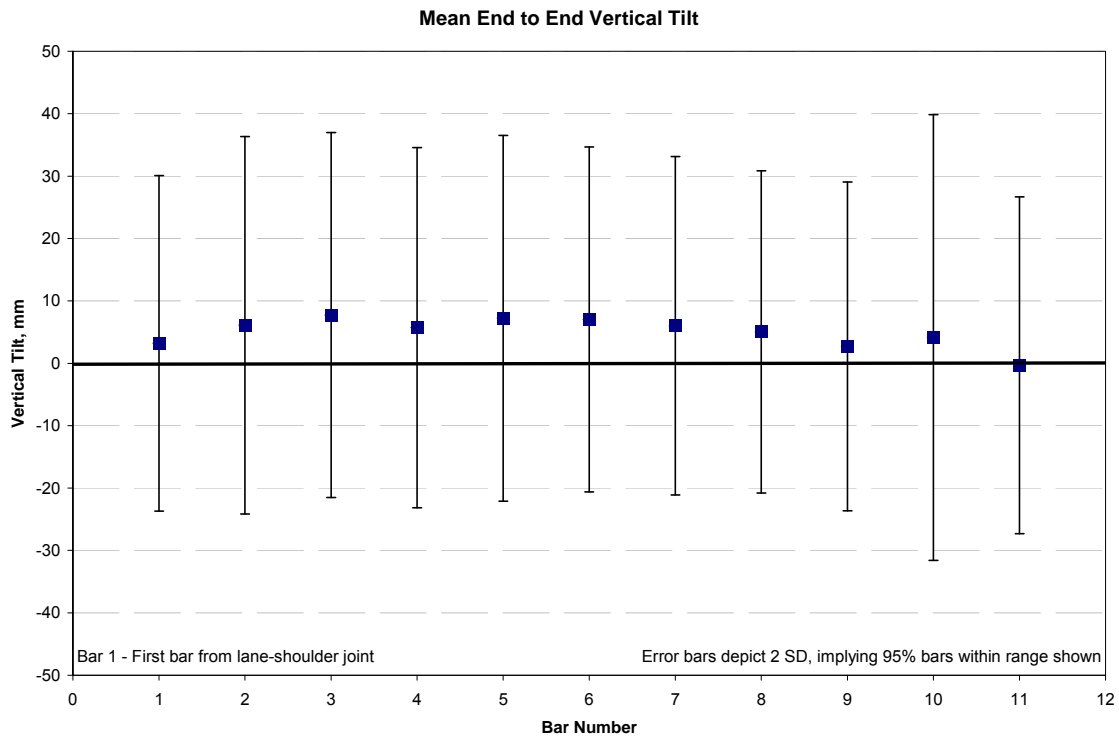
Figure B.25. Mean and range of vertical tilts for each bar position for the 35 scanned joints for 1-IL2.
