**APPENDIX C**

**STRUCTURAL INVESTIGATION & FULL-SCALE GIRDER TESTING**

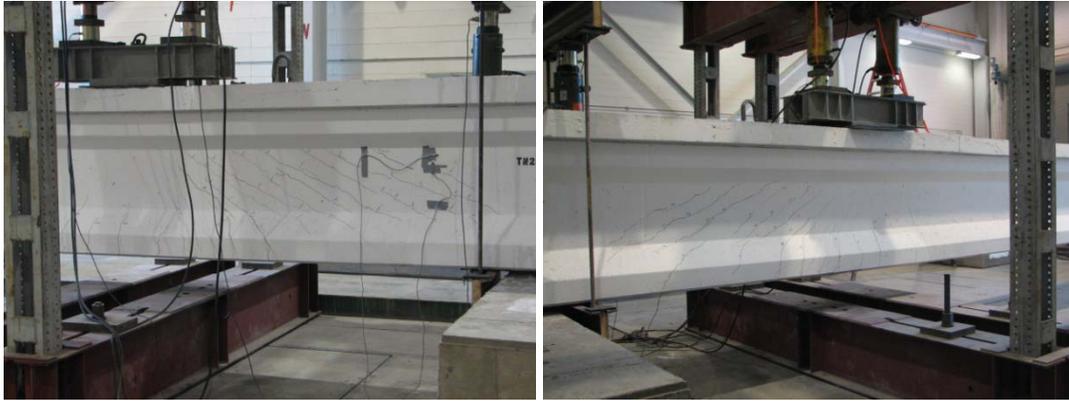
Figure C.1-12. Crack patterns at failure

Force was then reapplied until the system began to no longer take any more load. At this point the applied load was 546 kips and the deflection at the location of loading reached 3 in. This was considered the point at which the girder reached failure. Cracking patterns that appeared were consistent with a classical flexural failure, Figure C.1-12. The beam was designed to fail in flexure, and this appeared to be the primary cause of failure. Some strand slippage, or bond failure was also apparent in the testing. Some of the strands sticking out of the ends rotated in the direction of the twisted wires as they slipped into the girder, Figure C.1-13.

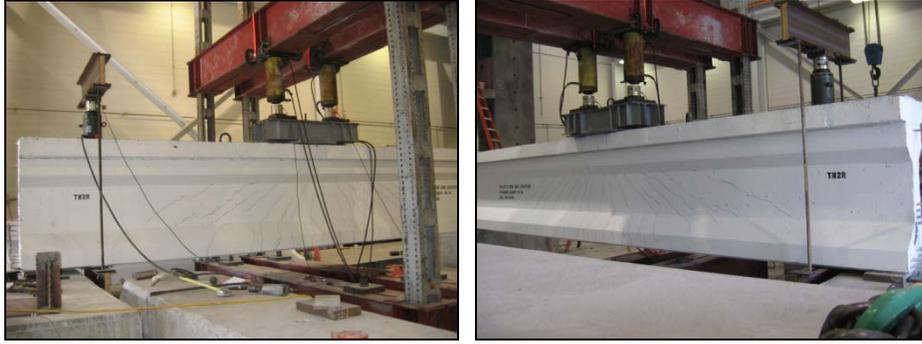
Figure C.1-18. Crack patterns at failure

Figure C.1-19. shows the load-deflection curve of End TN2R. The girder with composite topping was calculated to resist a point load of up to 604 kips, located 12 ft from the end. The actual maximum load reached before failure when the loading had to be stopped was 800 kips.

The point of loading where the Load Deflection curve first attempted to level out was at 630 kips. This is still 4.3% higher than the expected load. This shows that there was no reduction in strength due to the conditions at the ends. As indicated earlier, there was no visible end zone

cracking due to prestress release. Whatever microcracking existed, which was not possible to measure, did not appear to have any detrimental effect on the flexural capacity of the member. No indicated of any reduction in shear capacity was observed as there was no diagonal compression crushing or stirrup breakage. [Figure C.1-20](#) shows the strand slippage with time. The curve shows that no noticeable slippage occurred until the load reaches the 800-kip level. This shows that the strands were in full bondage with the concrete up to the 800-kip load level.

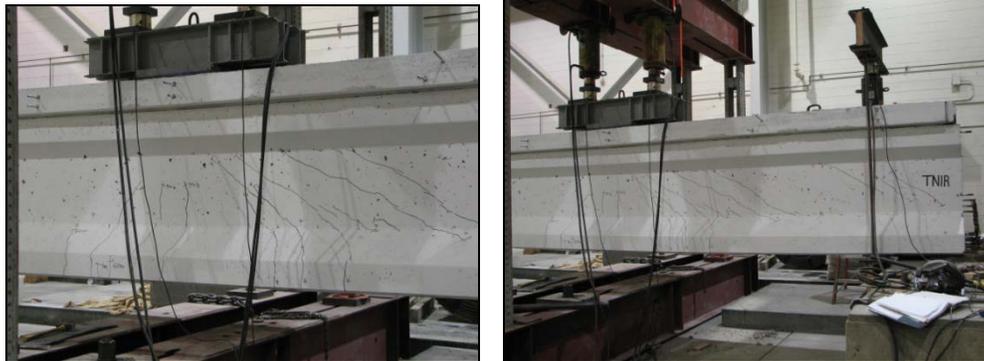
[Figure C.1-24](#). Crack patterns at failure

Cracking patterns that appeared were consistent with a classical flexural failure. The beam was designed to fail in flexure, and this appeared to be the primary cause of failure. Some strand slippage, or bond failure was also apparent in the testing. Some of the strands sticking out of the ends slightly rotated in the direction of the twisted wires as they slipped into the girder. Upon closer inspection, one could also see that the strands had recessed into the face of the girder. [Figure C.1-24](#) and [Figure C.1-25](#) show slippage of the strands as the girders were tested. The strand on the East side of the lab slipped 0.39 inches while the strand on the West side of the lab slipped 0.50 inches. [Figure C.1-26](#) shows the load-deflection curve of End TN1R, and [Figure C.1-27](#) shows the slippage of the East and West strands.

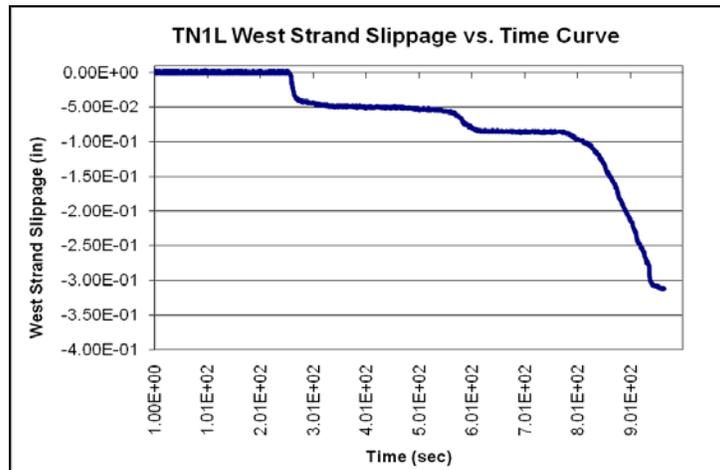
Figure C.1-31. Strand slippage vs. time curve for the West strand

End TN1L was tested on September 9, 2008, the same day that End TN1R had been tested. Load was slowly applied to the system in intervals of 100k. After each additional 100 kips, the loading was paused so that the girder could be investigated and marked for cracks. Loading continued until the girder was holding a point load of 638 kips and was no longer taking on any further load. At this failure point, the girder was deflected 1.38 in at the location of loading. When the load was removed, the girder retained a permanent plastic deformation of 0.32 in. Strand slippage was very apparent in this test. Some of the strands sticking out of the ends rotated in the direction of the twisted wires as they slipped into the girder. The concrete around the prestressing strands began to break away, as shown in [Figure C.1-30](#). The gauge on the strand on the West side of the lab gave a maximum slippage of 0.327 in., as shown in [Figure C.1-31](#) The gauge on the East side of the lab malfunctioned, and did not give useable results. Cracking patterns that

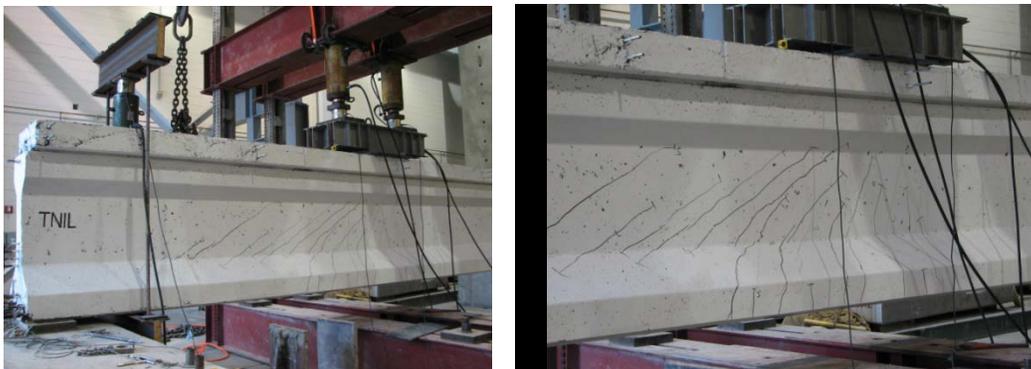
Figure C.1-32. Crack patterns at failure

appeared were consistent with a classical flexural failure, as shown in Figure C.1-32. The beam was designed to fail in flexure, and this appeared to be the primary cause of failure.

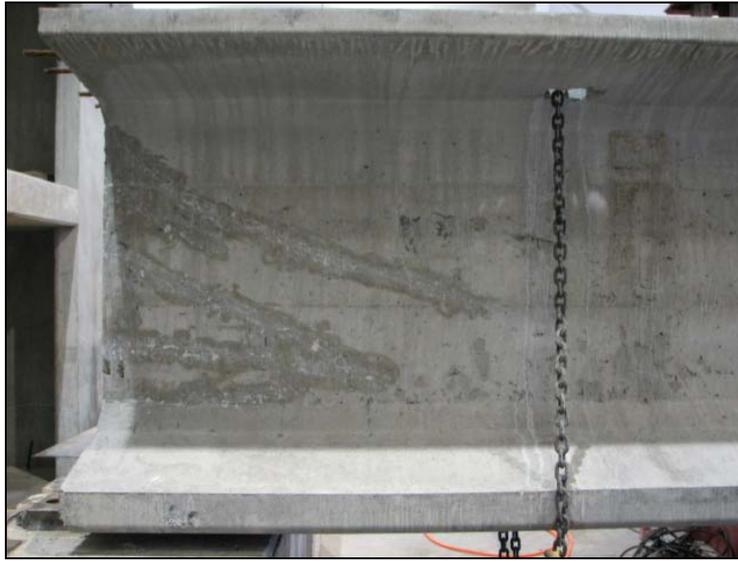
The end zone crack on End WA2L of the Washington girder were repaired with epoxy injection, shown in Figures C.2-13 and C.2-14. The process used was the procedure typically used by Washington and outlined in the PCI Concrete Repair Manual. Injection ports were affixed along the lengths of the cracks that were repaired, and the exterior of the cracks were closed using a sealant. Epoxy was then pumped into the injection ports, moving from the bottom of the girder to the top until all of the cracks were completely sealed.

Figure C.2-13. End WA2L showing repaired cracks

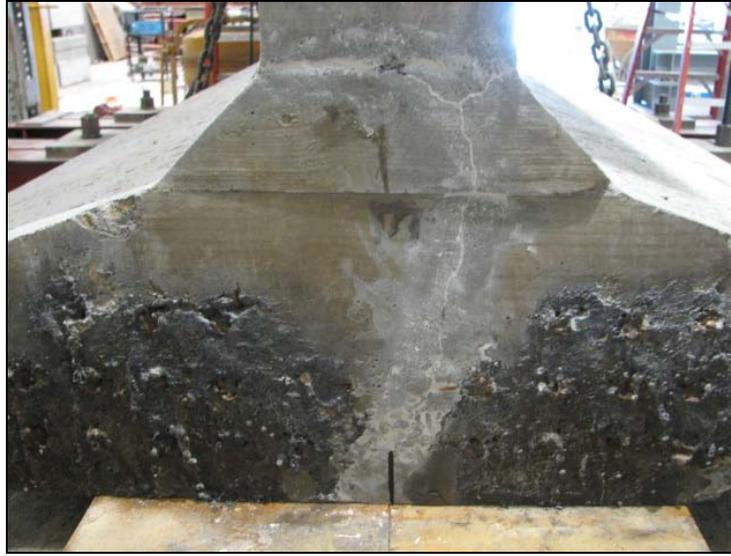
Figure C.2-14. Cracks showing epoxy injection

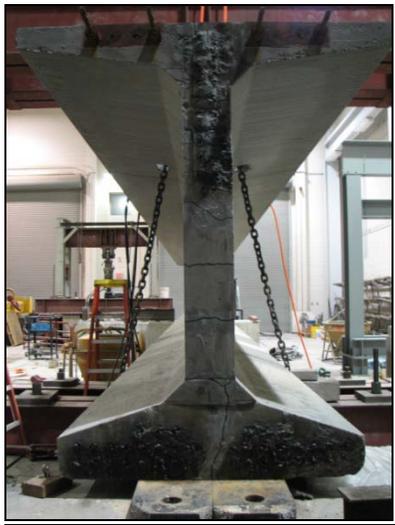
[Figure C.2-16](#) shows the girders after they had been painted white. The girders were painted white so that it would be easier to detect very small cracks formed during testing. The end zone cracks were also drawn in with marker so that they could be easily seen from a distance.

Figure C.2-16. End zone cracks before testing

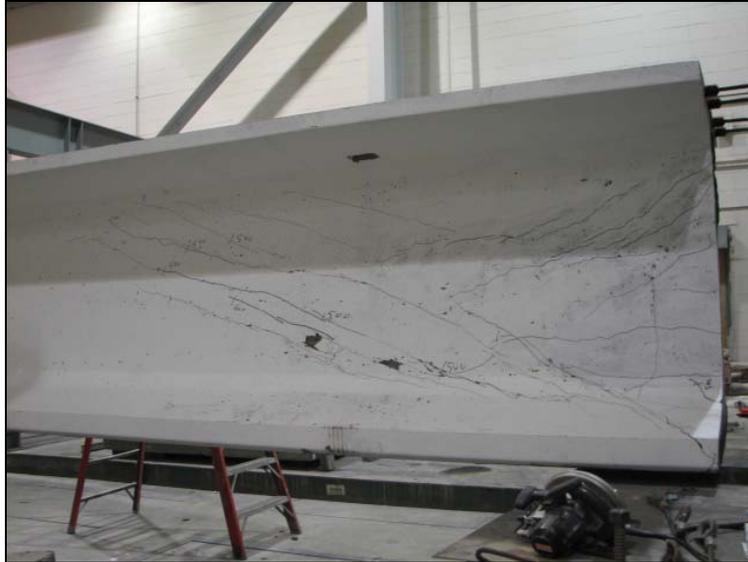
Load was slowly applied to the system in intervals of 100k. After each additional 100k, the loading was paused so that the girder could be investigated and marked for cracks. This continued until it began to approach the design load and it became not longer safe to approach the beam. At this point, loading continued until failure, as shown in Figure C.2-17. The highest load reached was 603.4 k. At this point there was a deflection of 0.977 in. After failure, the beam was unloaded, leaving a permanent plastic deformation of 0.224 in. at the location of loading.

Figure C.2-17. End WA2L after shear failure

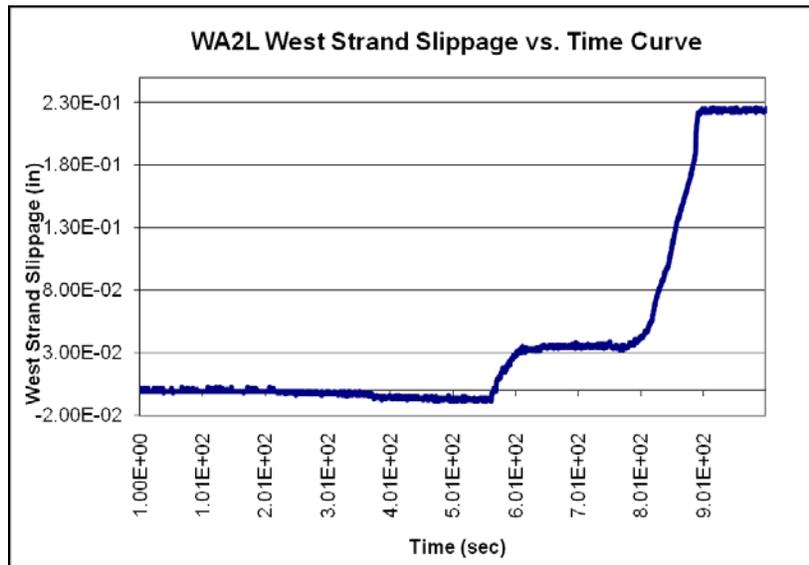
There was evidence of strand slippage in the prestressing strands of the girder. Simply by looking at the end of the girder one could tell that the strands had retracted in, visible in Figure C.2-19. Originally, the prestressing strands had been cut flush with the end of the girder. The lab

in Nebraska accentuated this flush surface by grinding down the jagged edges of the strands so that they were flat and even with the girder edge. Manual measurement of the slippage with a ruler showed that the strands slipped somewhere between 1/8 in. and 1/4 in. (0.125-0.25 in.) According to the slippage gauges, the East strand on the outer edge of the flange had a slippage of 0.340 in. at failure.(Figure C.2-20) The West strand located towards the centerline of the girder had a slippage of 0.207 in. at failure.(Figure C.2-21) This strand slippage would have affected the capacity of the girder. The failure load would have been higher if no strand slippage had occurred. Therefore, it can be deduced that in an ideal situation with improved end anchorage conditions, the girder would have performed even better than the test showed with a higher load capacity.

Figure C.2-20. Strand Slippage on West Strand (interior strand)

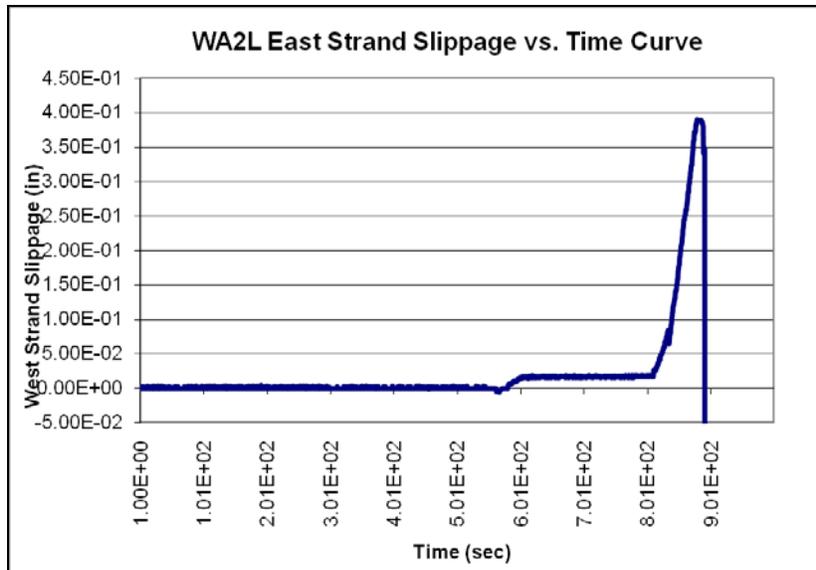
Figure C.2-21. Strand Slippage on East Strand (exterior strand)

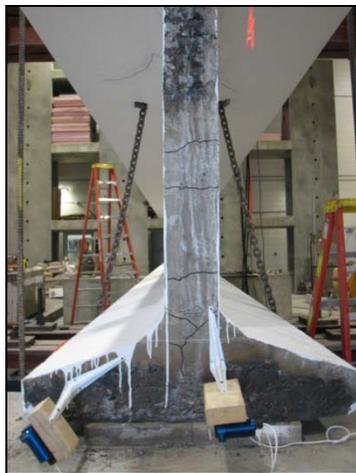
Figure C.2-23 and C.2-24 shows the girder after it had been painted white. The girders were painted white so that it would be easier to detect very small cracks formed during testing. The end zone cracks were also drawn in with marker so that they could be easily seen from a distance.

Figure C.2-24. End zone cracks before testing

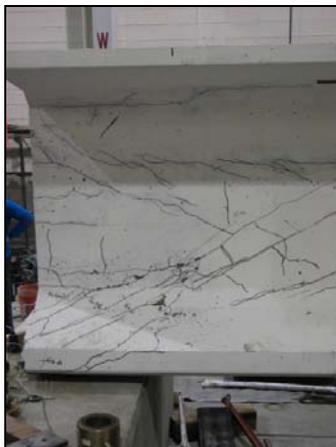
Load was slowly applied to the system in intervals of 100k. After each additional 100k, the loading was paused so that the girder could be investigated and marked for cracks. This continued until it began to approach the design load and it became not longer safe to approach the beam. After this time, loading continued until failure. The highest load reached was 749.8 k. This load produced a deflection of 0.783 in. After failure, the beam was unloaded, leaving a permanent plastic deformation of 0.426 in. at the location of loading. Figures D.2.1-25 and C.2-26 show the typical shear crack patterns after failure.

Figure C.2-26. End WA2R after shear failure

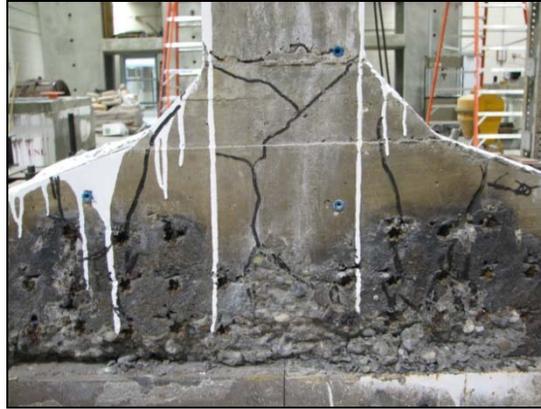
There was evidence of strand slippage in the prestressing strands of the girder. Simply by looking at the end of the girder one could tell that the strands had retracted in, visible in Figure C.2-28. Originally, the prestressing strands had been cut flush with the end of the girder. The lab in Nebraska accentuated this flush surface by grinding down the jagged edges of the strands so that they were flat and even with the girder edge. Manual measurement of the slippage with a ruler showed that the strands slipped somewhere around 1/16 in. (.0625) According to the slippage gauges, the West strand on the outer edge of the flange had a slippage of 0.075 in. at failure. (Figure C.2-29) The East strand located towards the centerline of the girder had a slippage of 0.23 in. at failure.(Figure C.2-30) This strand slippage would have affected the capacity of the girder. The failure load would have been higher if no strand slippage had occurred. Therefore, it can be deduced that in an ideal situation with improved end anchorage conditions, the girder would have performed even better than the test showed with a higher load capacity.

Figure C.2-28. Evidence of Strand Slippage

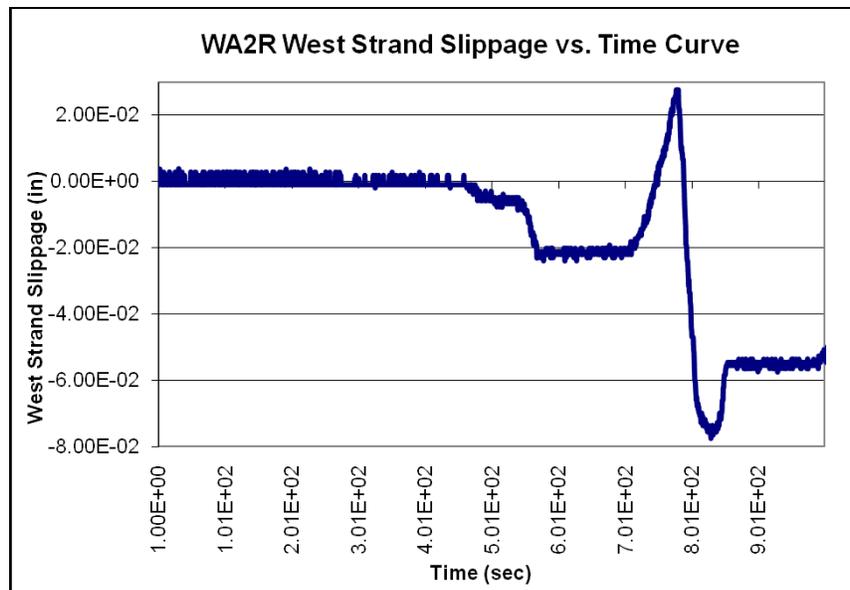
Figure C.2-29. Strand Slippage on West Strand (exterior strand)

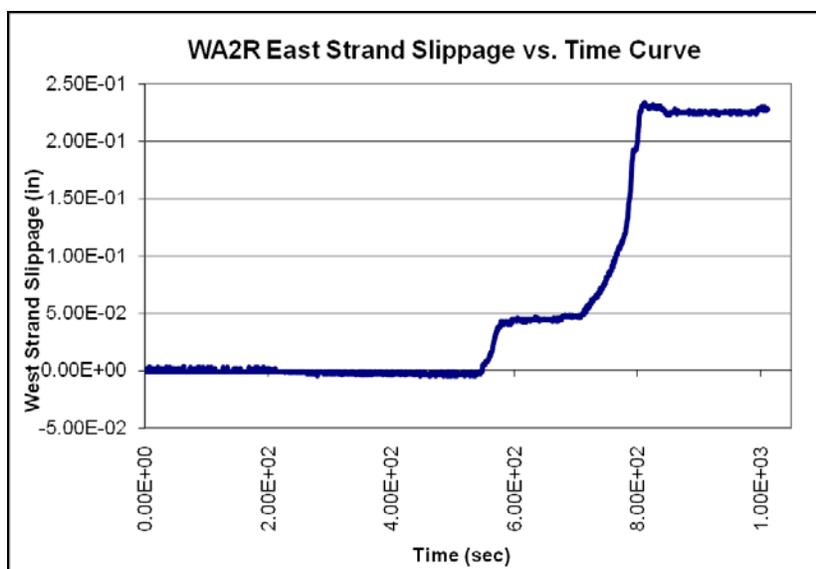
Figure C.2-30. Strand Slippage on East Strand (interior strand)

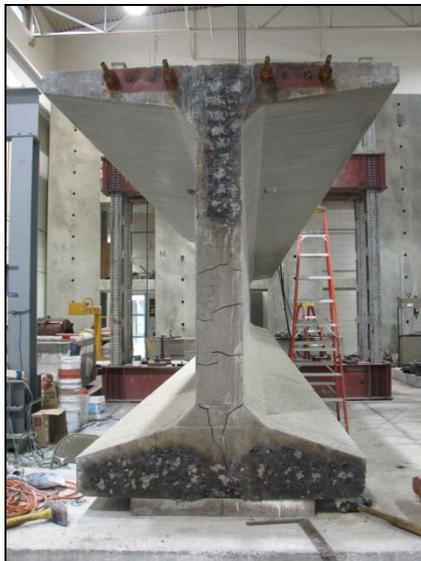
Figure C.2-37. End zone cracks before testing

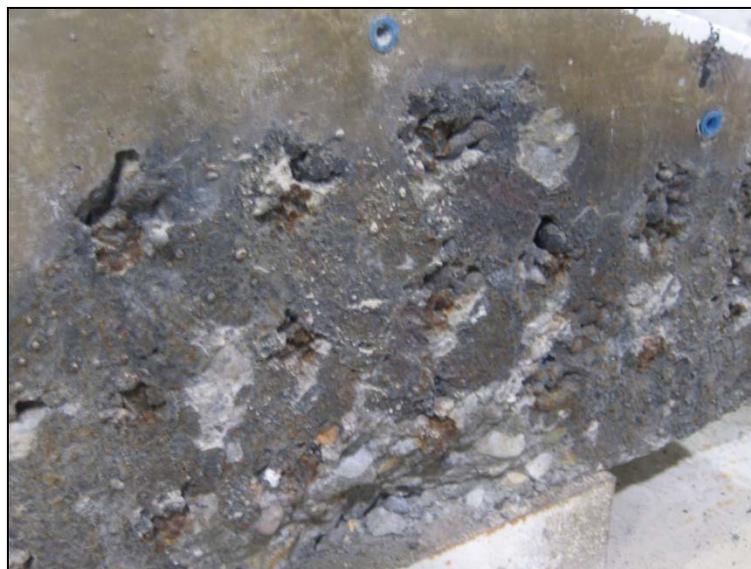
There was evidence of strand slippage in the prestressing strands of the girder for this end as well. Visual investigation of the strands at the end of the girder showed that they had moved into the girder a bit, but not as far as the previous end. This is shown in Figure C.2-40. This would be because the end didn't actually reach failure. If it had, the strands would have traveled farther into the girder as in the other cases. Originally, the prestressing strands had been cut flush with the end of the girder. The lab in Nebraska accentuated this flush surface by grinding down the jagged edges of the strands so that they were flat and even with the girder edge. The slippage gauge was applied to a strand in the bottom row, towards the outer edge of the flange. This was estimated to be one of the strands most likely to slip.

Figure C.2-40. Evidence of Strand Slippage

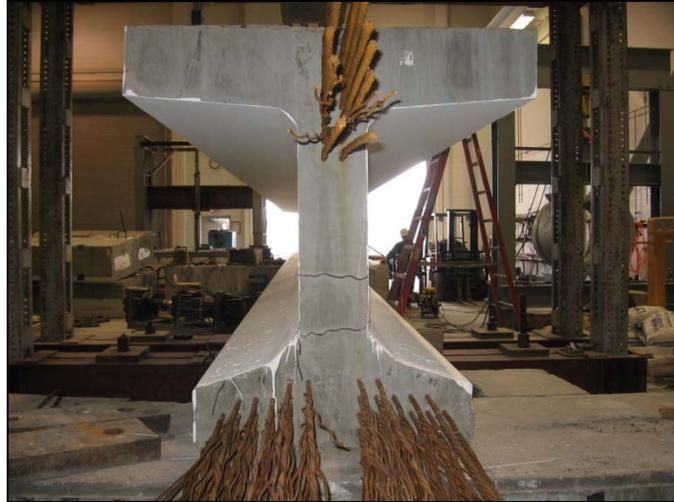
Figure C.3-11(cont.) End zone cracks before testing

Figure C.3-11 shows the girders after they had been painted white. The girders were painted white so that it would be easier to detect very small cracks formed during testing. The cracked paint is easier to see than cracked concrete alone. The end zone cracks were also drawn in with marker so that they could be easily seen from a distance.

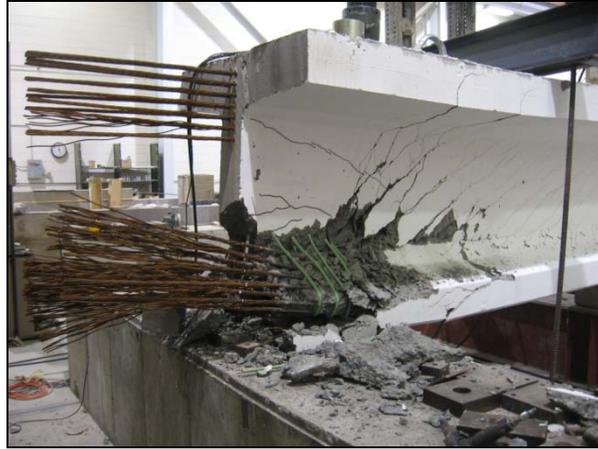
Figure C.3-12(cont.) End VA1R after bearing failure

Load was slowly applied to the system in intervals of 100k. After each additional 100k, the loading was paused so that the girder could be investigated and marked for cracks. This continued until it began to approach the design load. At this point, loading continued until failure. This end of the girder was designed for flexural failure. However, in this case, the failure that occurred was bearing failure at 897 k. The girder was supported on a steel base that was 12 inches in the direction of the girder length, and 16 inches in the direction of the girder width. This was not enough bearing to support the girder under this loading. Therefore, at failure the concrete around the support crumbled and burst outwards. Images of the girder after failure are shown in [Figure C.3-12](#).

One half of the bottom prestressing strands shifted upwards. The bottom confinement reinforcement bars were of the same shape and design of those used in the Virginia production girders. The #4 bars were bent around the bottom prestressing strands in a closed shape; however the ends did not overlap. Therefore, at failure, the closed shape did not hold. If the ends had overlapped, then the bars would have more of a chance to develop within the concrete and would have taken more force before bursting.

The Virginia girders were designed without internal base plates. Instead, the girder had to be placed on a metal base, designed to be large enough to distribute the load to the girder without causing failure. For End VA1R, the metal base used was not large enough. For the next test, End VA1L, a larger metal base was used to prevent the same premature failure. Also, the metal base on each end was placed on metal rollers. The rollers would allow the supports to pivot, making flexural failure more likely.

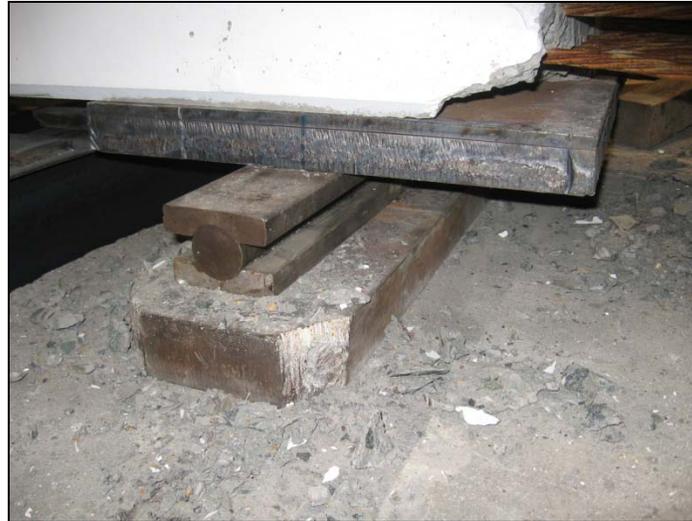
[Figure C.3-15](#). Support with roller

Due to the bearing failure of the previous girder, the base plate detail was improved for End VA1L. A 26"x24"x2" metal plate was placed under each support. At least 18 in. of the girder end had to be placed upon the base plate. Metal rollers were midway under each metal plate. The

team tried to get the metal roller to be directly under the beam at 6 in. from the girder end to stay consistent with the previous tests. This roller allowed the end of the girder to rotate during testing, decreasing the possibility of another bearing failure. [Figure C.3-15](#) shows the roller and baseplate support.

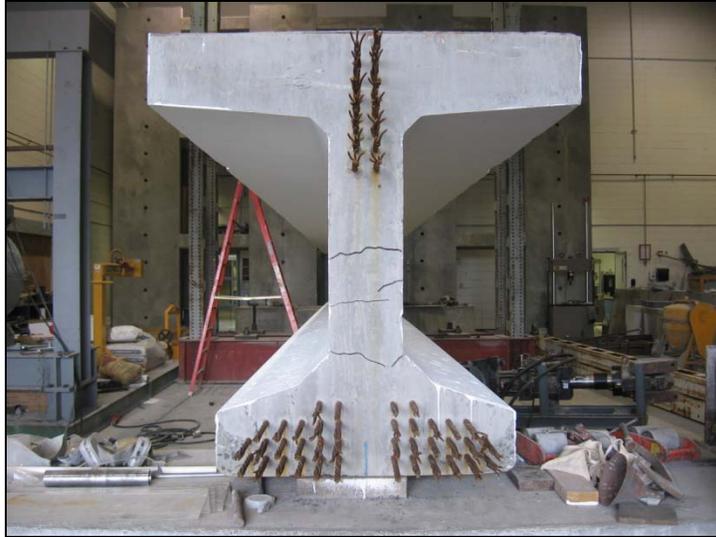
Figure C.3-16(cont.) End zone cracks before testing

[Figure C.3-16](#) shows the girders after they had been painted white. The girders were painted white so that it would be easier to detect very small cracks formed during testing. The cracked paint is easier to see than cracked concrete alone. The end zone cracks were also drawn in with marker so that they could be easily seen from a distance.

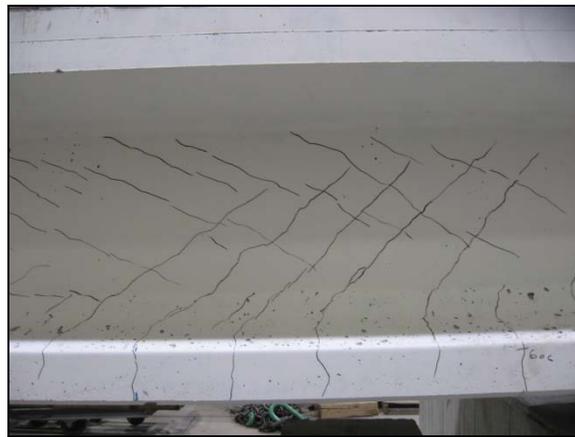
Figure C.3-18. Center of VA1 where the shear cracks for each end overlapped

The highest load reached was 1,108 k. This load produced a deflection of 1.18 in. After failure, the beam was unloaded, leaving a permanent plastic deformation of 2.42 in. at the location of loading. It was visibly damaged and drooped down at that location. Figures C.3-17 and C.3-18 show End VA1L after failure.

Figure C.3-19 shows the load-deflection curve of the test. The highest load reached was 1,108 k. At this point the girder failed in shear. Flexural cracks were also appearing near the girder's failure, however, the shear cracks appeared first and were much wider. At failure at the location of loading, the girder deflected 1.18 in. With the actual concrete strength of  $f'_c = 12,215$  psi, the girder was calculated to resist a point load of 1,102 k located 12 ft. away from the girder end. The failure for this case would be flexural, not shear. The capacity for this end of the girder exceeded the calculated capacity, but just by a few kips. However, the girder failed in shear when it was expected to fail in flexure. It seems that the point of flexural failure for that beam was higher than the point of shear failure. Regardless, the girder still outperformed the estimated capacity, showing that the end zone cracks were unable to lower the capacity of the girder below the expected value.

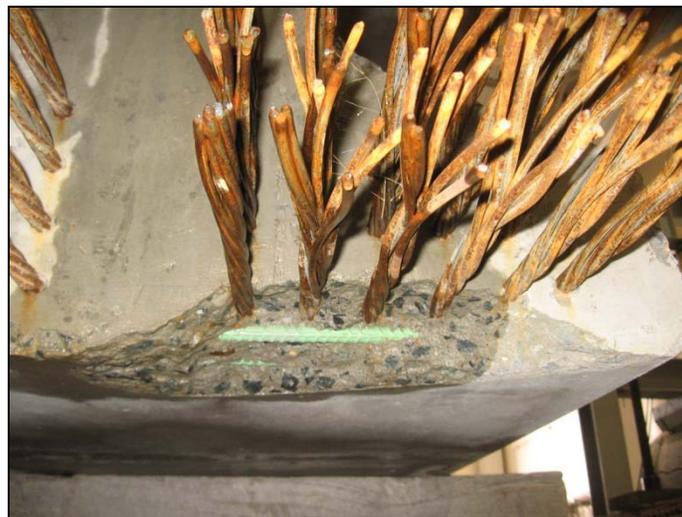
[Figure C.3-21](#). Damaged ends upon arrival

When the girder arrived at the lab in Omaha, NE, there was some damage to End VA2L, shown in [Figure C.3-21](#). A few inches of concrete was chipped off of the bottom corner. This exposed some of the bottom confinement reinforcement bars, as well as exposing a few of the prestressing strands a few inches too soon. This would move the development length for these few strands in a few inches.

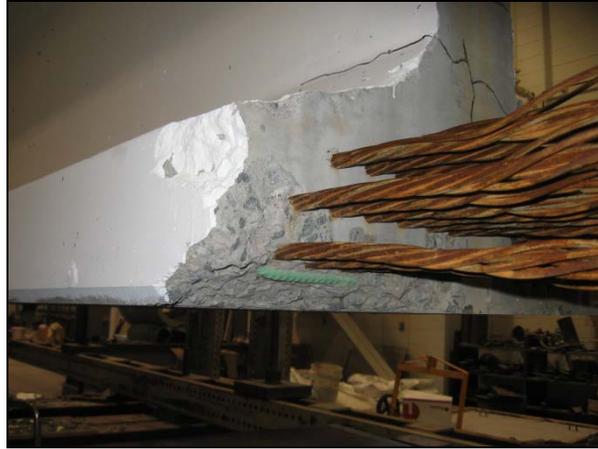
Figure C.3-25. Damaged ends upon arrival to the laboratory

When the girder arrived at the lab in Omaha, NE, there was some damage to End VA2R, shown in [Figure C.3-25](#). A few inches of concrete was chipped off of the bottom corner. This exposed some of the bottom confinement reinforcement bars, as well as exposing a few of the prestressing strands a few inches too soon. This would move the development length for these few strands in a few inches.

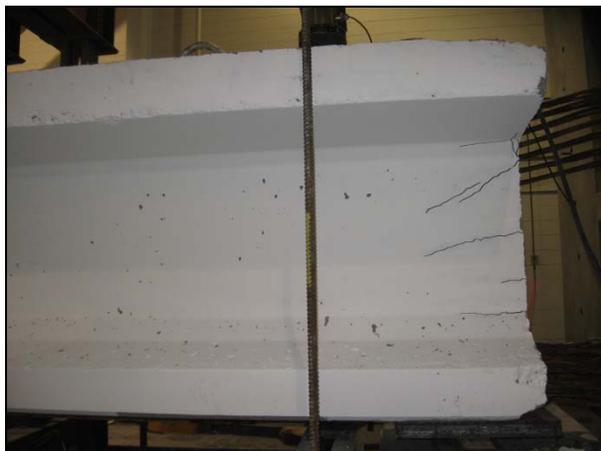
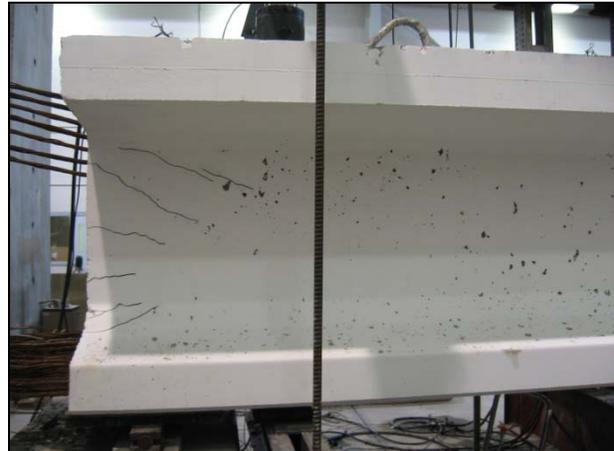
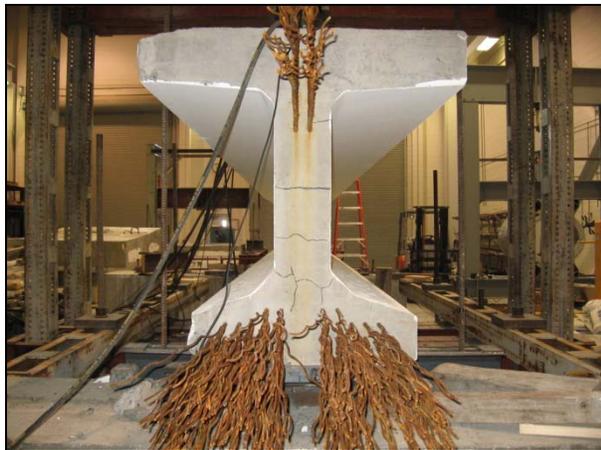
Figure C.3-25. End zone cracks before testing

Figure C.3-25 shows the girders after they had been painted white. The girders were painted white so that it would be easier to detect very small cracks formed during testing. The cracked paint is easier to see than cracked concrete alone. The end zone cracks were also drawn in with black marker so that they could be easily seen from a distance.

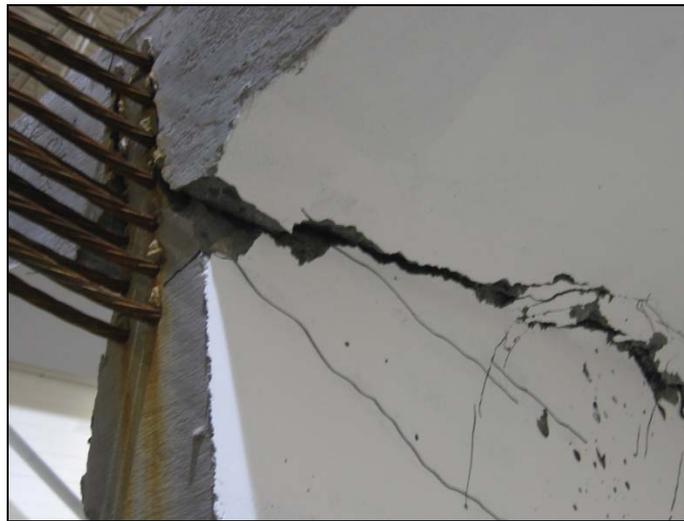
As with the Virginia girder VA2, the sections of concrete that contained the prestressing strands attempted to shift in towards the center of the girder at failure. In this case the top flanges stayed in place while the bottom flange and web slipped inwards. [Figure C.3-29](#) shows how the section containing the top prestressing strands has separated from the sections of top flange, which contains no prestressing force.

[Figure C.3-29](#). End VA1R after shear failure, showing movement

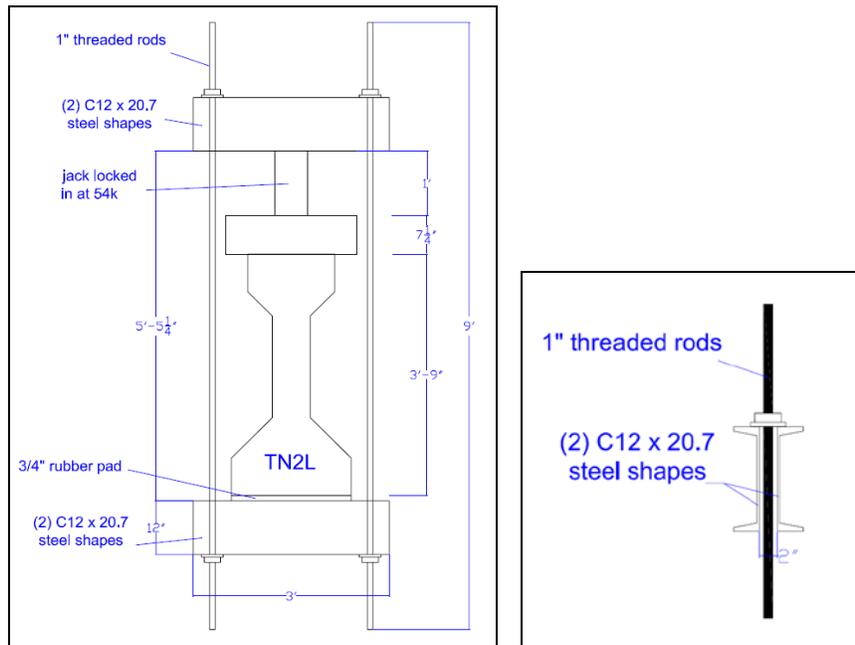
Figure C.4-8. End Clamping Detail

After the deck was cured, a clamping force mechanism was placed 30" in from the end of the girder in order to simulate the bridge weight acting on the supports. This 60-kip applied clamping force was calculated as the balance between the reaction generated by the 125 ft bridge that the original production girders were being manufactured for (taking into consideration weight of girder, deck and barriers) and the reaction generated by the 42 ft long specimen (taking into consideration weight of the girder and deck). This clamping mechanism was placed only at the end being tested, which was TN2L. It was located 30" from the end of the girder. The clamping force was provided by a system of steel beams located below and above the girder connected by threaded rods, as shown in Figure C.4-8 and Figure C.4-9. The steel beams were tightened with a hydraulic jack. Table C.4-1 shows the concrete strength of the girders and deck slab at time of testing.

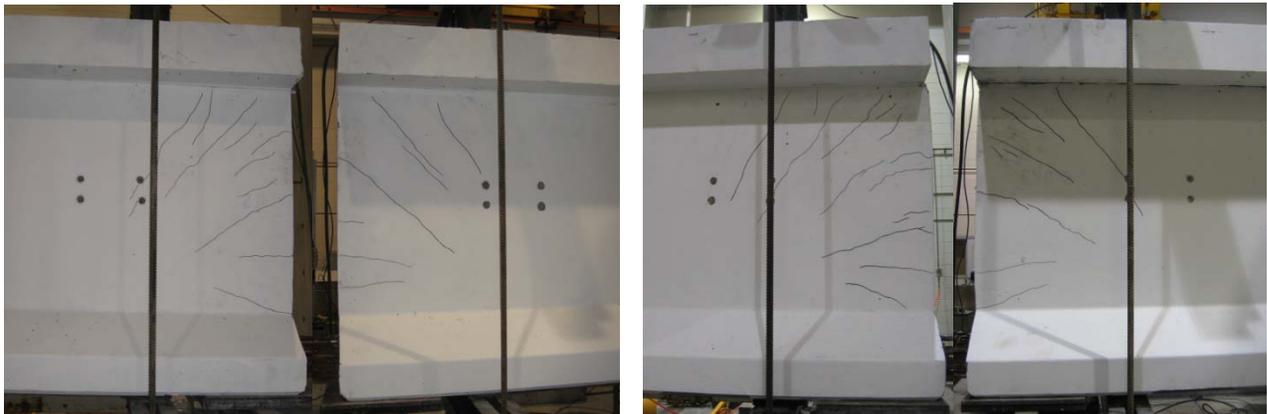
Figure C.4-10. Comparison of Ends FL2R and FL2L

All four ends experienced end zone cracking. The longest cracks did not extend further than 3 ft in from the girder end. All cracks were around 0.004” to 0.006” in width. These crack lengths and widths are common for end zone cracks and are comparable to the other girders that have been brought into the lab. At this width, the cracks are usually not expected to be much of a problem by the precaster.

Since the girder was an inverted-T, there was no top flange at the time of detensioning to counteract the tensile forces at the top of the girder. Six #6 bars were placed at the top of the web to offset these tensile forces, but it was not enough. As it was produced, the beam was in violation of the AASHTO limits on top tension. However, it was decided that the forces were in control enough for this experiment. Because of this tensile force at the top of the member, there were vertical cracks running downward from the top of the web. These cracks appeared approximately every 6” or so, were 1-2 feet in length, and ran the entire length of the girder. These cracks were not a hindrance to the experiment, so they were ignored.

End FL2L appears to have a larger number of end zone cracks than End FL2R (Figure C.4-10). Both ends look similar, but there are more cracks on End FL2L and they extend further into the girder than those on End FL2R. End FL2L was designed using typical LRFD specifications while End FL2R was designed using a method that alters LRFD to place a larger percentage of the reinforcement steel closer to the girder end. In this case it appears to have done a better job at preventing cracks than the typical LRFD design.

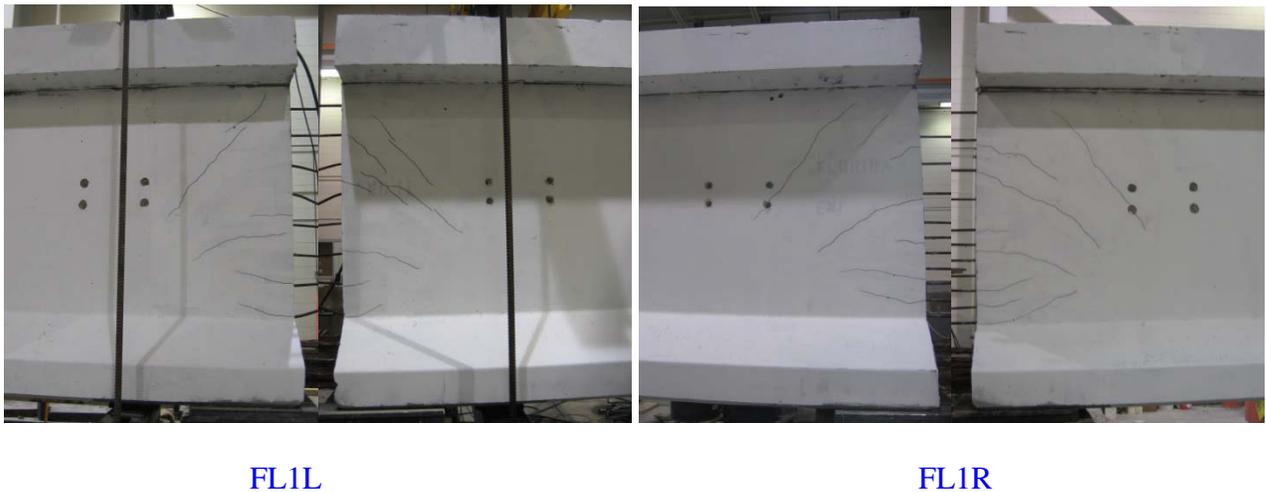
Figure C.4-11. Comparison of Ends FL1L and FL1R

End FL1L and FL1R experienced very similar cracking patterns and amount of cracking (Figure C.4-11). The crack widths for each were also similar. End FL1L had end reinforcement typical of Florida beams while End FL1R contained that same design of end reinforcement, but with a large number of bars removed. The cracks on End FL1L did not extend as far into the girder as the cracks on End FL1R. This would be consistent with the reinforcement details. However, there is not a big enough improvement between the two to justify using that much more steel for reinforcement.

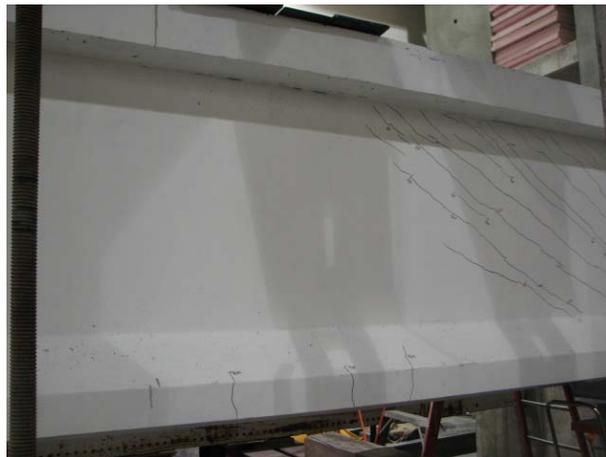
Figure C.4-14. End FL2R after loading was stopped (flexure cracks)

The load that was reached was very close to, but still under, the anticipated capacity of 1,229 k. Under this much load the girder was starting to crack and show signs of approaching failure. The crack patterns after the full load was applied are shown in Figure C.4-13 and Figure C.4-14. Most of the cracks that appeared were shear in nature. Flexural cracks were small and very few, and did not start to appear until the load reached 900 k. Therefore it is assumed that the girder

would have failed in shear first before the flexural failure point was reached. This may be caused by a insufficient amount of shear reinforcement due to placement error, or it may be that the flexural failure capacity exceeds that which pairs of #5 bars at 6" spacing could provide. At the maximum loading the girder experienced a deflection of 0.946" at the location of loading. Further load upon the system would cause this deflection to increase until failure.

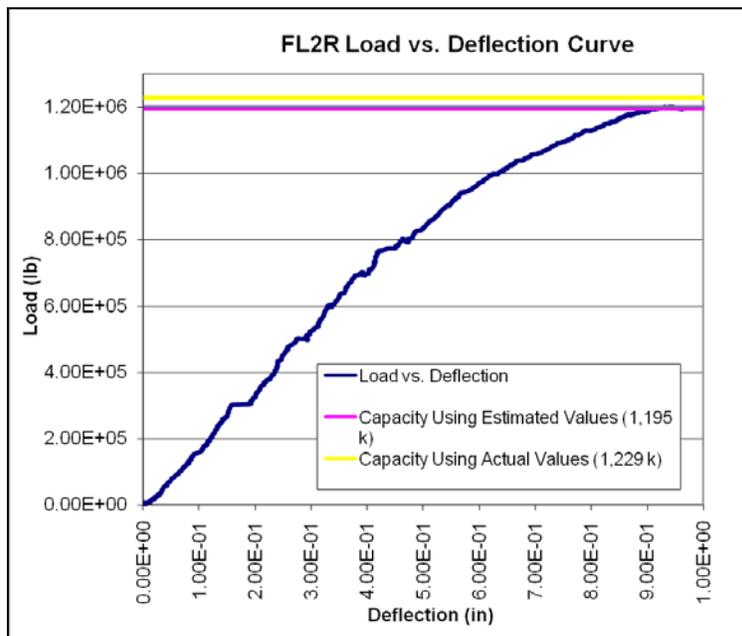
Figure C.4-15. Load Deflection Curve for End FL2R

The test setup did not have the capacity to cause the girder to fail, but the load cells from the test were able to record enough data to get a fine load vs. deflection curve, shown in [Figure C.4-15](#). From the curve one can see that the girder was able to withstand the design load of 1,195 k, and would have been able to exceed this load as well if it had been subjected to a greater force. Therefore it can be stated that even though the girder experienced end zone cracks that were not repaired in any way, it still was able to exceed the required capacity. The prestressed strands were extended beyond the end of the girder and were marked before the test to pinpoint their location with respect to the girder end surface. After the test was complete these marks were inspected to see if any strand slippage occurred. This showed that there was no significant visible

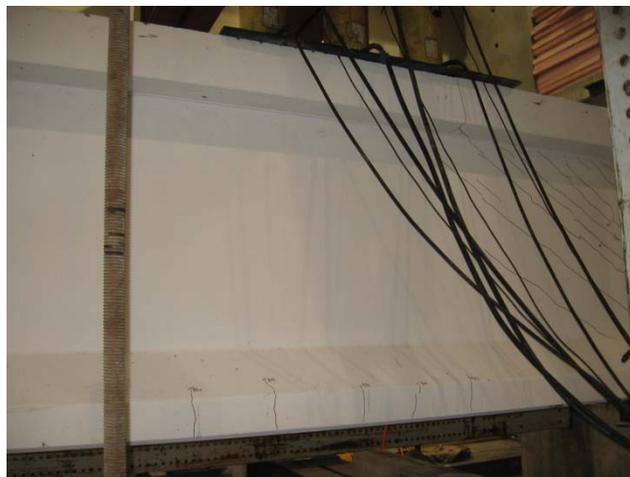
Figure C.4-18. End FL2L after loading was stopped (flexure cracks)

As expected, the girder did not fail before reaching the maximum load of 1,200 k. It is anticipated however, that the girder would have failed in shear before reaching the calculated flexural failure load. Under the heavy point load, the girder was experiencing cracks as it approached failure. The majority of the cracks were due to shear stress, while only a few small cracks in the bottom flange were from flexural stresses. Images of both types of cracking are shown in Figure C.4-17 and Figure C.4-18. Just like in the previous test, flexural cracks in the bottom flange right below the point of loading did not appear until the load reached 900 k. Therefore, from looking at the girder and from looking at how the load vs. deflection graph tapers off, it is expected that the girder would have failed in shear before the anticipated flexural failure point of 1,461 k was reached. Once again, this may be caused by there not being enough shear reinforcement placed in the girder at the precasting plant. However, since the girder was

not broken open at this point, the team did not yet consider this as a problem. At the maximum loading, the girder had deflected 1.247" at the location of loading. When the load was released a permanent deflection of 0.278" remained.

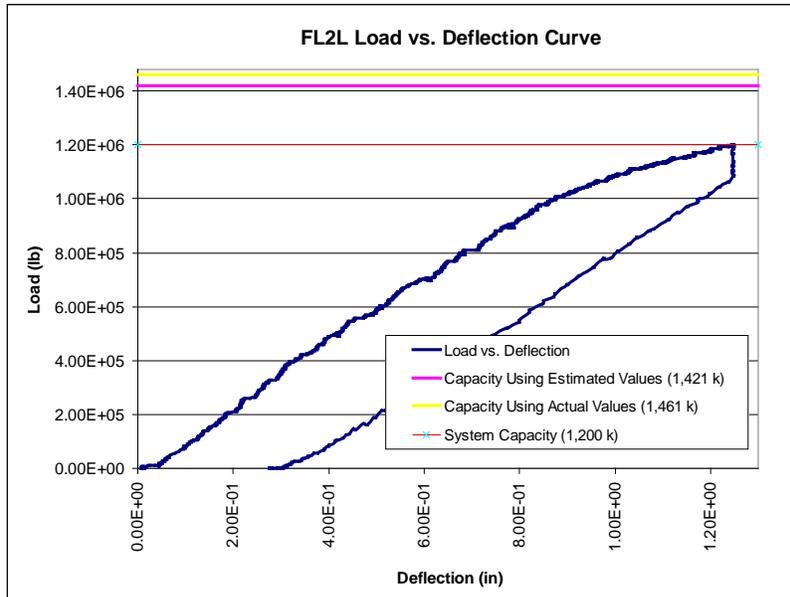
Figure C.4-19. Load Deflection Curve for End FL2L

The load vs. deflection curve from testing End FL2L is shown in [Figure C.4-19](#). From the curve, it can be deduced that the failure of the girder would have occurred not long after the maximum load of 1,200 k. It is assumed that this failure would have been due to shear forces. This would have caused the girder to fail before the required design load. However, it is expected that if the shear reinforcement had been increased to what had originally been designed, the girder would have withheld more load and flexural failure would have been the controlling factor once again. Even though the girder may have failed before its capacity had been reached, this failure was not due to end zone cracking. Even though the cracks were unrepaired, there was no sign that these cracks did anything to accelerate the failure of the girder. Upon close investigation, the end zone cracks did not open any during the testing, nor was there any other type of movement around them. In fact, since the primary motive for cracking during loading was shear, the forces acting

on the girder at this time would have been pushing the end zone cracks together. Looking at Figure C.4-17, it can be observed that the shear cracks caused by loading run perpendicular to the diagonal end zone cracks. From this, it can be deduced that the presence of end zone cracking on this girder did not affect the final structural capacity in any way.

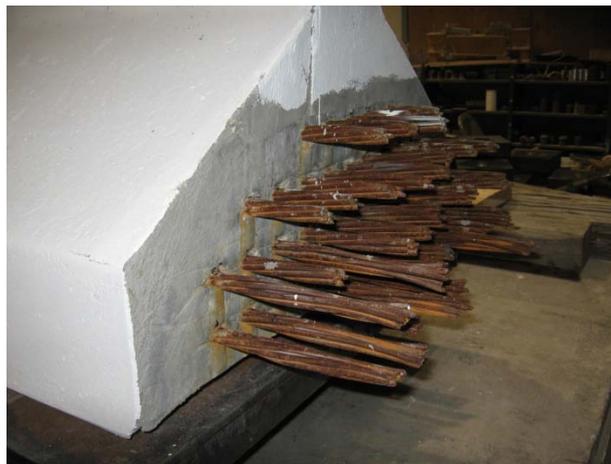
Figure C.4-20. Markings for strand slippage

The prestressed strands were extended beyond the end of the girder and were marked before the test to pinpoint their location with respect to the girder end surface. (Figure C.4-20) After the test was complete these marks were inspected to see if any strand slippage occurred. This showed that there was no significant visible change in the placement of the strands, and therefore strand slippage was not a major concern for this test, nor a reason for reduced structural capacity.

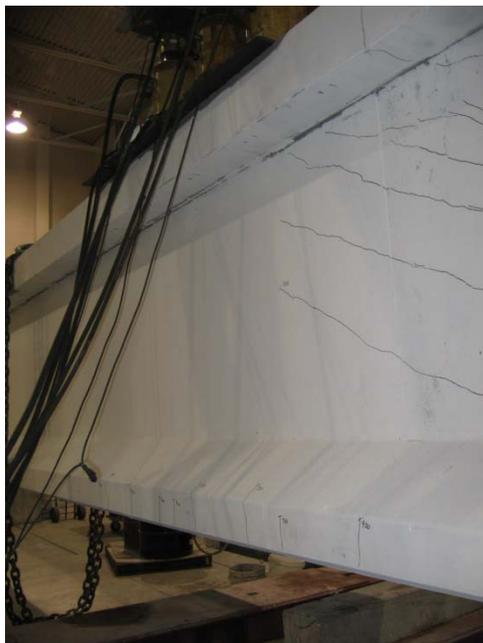
Flexural cracks

The failure was sudden and violent. Before failure, shear cracks were appearing on both sides of the point load. A few were on the end towards FL1R, but the majority of the cracks were right after the support on the end FL1L. Figure C.4-22 shows this pattern, just before failure.

Figure C.4-22. End FL1L Crack Patterns just before failure

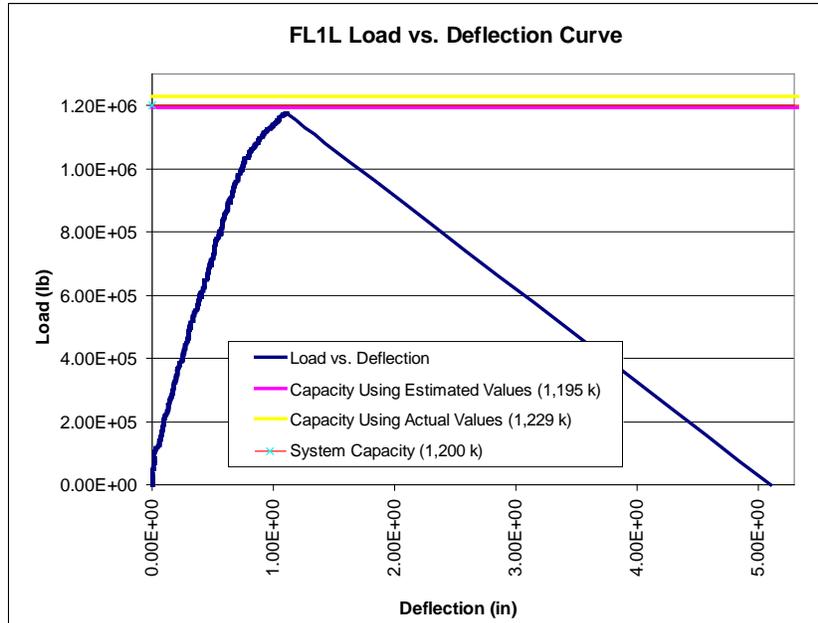
Figure C.4-26. Load Deflection Curve for End FL1L

At the highest load that the girder carried, right before failure, the beam was deflected 1.10" at the point of loading. The maximum deflection that was recorded was 5.33", right after failure. When the load was removed the girder lifted slightly leaving what was left of the girder a permanent deflection of 4.47"

The load vs. deflection curve from testing End FL1L is shown in [Figure C.4-26](#). The curve shows the gradual tapering off of the load just before failure. The girder failed to reach the required design capacity, but as explained earlier, this was due to insufficient shear reinforcement. If the correct amount of vertical bars had been implemented it is assumed that the girder would have been able to exceed capacity. The failure of the girder was not affected by the end zone cracks that were present. The cracks were unchanged throughout the testing, so there was no width growth nor slipping. The method of failure was shear, and the shear cracks that appeared were perpendicular to the already present diagonal end zone cracks. This shows that the forces experienced by the girder during testing were working in opposition to the forces that caused the end zone cracks. This force would have been working to close these end cracks. Therefore, the presence of end zone cracks in the Florida beam did not advert affect the structural capacity of the girder.

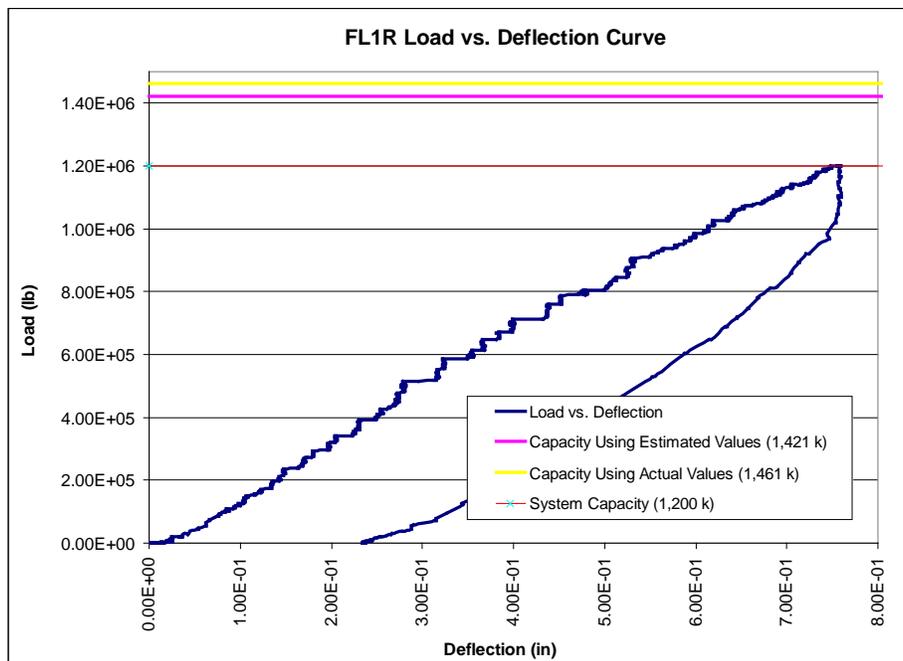
Figure C.4-31. Load Deflection Curve for End FL1R

The load vs. deflection graph from testing End FL2L is shown in Figure C.4-31. It is clearly shown that the curve had not yet started to taper off, and that there was quite a bit of capacity left in the girder before failure. It is not shown whether the girder would reach the intended capacity of 1,461 k or not, but with the reduced shear reinforcement it is not likely. However, this possible failure to perform to specifications is not the fault of the end zone reinforcement, but of the shear reinforcement. The end zone cracks were not altered or opened in any way during testing. In fact, the diagonal shear cracks that appeared were perpendicular to the diagonal end zone cracks. This shows that the forces on the member were acting in a direction that would push the end zone cracks together, not apart (Figure C.4-29 and Figure C.4-30). Therefore, the unrepaired end zone cracks on the Florida specimen did not negatively affect the structural capacity of the girder.
