Retrofitting Procedures for Fatigue-Damaged Full-Scale Welded Bridge Beams

A digest of interim findings from NCHRP Project 12-15(2), "Retrofitting Procedures for Fatigue-Damaged Full-Scale Welded Bridge Beams," by John W. Fisher, Fritz Engineering Laboratory, Lehigh University

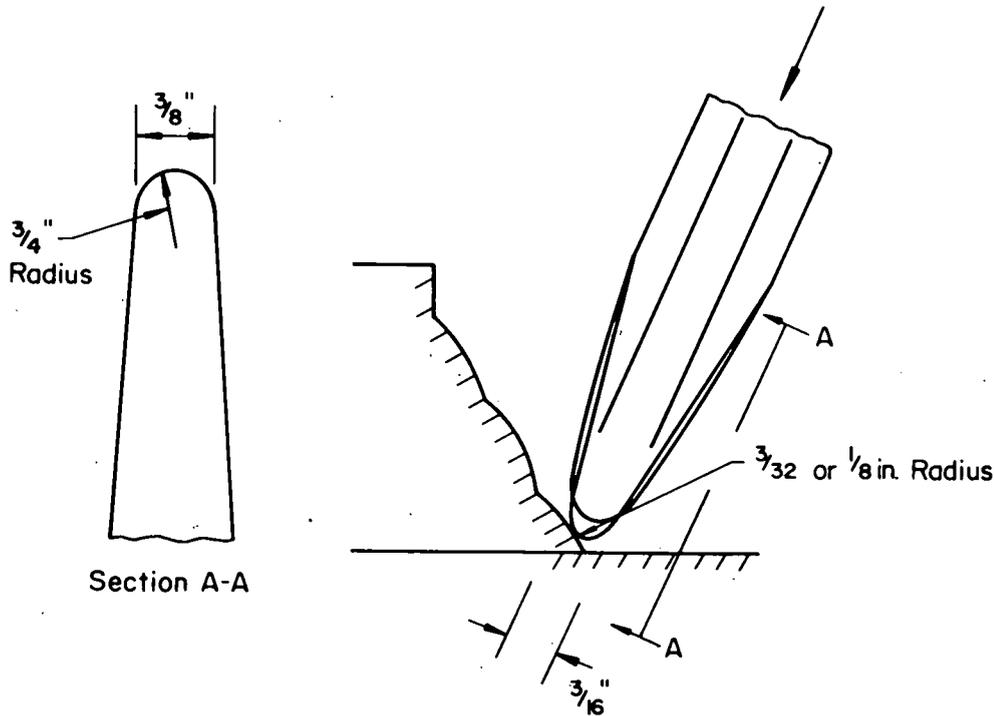
Figure 2. Schematic of peening tool (from British Naval Construction Research Establishment).

Peening and gas tungsten arc remelting procedures(1) were used to retrofit fatigue-damaged beams in span No. 10 of the Yellow Mill Pond Bridge. Peening was performed with a small pneumatic hammer operated at 0.17 N/mm² (25 psi) air pressure. The end of the peening tool was shaped with a 19-mm (3/4 in.) radius about one axis and a 3-mm (1/8 in.) radius about the other axis (see Figure 2). All sharp edges were ground smooth. Several minutes were required to peen the weld toe. Peening was continued until the weld toe became smooth. The depth of indentation due to peening was approximately 0.8 mm (0.03 in.).
