Web-Only Document 148:

Debris Photographic Archive and Supplemental Materials for *NCHRP Report 653*

Appendices to Contractor's Final Report for NCHRP Project 24-26
Submitted September 2009

Debris Accumulation at Bridges and its Effect on Scour

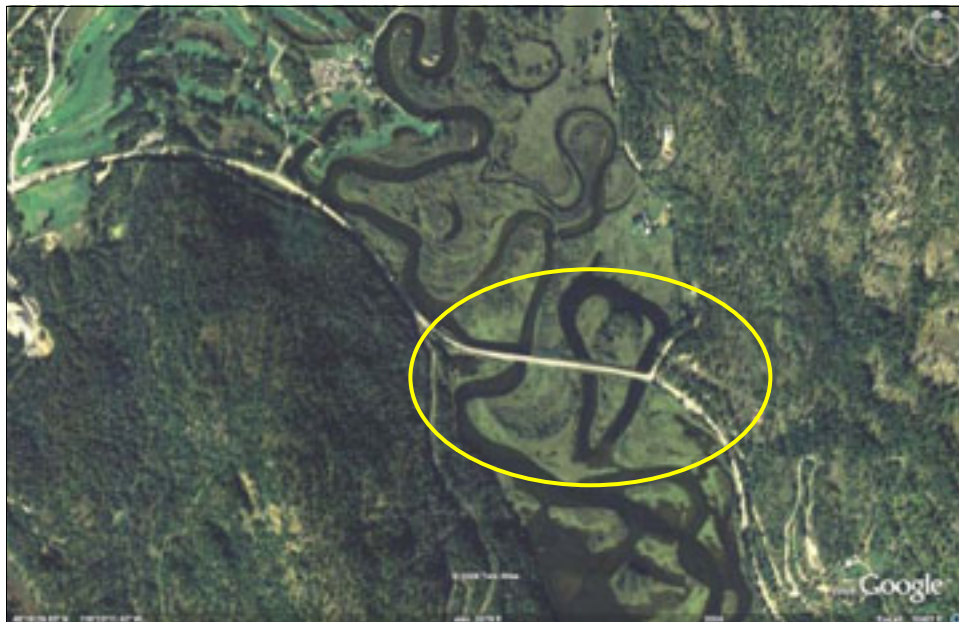
Figures A.1 and A.2 show images obtained by entering the latitude and longitude for S.H. 200 over the Pack River, found in the accompanying Excel™ spreadsheet into the program. When aerial images are examined, a user is able to see that upstream of the bridge the channel is highly meandering, unstable and subject to frequent cutoffs.

Figure A.1. Aerial view of State Highway 200 over the Pack River.

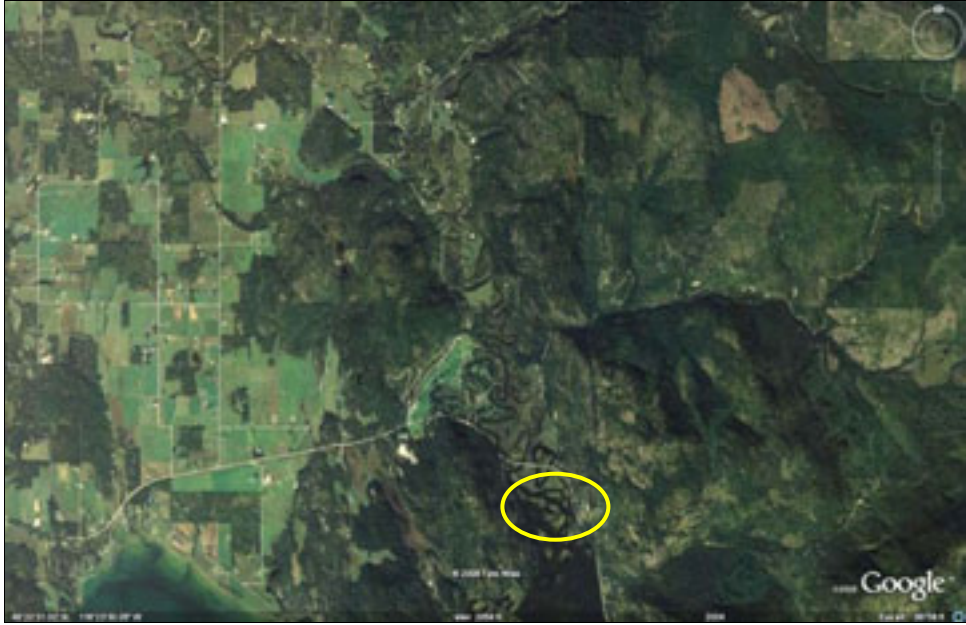
Figure A.2. Aerial view of State Highway 200 over the Pack River.

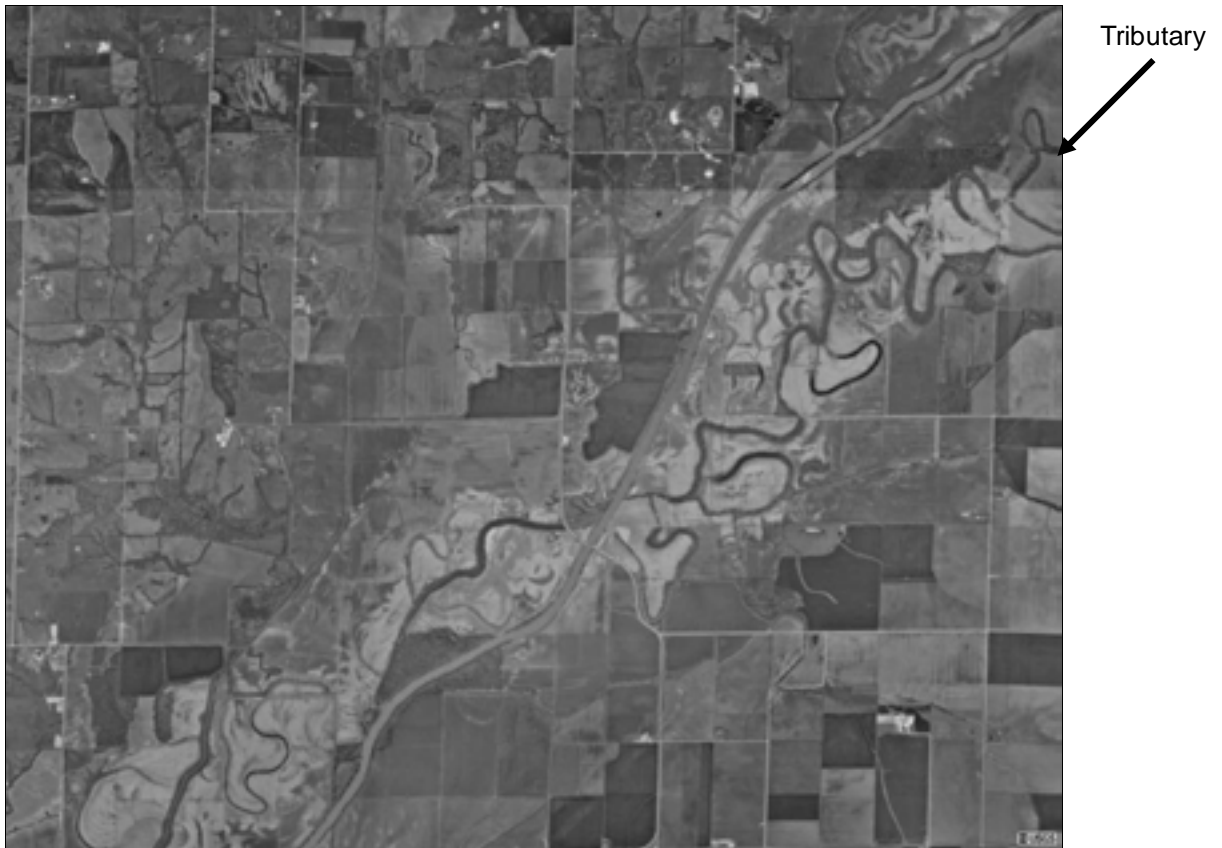
Further information about this site was gathered from the NBI and input into the accompanying spreadsheet. A user could compile more information by collecting aerial photographs from varying years and compare differences. Aerial photographs are available from numerous sources. **Figures A.3** and **A.4** show aerial imagery from 1995 collected from TerraServer-USA.NET Web Service and a 2005 image collected from Google Earth™. Observable in Figures A.3 and A.4 are changes in forest cover, represented by the dark areas, especially on the meandering tributary on the right of the picture. This tributary joins the Chariton River just upstream of the State Route 129 Bridge.

Figure A.3. Aerial view of State Highway 129 over the Chariton River taken in 1995.

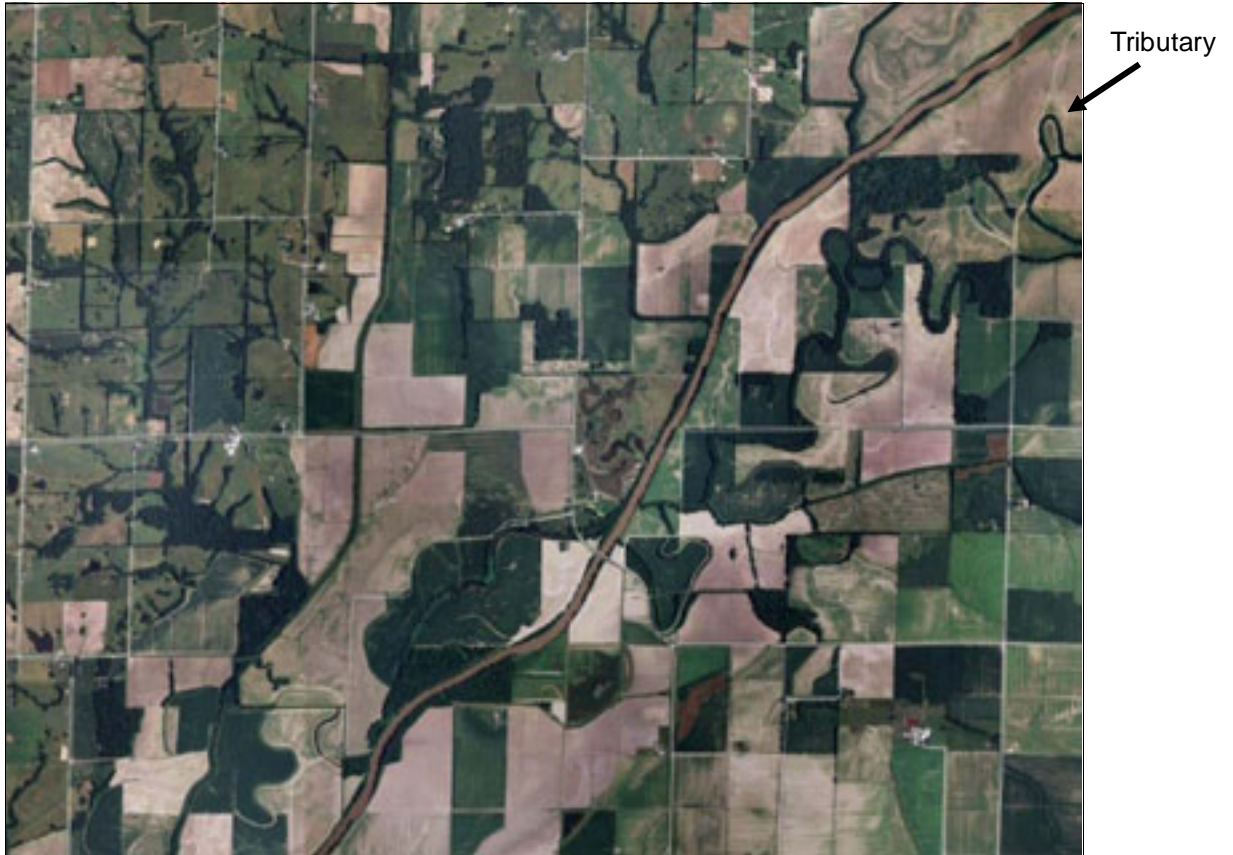
Figure A.4. Aerial view of State Highway 129 over the Chariton River taken in 2005.

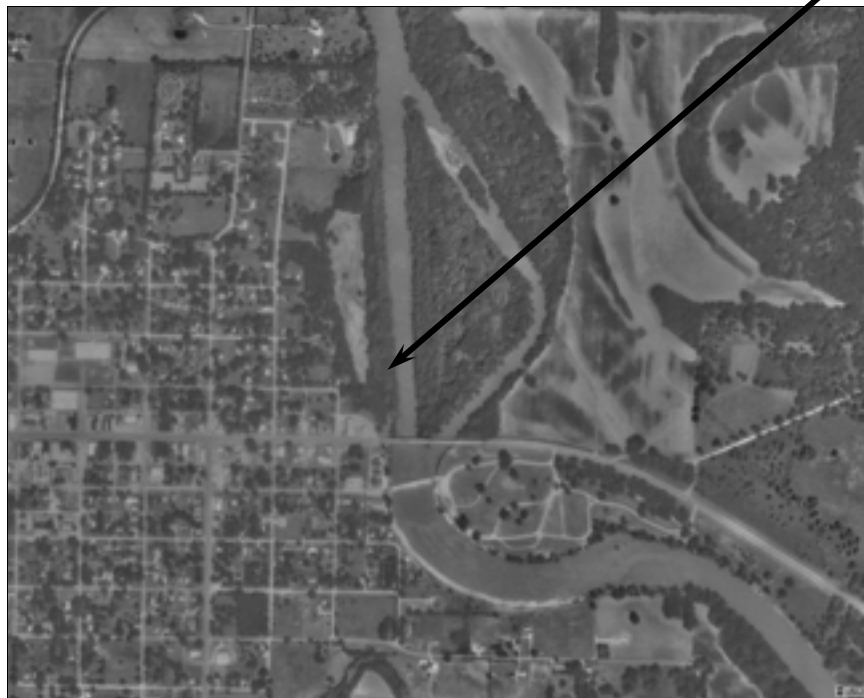
Figure 1.2. Aerial view.

- The upstream channel was split approaching the bridge. A large island lies directly upstream of Pier #2. The majority of the flow was contained in the wider right channel (**Figure 1.2**).

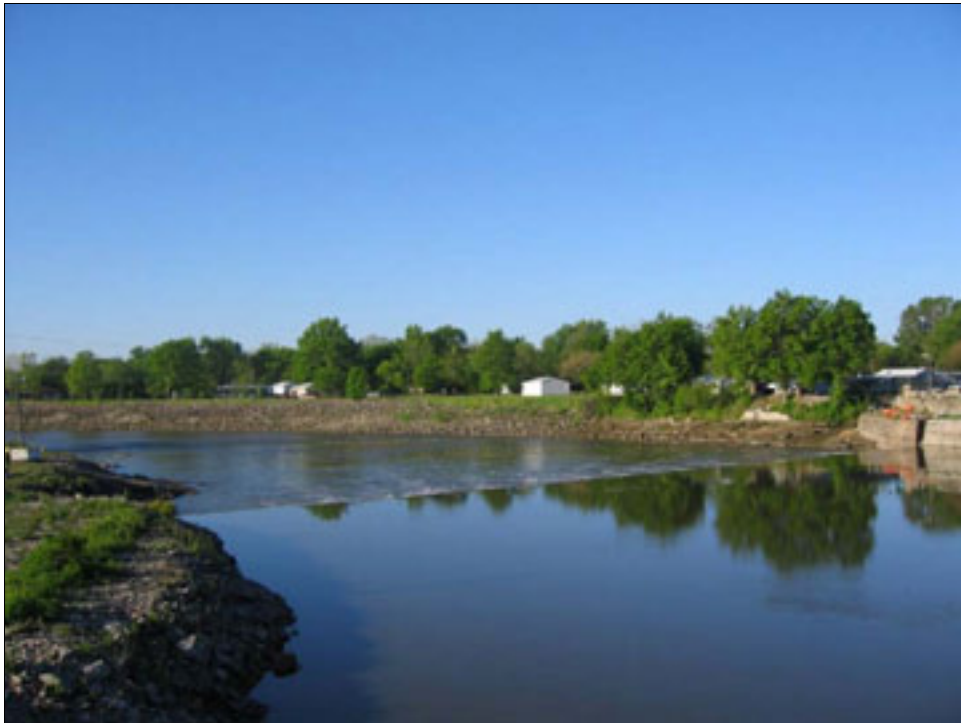
Figure 1.4. Spillway downstream of the bridge.

- Debris build up was heavy on the upstream nose of Pier #3, located in the larger channel (**Figure 1.3**).
- A spill dam was located approximately 200 feet downstream of the bridge (**Figure 1.4**).

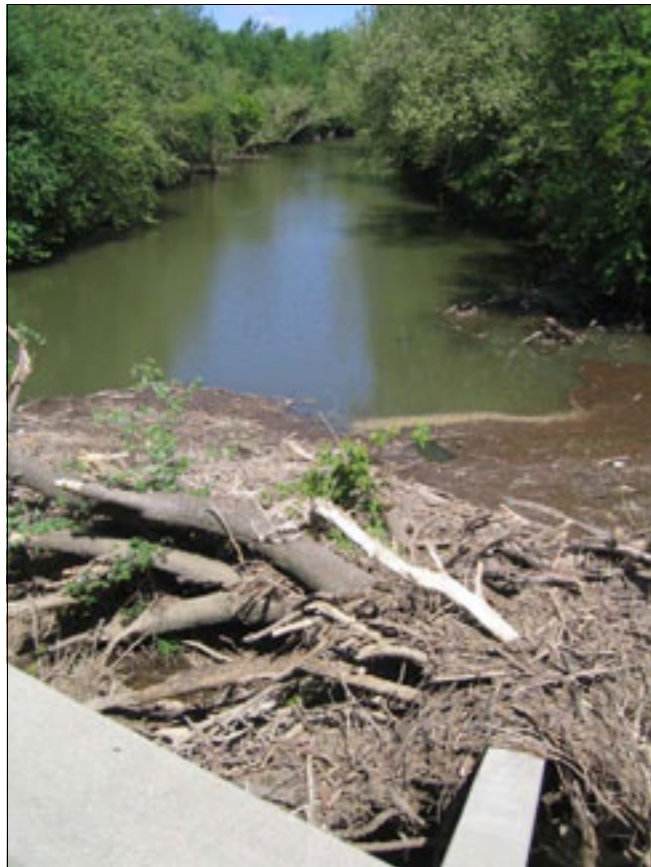
Figure 3.8. Looking upstream from the bridge deck.
