**Application of Infrared Thermographic Imaging  
to Bituminous Concrete Pavements**

**Interim Report**

Research Report No. 2229-1-01-9

University of Connecticut  
Connecticut Advanced Pavement Laboratory

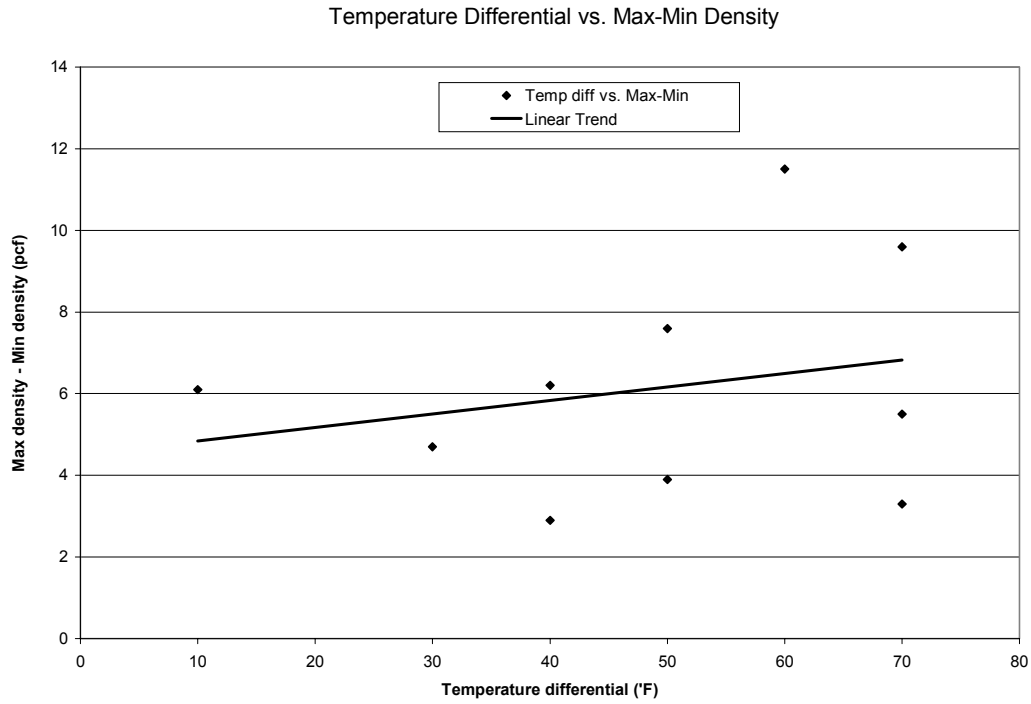
**Figure 8. Distribution of Temperature Differential with Maximum Change in Density.**

Nuclear density tests were taken through a few cool spots at some locations. The typical mat temperature was approximately 265°F and the maximum temperature differential was typically around 70°F. The distribution of temperature differential with change in density is shown in Figure 8. Figure 9 indicates the change in average density with temperature differential through the cool spot. The figures indicate that as the temperature differential increases, there is a drop in density. This drop in density can be explained by the cooler HMA's resistance to compaction. Cool spots typically started 1.5 feet to either side of the paver pass centerline and extended forward towards the edges of the paver pass. These tend to be cyclic when the haul units dumped directly into the paver hopper.
