# Evaluation of Materials, Procedures, and Equipment for Pavement Maintenance

L.D. Evans, C.A. Good Mojab, A.T. Patel, A.R. Romine, K.L. Smith, and  
T.P. Wilson, *ERES Consultants, Inc.*

Beginning in March 1991, the Strategic Highway Research Program (SHRP) Project H-106 began installing 22 test sites for the investigation of various pavement maintenance materials and procedures for four different pavement maintenance activities: pothole repair in asphalt concrete (AC) pavements, crack sealing and filling in AC pavements, joint resealing in portland cement concrete (PCC) pavements, and partial-depth spall repair in PCC pavements. Since the installation of the test sites, all of the 1,250 pothole repairs, 1,600 partial-depth spall repairs, 6700 m (22,000 ft) of crack sealing, and 1,600 resealed joints have been periodically evaluated to document their performance under actual field conditions. The SHRP H-106 project concluded in March 1993, with the production of final reports, manuals of practice, and training and implementation packages. A continued monitoring contract was awarded by the Federal Highway Administration beginning in September 1993 to ensure that the H-106 test si

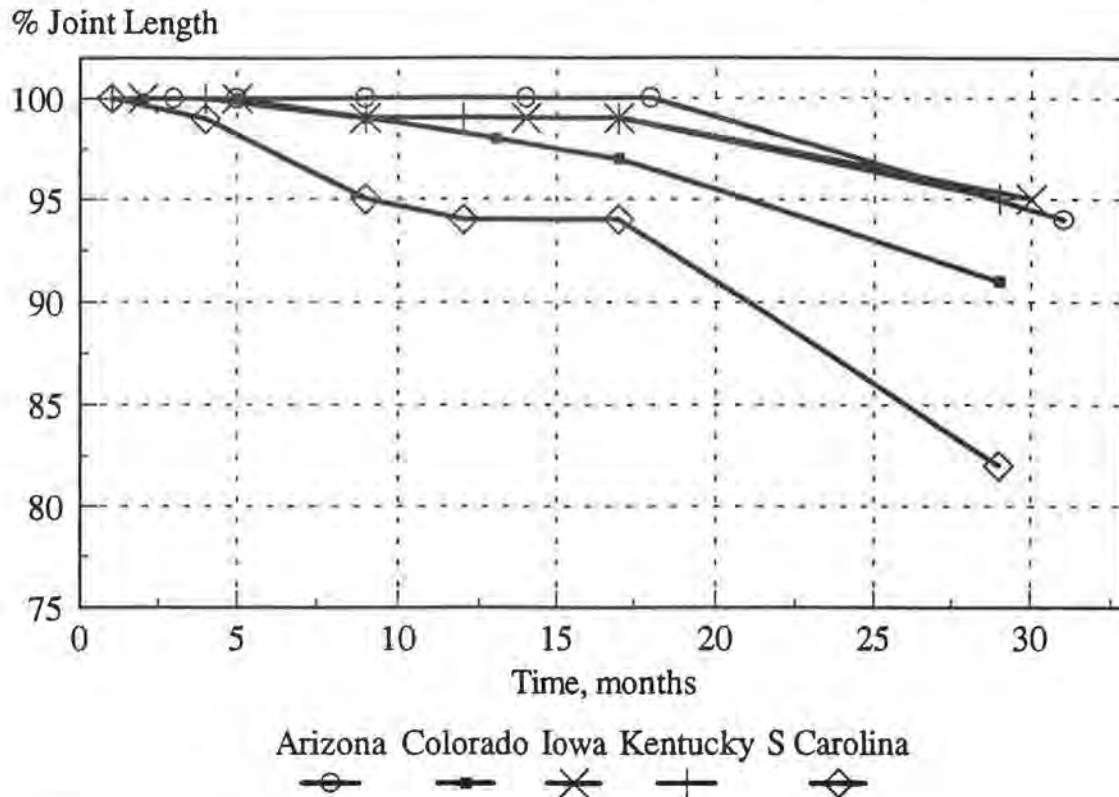
FIGURE 6 Survival of primary joint sealant materials by test site.

A comparison by state of the primary seals, shown in Figure 6, indicates that the rate of failure has increased now that the seals have passed two winters and three summers. The seals in South Carolina, a wet-nonnfreeze region state, are not surviving as well as in other states. This is primarily due to the adhesion failure in the configuration 3 joints, where unfailed silicone sealant was partially removed by the plowing operation. The silicone that remained on the joint walls inhibited bonding of the new sealants and has led to significant adhesion loss.
