Granular Base Failures in Low-Volume Roads in Ontario, Canada

C. A. Rogers, S. I. Szoke, and R. G. Gorman, *Ontario Ministry of Transportation, Canada*

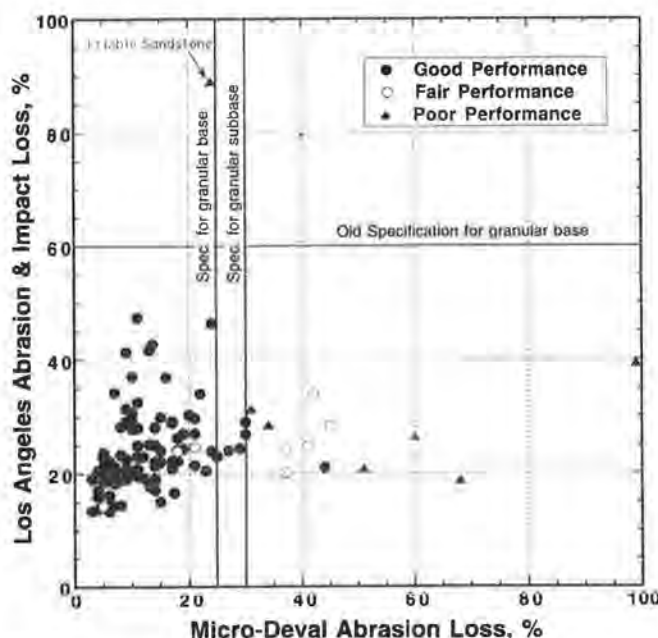
FIGURE 3 Los Angeles abrasion and impact loss value plotted against Micro-Deval abrasion loss value.

Figure 3 shows Los Angeles abrasion and impact loss against Micro-Deval abrasion loss. It can be seen that the Micro-Deval test is good at separating the majority
