## Crash Barrier Tests on Multiflora Rose Hedges

RUSSELL R. SKELTON, University of New Hampshire

Multiflora rose hedges offer definite advantages as safety barriers for highways, as shown by a recent investigation conducted for the Bureau of Public Roads. In a study of the effectiveness of a hedge of mature multiflora rose plants, a modern automobile was stopped by the planted mass gradually and without injury to the driver or damage to the vehicle.

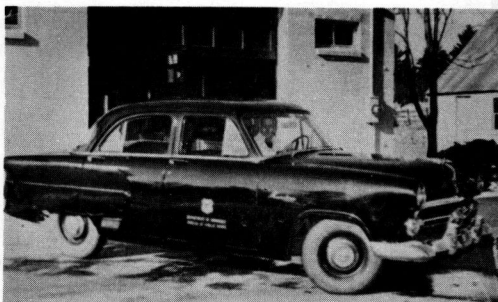
Figure 2. Test car as received.

The test car, a 1952 Ford, 6-cylinder, 4-door sedan, was loaned to the University by the Bureau for the duration of the 2-season field test period. It was stripped of all nonessential interior equipment that could possibly contribute to the injury of an occupant. The seats were removed and two front bucket-type seats were bolted to the floor. Two sets of 4-in. seat belts and two sets of shoulder harness were fastened securely to the floor of the car. The dash assembly was fitted with a 6-in. covering of polystyrene plastic foam. Figure 2 shows the test car as received, and Figure 3 shows the protective plastic foam being fitted to the interior.

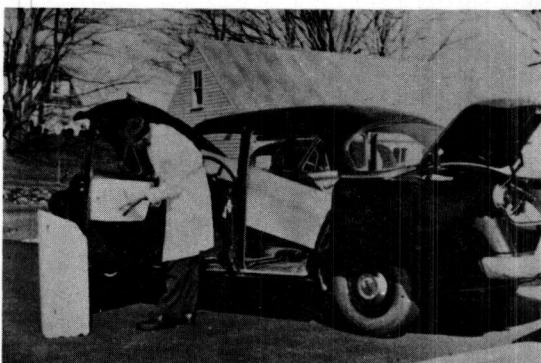
Figure 3. Test car being equipped with plastic foam.

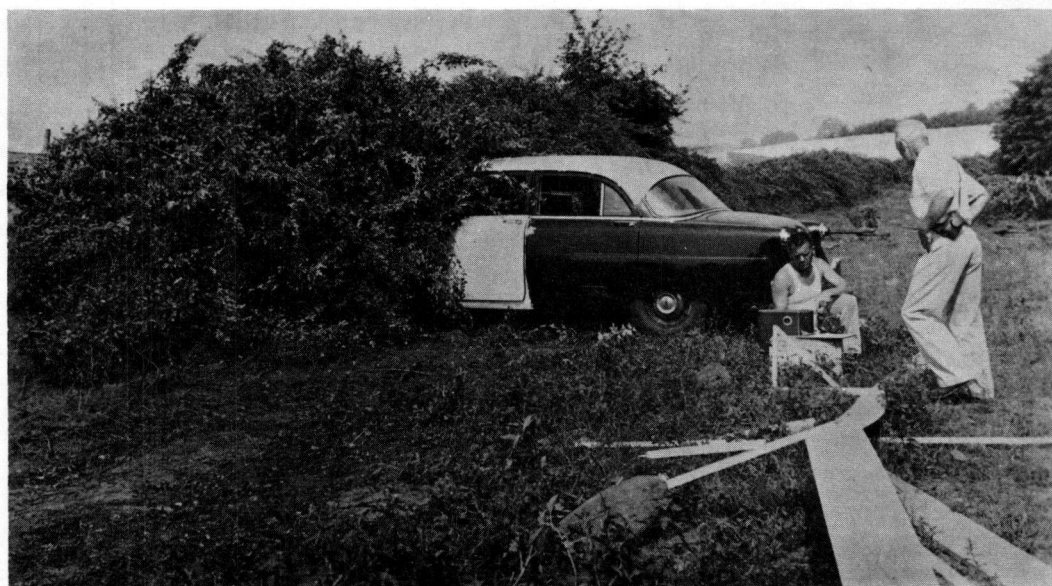
Figure 13. Final position of car—test No. 2.

Test No. 2 was a low-speed test intended to duplicate test No. 1. Unfortunately the car hit to the right of the hedge center causing the rear to slide severely to the right. The sliding action which developed, rendered the test unusable for comparative purposes with respect to the accelerations. The stopping distance of 26.0 ft closely approximated that for test No. 1. The final position of car is shown in Figure 13.
