HIGHWAY RESEARCH BOARD

Bulletin 185

***Tests of Energy-Absorbing
Traffic Barriers***

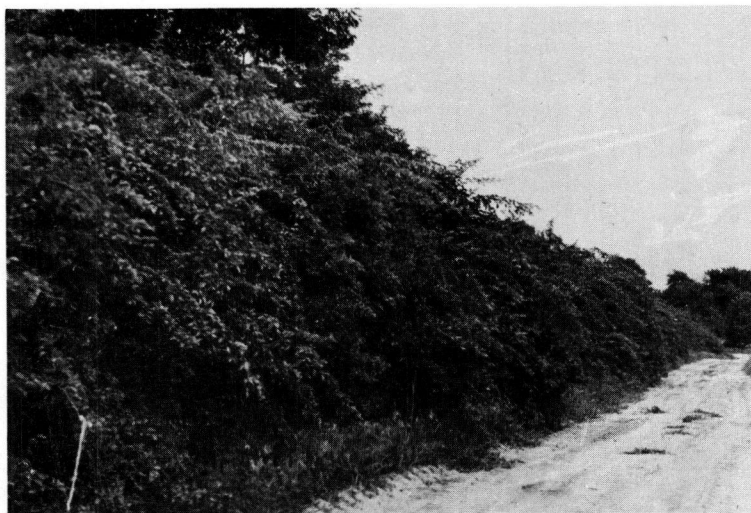
A narrow earth road ran parallel with the hedge for its entire length. This road was used for the approach run for all tests. Figure 1 shows one section of the multiflora rose hedge and the adjacent road. The section shown contained 310 ft of usable hedge, which was essentially used for crash testing at various angles of approach. The extreme end was used for one high speed winter test.

Figure 1. Typical section of multiflora rose hedge.

Test No. 9 was run on a section of the hedge, shown in the foreground of Figure 1. It was made on a 10-deg angle approach and was planned for a speed of 30 mph. The performance of the car was similar to that for previous angle tests. The car was stopped by the hedge, but the impact with

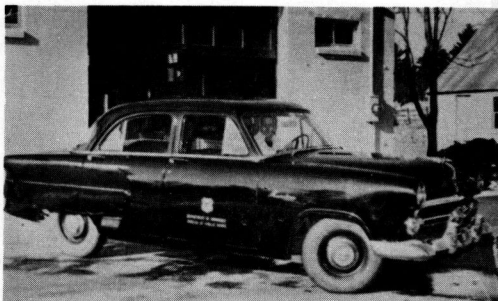
The test car, a 1952 Ford, 6-cylinder, 4-door sedan, was loaned to the University by the Bureau for the duration of the 2-season field test period. It was stripped of all nonessential interior equipment that could possibly contribute to the injury of an occupant. The seats were removed and two front bucket-type seats were bolted to the floor. Two sets of 4-in. seat belts and two sets of shoulder harness were fastened securely to the floor of the car. The dash assembly was fitted with a 6-in. covering of polystyrene plastic foam. Figure 2 shows the test car as received, and Figure 3 shows the protective plastic foam being fitted to the interior.

Figure 2. Test car as received.

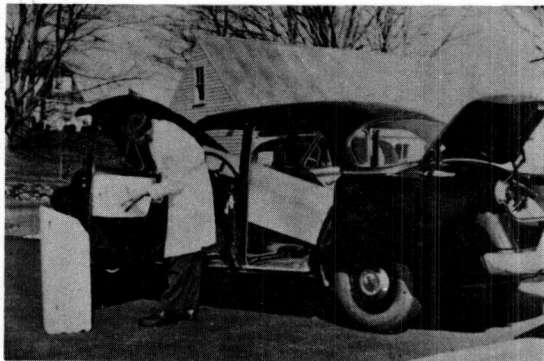
Figure 3. Test car being equipped with plastic foam.

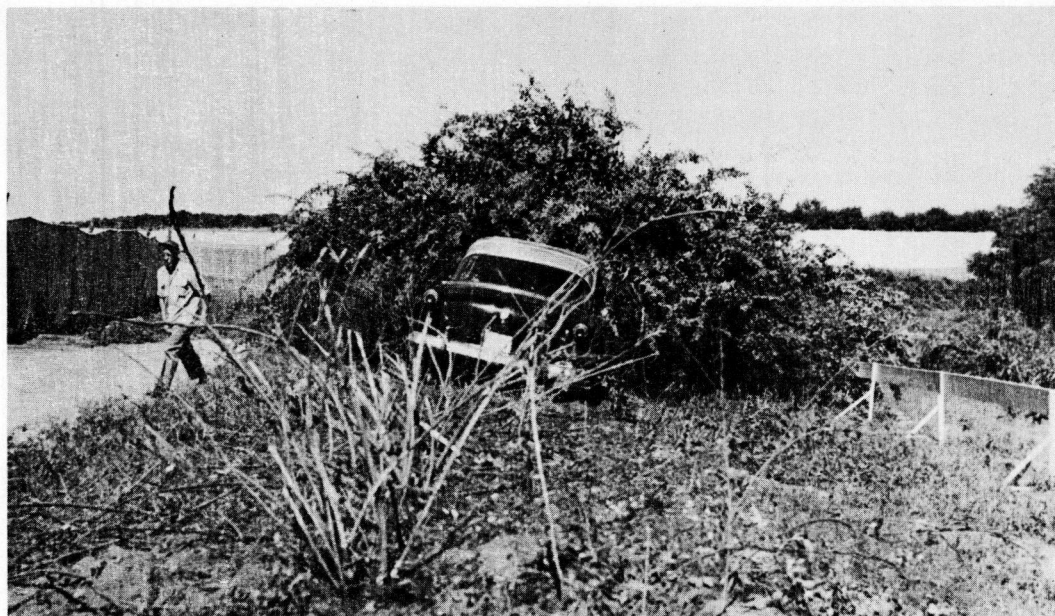
As the loose mass was accumulated and as the car pushed the entangled mass ahead, the forward bushes were either pushed down or were stripped of their foliage (Fig. 11). In the last one-third of the stopping interval the loose mass was compressed with little forward movement, which resulted in the car being stopped very gradually. A tendency for the car to ride "up" on the bushes and the softness of the ground under the bushes makes it doubtful that the use of brakes would have materially shortened the stop. In two tests where the hedge was wider than 8 ft, and where smaller seedling plants grew outside the axis, the car cut a path along the axis leaving a fringe of bushes on each side. This was the case for test No. 7 (Fig. 12).

Figure 11. Position of test car after test No. 6.

In this particular test the individual bushes were closer than usual, evenly spaced, and the canes were large (Fig. 11). The average diameter was about $3/4$ in. and the maximum was $1-3/8$ in. The bushes were counted before and after the test and there were 26 bushes destroyed in the test. When the enlarged longitudinal section of the accelerometer record was analyzed, there were 26 distinct peaks averaging 1.25 G over about two-thirds of the stopping distance of 51.8 ft. Field notes indicated that the bushes were sheared off completely in the first half of the stopping distance.

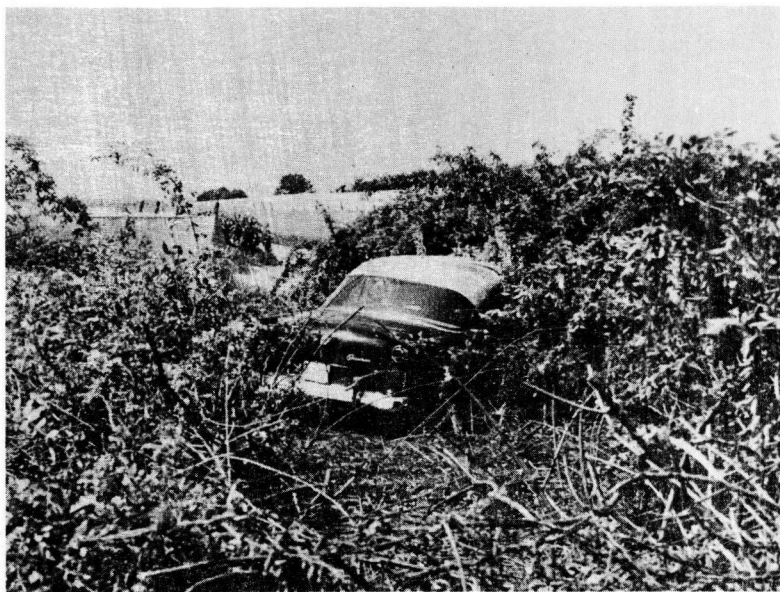
Figure 12. Path through wide section of hedge—test No. 7.

The car was declutched about 15 ft ahead of the contact point. It followed a straight path along the axis of the bushes until near the end of the run, where the rear end moved laterally until it came to rest at an angle of about 45 deg with the axis. The final position is shown in Figure 12, the car cutting a path through the bushes. About 3 to 4 ft of partially damaged bushes can be seen on both sides. The mass of bushes above the hood of the car had not yet settled at the time of the picture.

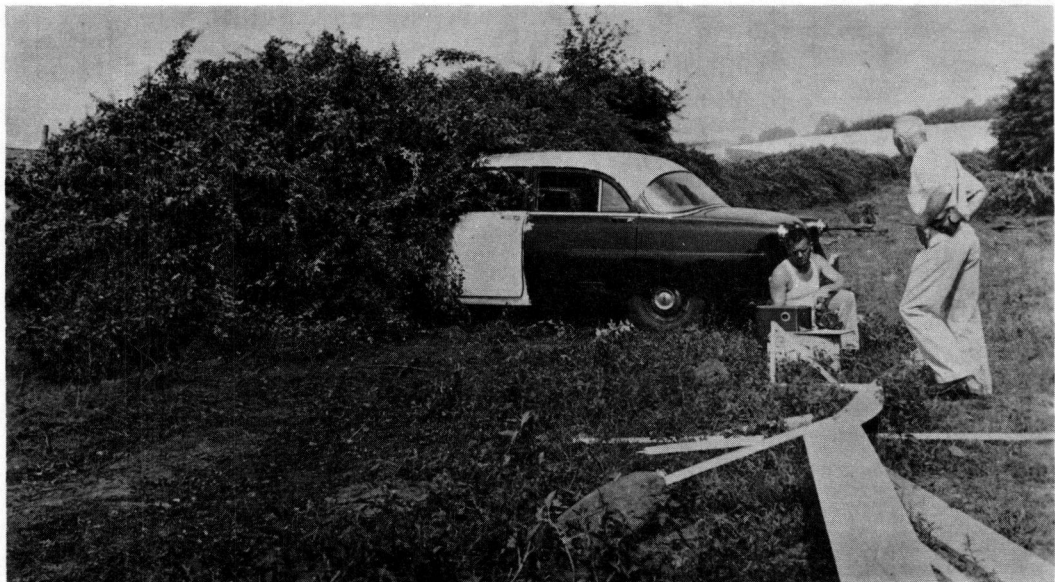
Test No. 2 was a low-speed test intended to duplicate test No. 1. Unfortunately the car hit to the right of the hedge center causing the rear to slide severely to the right. The sliding action which developed, rendered the test unusable for comparative purposes with respect to the accelerations. The stopping distance of 26.0 ft closely approximated that for test No. 1. The final position of car is shown in Figure 13.

Figure 13. Final position of car—test No. 2.

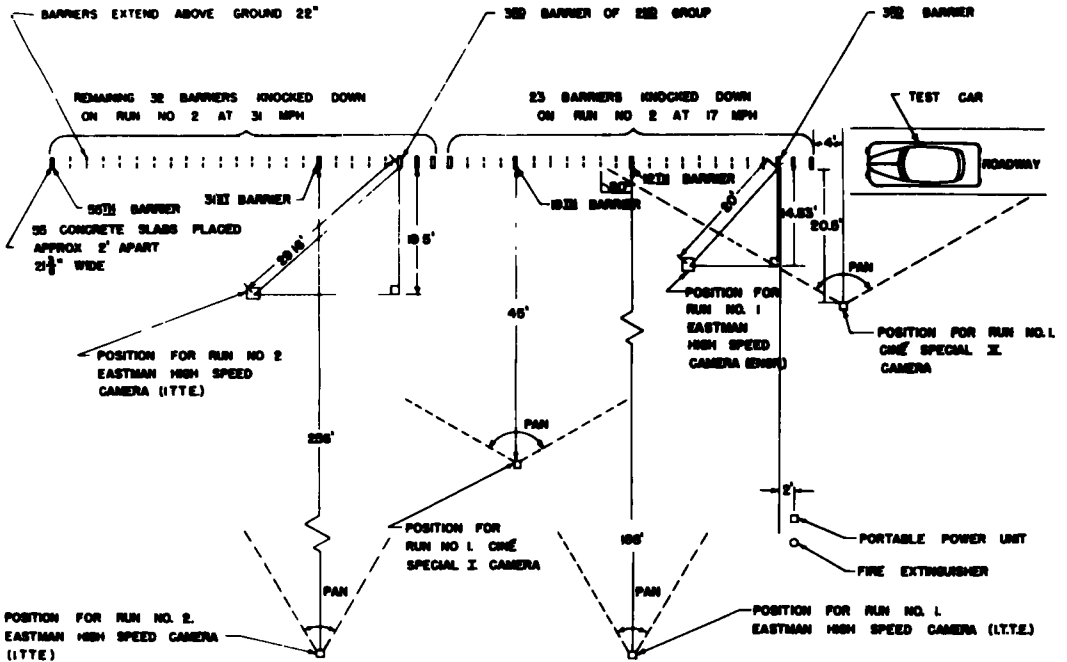
side. A plan view of the field setup is shown in Figure 8.

PLAN OF TEST SITE
