HIGHWAY RESEARCH BOARD

Bulletin 290

Developments in Salvaging Old Pavements by Resurfacing

1961

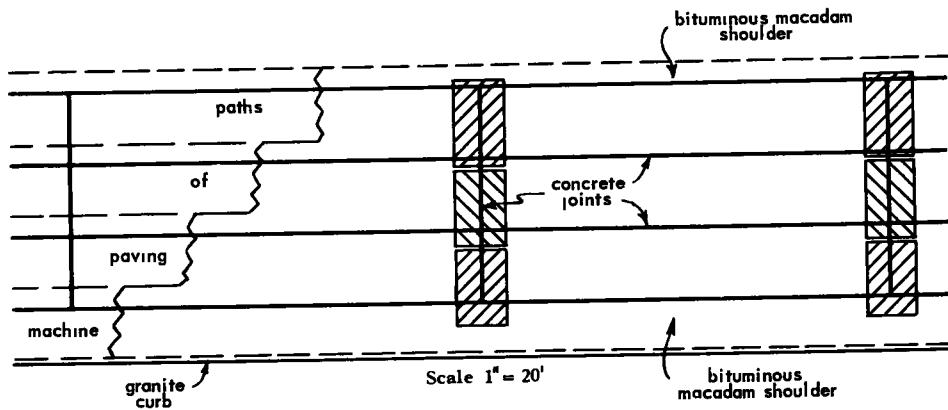
Figure 2. Placement of fabric on road. Transverse joint reinforcing with sheet fabric.

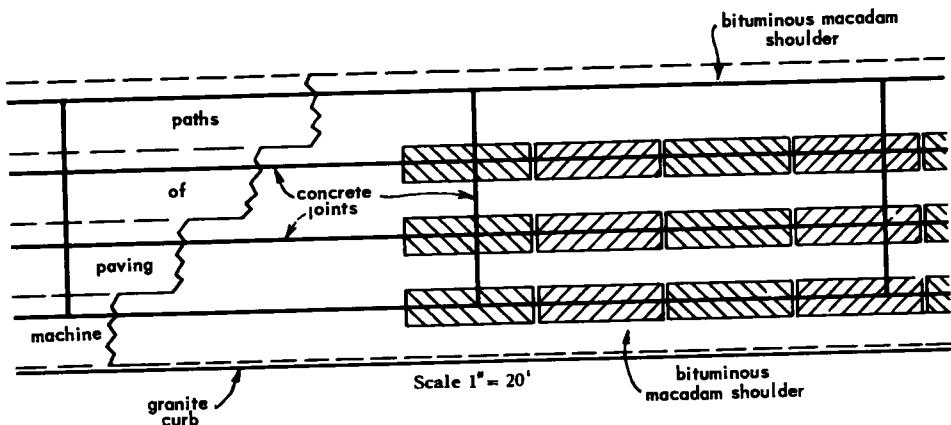
Figure 4. Placement of fabric on road. Longitudinal joint reinforcing with sheet fabric.

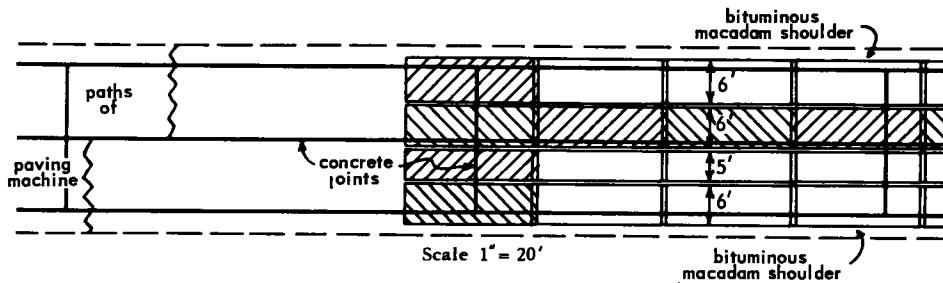
Figure 6. Placement of fabric on road. Continuous reinforcing with sheet fabric.

As given in Table 2, the Walpole test sections were constructed using continuous reinforcement not only over the whole area of the portland cement concrete slabs but also extending over each side onto the shoulders (Figs. 6, 8, and 12).

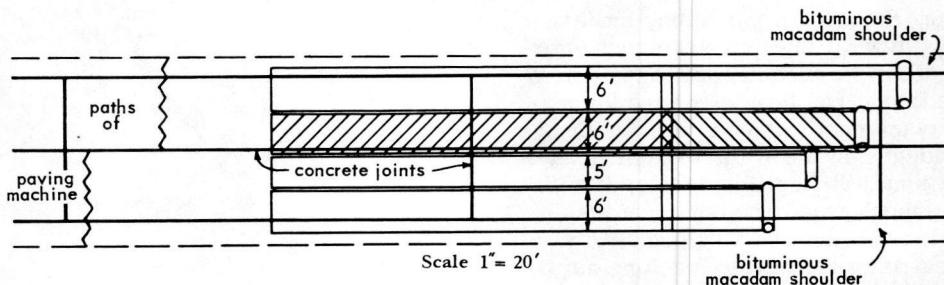
Figure 8. Placement of fabric on road. Continuous reinforcing with roll fabric.

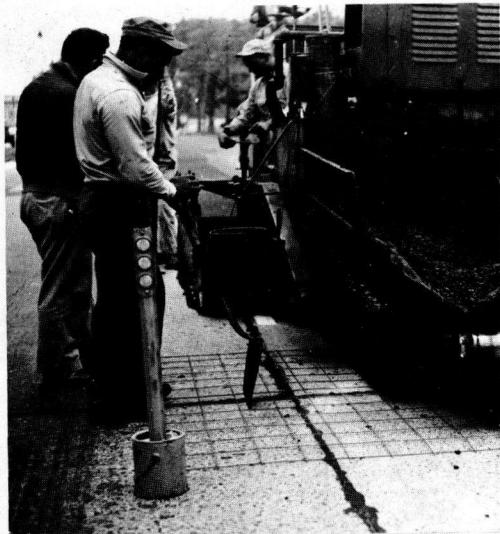
Figure 9. Typical installation of transverse reinforcing over joint.

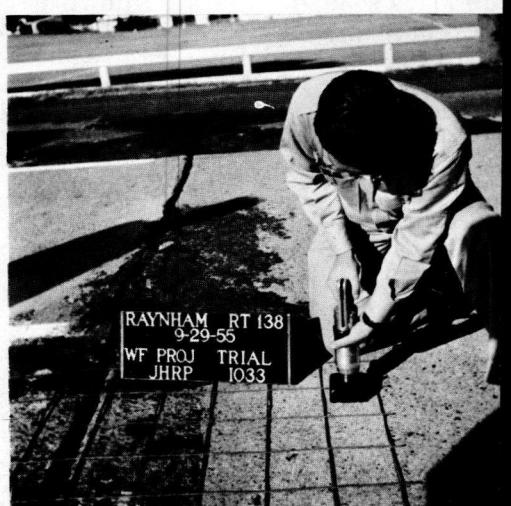
Figure 10. Remington stud driver used to hold down fabric sheets.

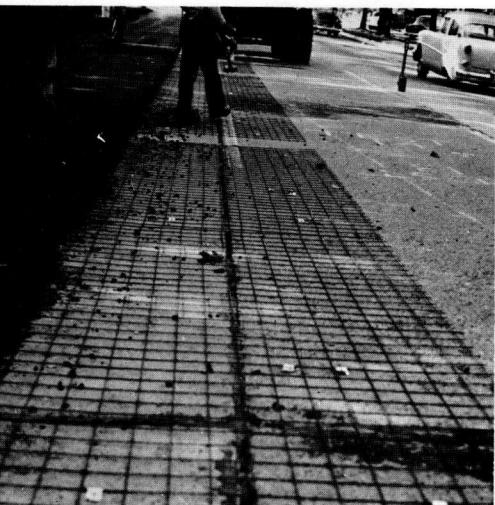
Figure 11. Typical installation of longitudinal reinforcing over joint.

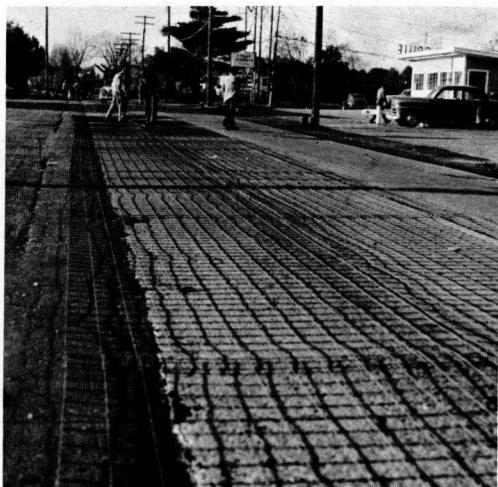
Figure 12. Placing continuous sheet reinforcing.

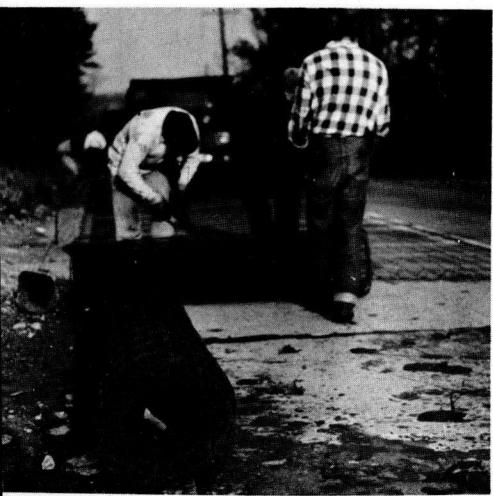
Figure 13. Placing continuous roll reinforcing.

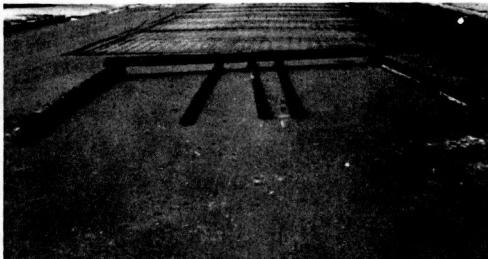
Figure 14. Sled used on Barber-Greene paver for holding down continuous reinforcing.

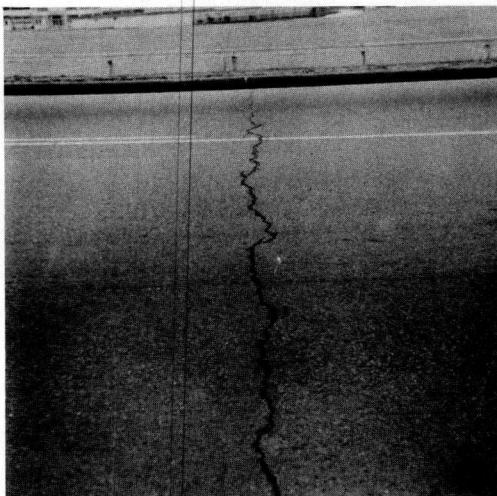
Figure 15. One of the cracks in non-reinforced section.

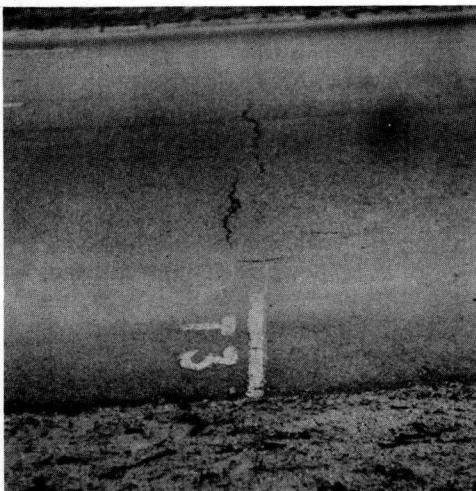
Figure 16. Crack above joint in reinforced section, Raynham.

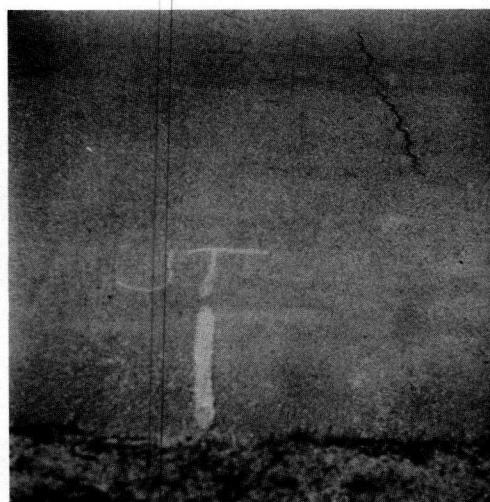
Figure 17. Crack at edge of reinforcement, Raynham.

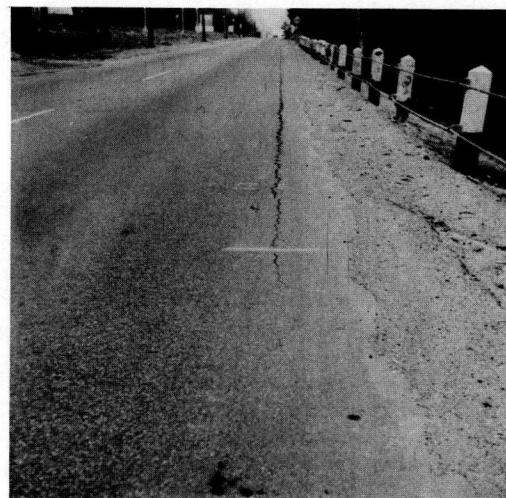
Figure 18. Longitudinal crack narrows down and stops at reinforced section (bottom), Walpole.

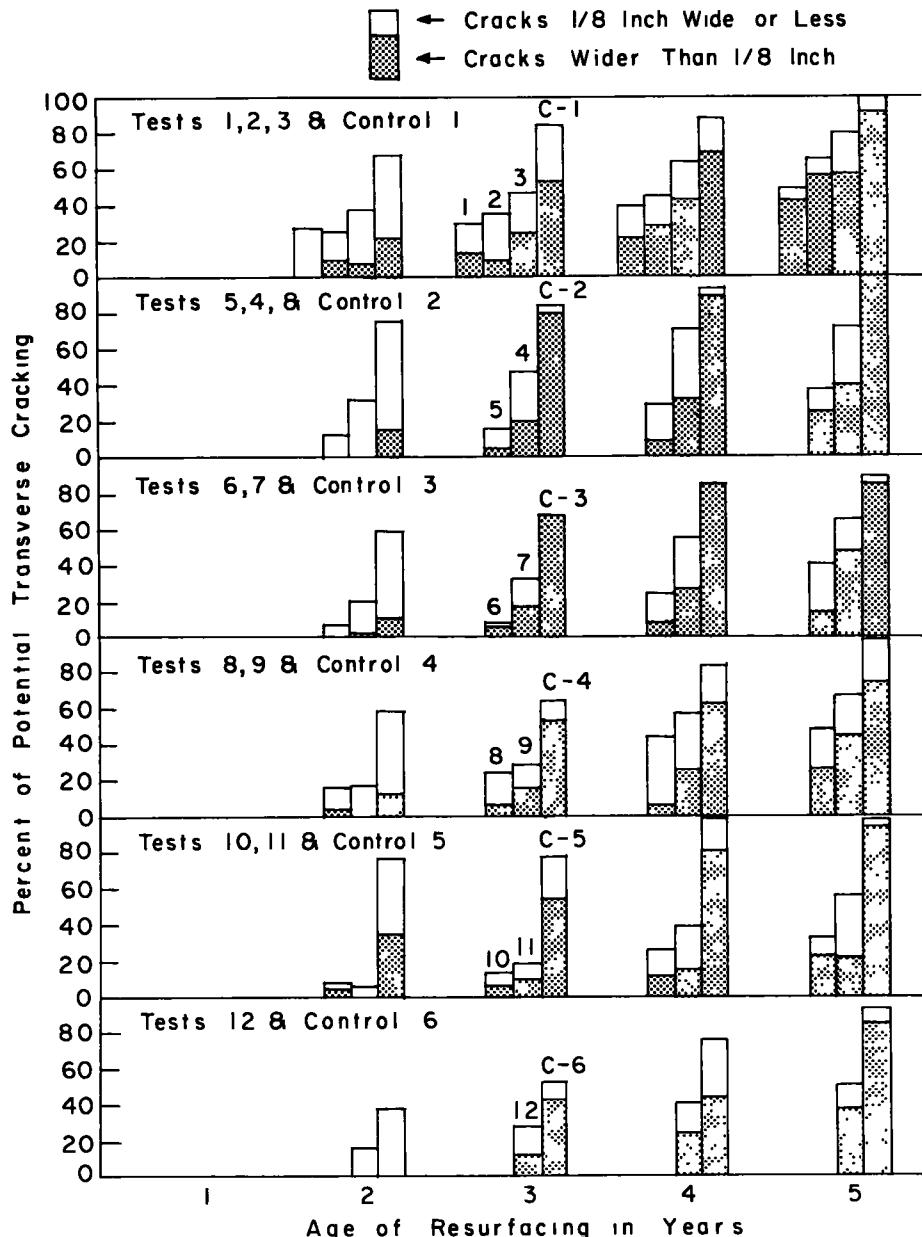
Figure 19. Comparison of transverse crack development for the Raynham Test Road using strip reinforcement.

The width of the strip reinforcement in Raynham varied between 5 and 10 ft. The 5-ft wide strips are herein called narrow, the 6½- to 7½-ft strips are called medium wide and the 10-ft strips are designated as wide. The percentage of total reflection cracking above the transverse joints is given in Figure 19. This figure contains six

areas as compared to the longitudinal joints. Figure 19 shows that all test sections and controls had cracks after two years of traffic and exposure to weather. In all cases the cracks increased in width and length with time. The most undesirable cracks are the wide ones because they require continued maintenance. Comparing the amount of wide cracks as well as the total cracking in Figure 19 it is apparent that the control sections in all cases had more of both types of cracking than any of the wire reinforced test sections. Thus, it can be said that any of the wire fabric reinforcement over the transverse joints will help in a degree to prevent reflection cracking. The lowest percentage of reflection cracks was found in test 10 (fabric style-6 x 6, $\frac{1}{8}$) which had about one-third of that in a comparable control section. If the percentage of the wide cracks is defined as the most important, test 6 (fabric style-3 x 6, $\frac{10}{10}$) is the best. In general, tests 5, 6, 8 and 10 are the best performers with total cracking from ab-

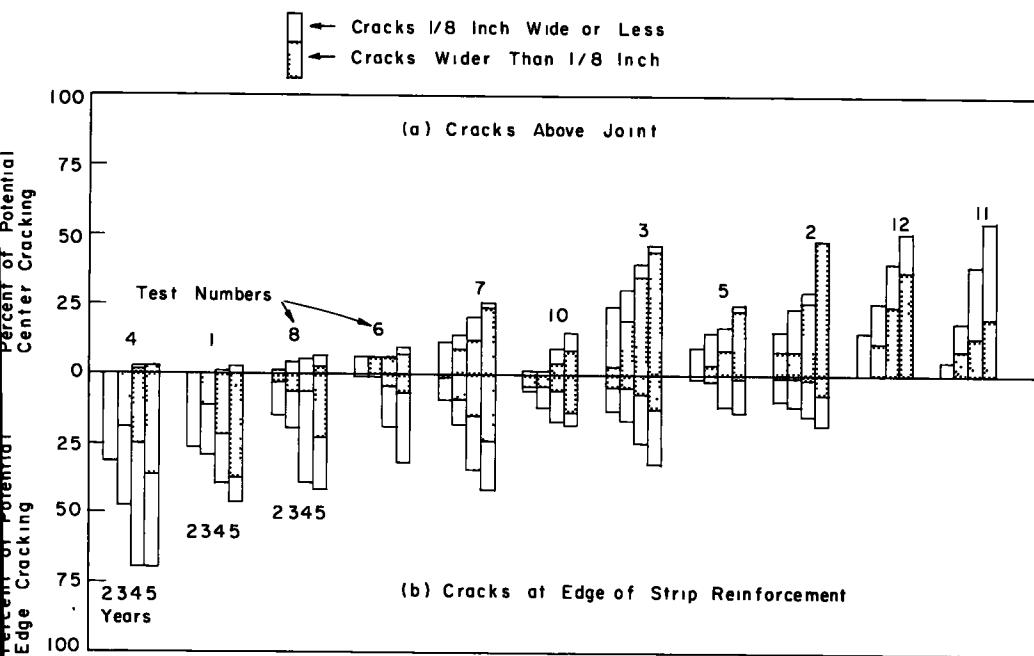
Figure 20. Comparison between the two types of transverse cracking in Raynham: (a) cracks right above the underlying joint and (b) cracks at the edge of the strip reinforcement.

Figure 20 shows a division between the amount of edge cracks and cracks right over a joint. Here again, the hatched area designates wide cracks, whereas the blank part of the bar denotes the narrow cracks. The arrangement of the bar graphs is slightly different in Figure 20 than in Figure 19, showing for each test section the development or increase in cracking with time. The control sections are not included in this comparison because they contain only one kind of crack; that is, only those immediately above the joint.

The two types of transverse cracks encountered in Raynham test section are compared in Figure 20. It is apparent that the type of reinforcement plays a great role in the structural behavior of the bituminous concrete and reinforcement combination. Laboratory studies show that the design and placement of the reinforcement for transverse joints is an engineering problem which requires balancing of "strength" to resist the forces of nature and traffic (11). For instance, if the strip reinforcement is made of stiff wire closely spaced and the width of the strip is not adequate, there will be no cracking immediately above the joint but the strongly reinforced section will transfer the strain to the edge of the reinforcement causing a crack there. On the other hand, the sizes of the wire fabric are small, the spacing between the wires is considerable, and the strip of wire fabric placed above the joint is wide, the likelihood of reflection cracks occurring immediately above the joint is high. Laboratory tests and theoretical studies indicate (10, 11, 17), that the behavior of welded wire fabric in the bituminous concrete is different from that of reinforcement placed in portland cement concrete. When a reinforced bituminous concrete layer is subjected to slow tension the longitudinal wires offer very little bond resistance. The main resistance to the strain of the reinforced overlay is exercised by the transverse wires which undergo a shear movement through the mix. The amount of shear movement depends on stress, temperature of mix, time of loading and other factors. Part of this movement is recoverable elastically, whereas the other part becomes a permanent deformation. The main factors that appear to play a role in deciding whether a crack will appear immediately above the joint or at the edge of the strip reinforcement are as follows:

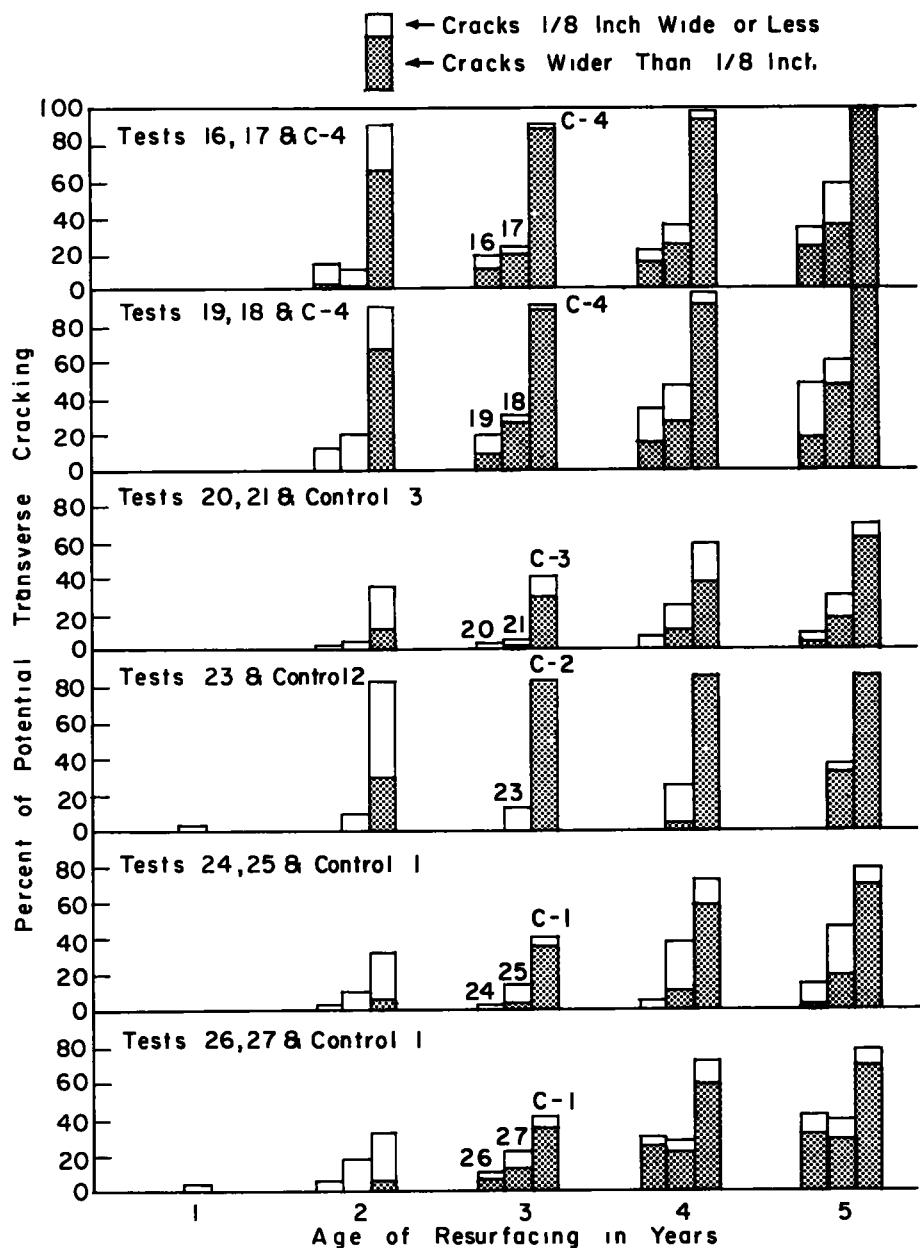
Figure 21. Comparison of transverse crack development for the Walpole Test Road using continuous reinforcement.

The cracking percentages for the transverse joints are shown in Figure 21. Three of the test sections contained wire fabric in sheets, whereas the rest of the test had the reinforcement in rolls of approximately the same length as the slabs. In Figure 21 the various test sections are compared with the adjacent control sections and, therefore, each section of the bar graphs has to be studied independently. For instance, tests 20 and 21 have an adjoining control section, C-3, which cannot be directly

compared with tests 16 and 17 because the control section adjacent to tests 20 and 21 shows about 70 percent cracking, whereas the control section next to tests 16 and 17 has cracked 100 percent. Again, as in the Raynham test results, the hatched area of the bar graphs denotes the amount of wide cracks, whereas the blank area gives the percentages of narrow cracks.

The Walpole Test Road contains three test sections with the continuous sheet of reinforcement and seven sections where rolls were used. Figure 21 summarizes the amount of transverse cracking and again it must be emphasized that comparisons can be made only between the tests and the adjacent control sections. Thus tests 20 and 2 should be compared with control 3 rather than with other controls. This calls for a caution when direct comparison between various sections are made.

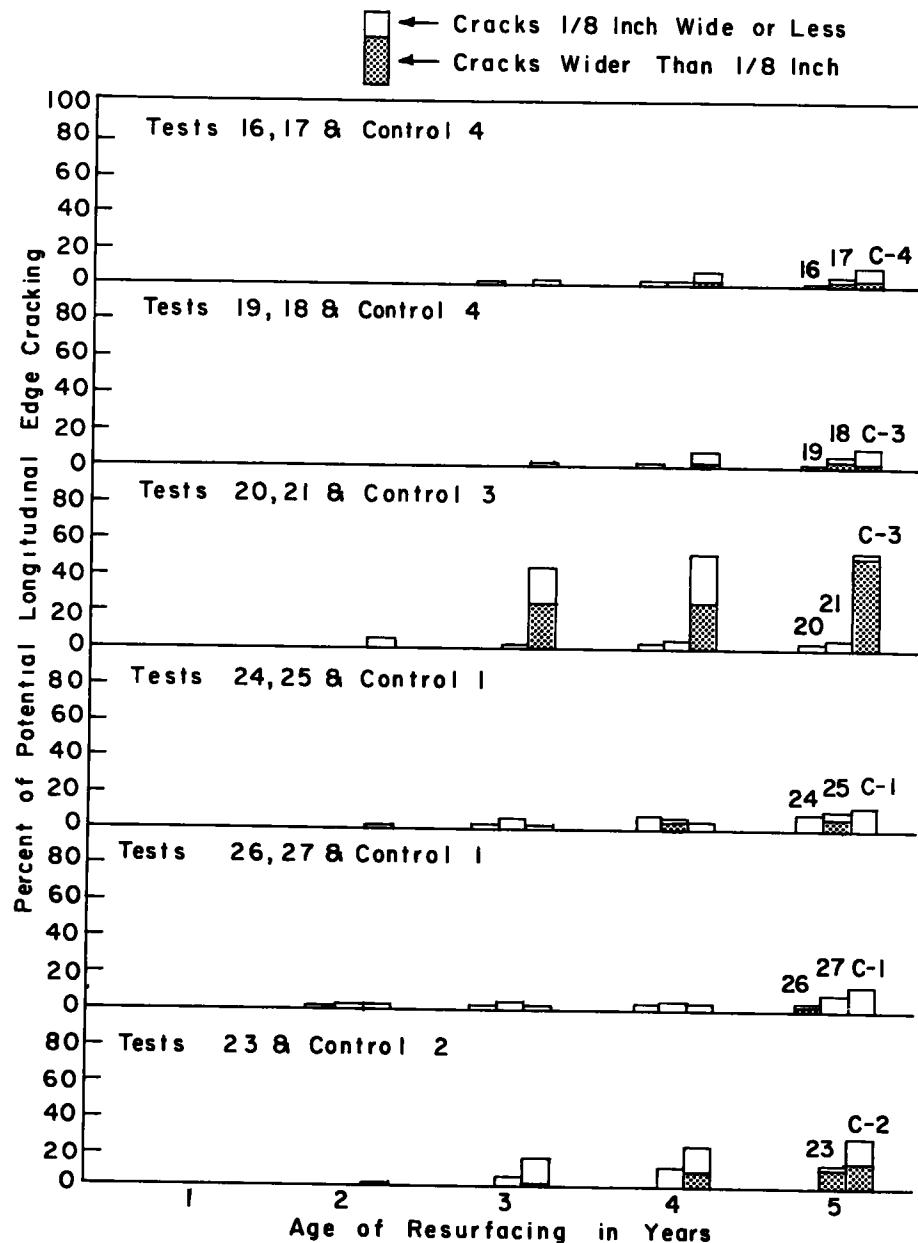
Figure 22. Comparison of longitudinal edge crack development for the Walpole Test Road.

Figure 22 shows a comparison for cracks along the edges of the pavement between the slab and the shoulder. Comparing Figure 21 with Figure 22 it is apparent that the amount of longitudinal cracking in Walpole is very small as compared to the transverse cracking.

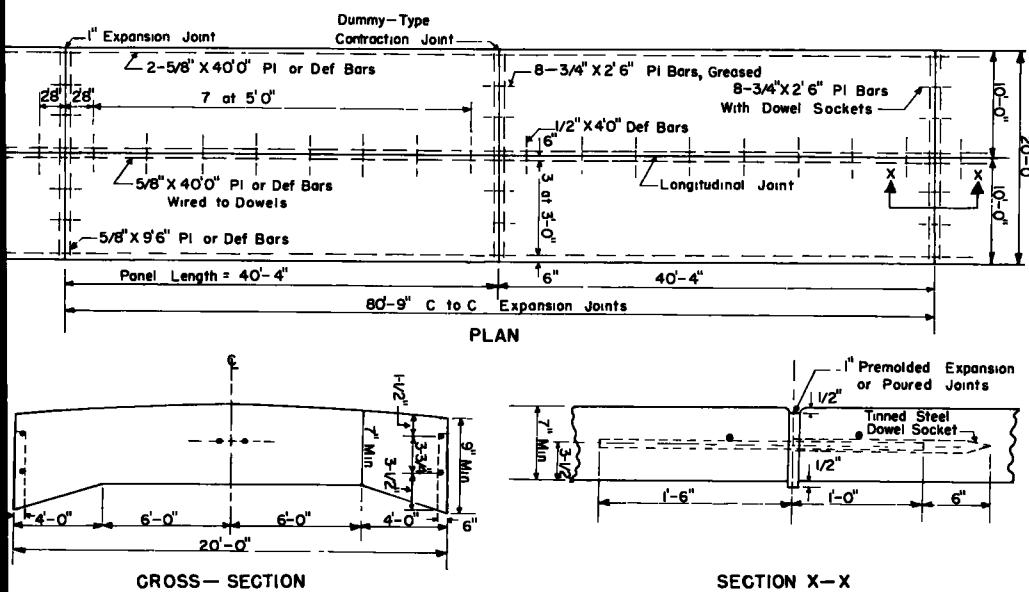
Figure 1. Concrete pavement details.

The old concrete pavement was constructed in 1931. The slab was 20 ft wide, 9 in. thick at the edges and tapered to 7 in. thick 4 ft from the edges, a typical 9-7-9 section. Panels were generally 40 ft 4 in. long, with every other joint being an expansion joint. The 1-in. expansion joints had $\frac{3}{4}$ -in. dowels with steel sockets on one end. The dummy-type contraction joints had $\frac{3}{4}$ -in. dowels which were greased on one end. Slab reinforcement consisted of two $\frac{5}{8}$ -in. bars along each edge and one along each side of centerline, one $\frac{5}{8}$ -in. bar along each side of the joints, and $\frac{1}{2}$ -in. by 4-ft tie bars across centerline. The pavement design is shown in more detail in Figure 1.

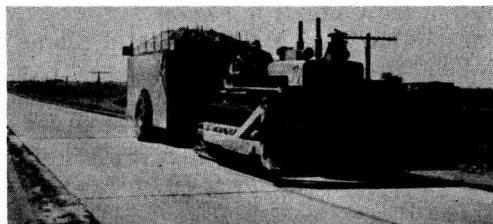
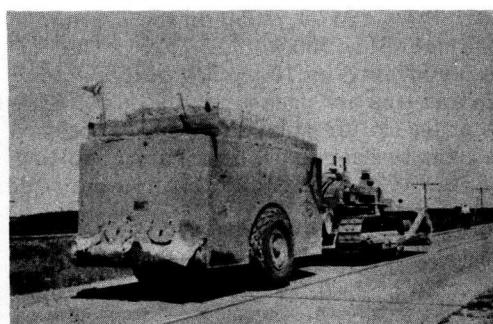
Figure 2. Fifty-nine-ton pavement breaker roller.

18.00 x 25, 24-ply, diamond tread tires inflated to 90-psi air pressure. The rolling width, measured from outside to outside of tire contact, was 8 ft 8 in. An International TD 24 tractor was used to pull the roller and did an excellent job of controlling it at all times. The roller-tractor combination is shown in Figure 2.

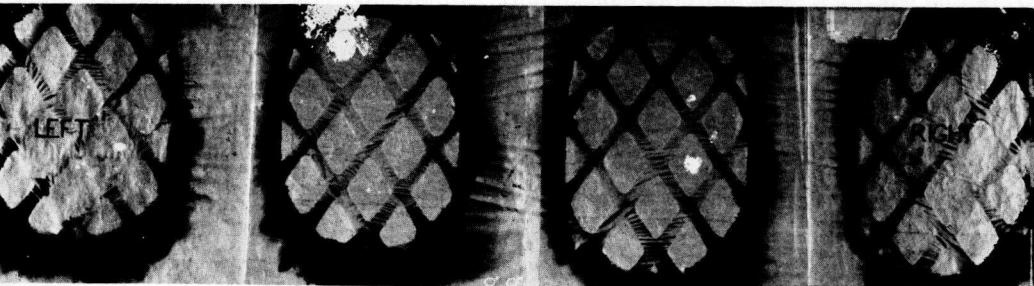
Figure 3. Tire contact areas, 59-ton pavement breaker roller.

To measure the tire contact areas, a length of 30-in. wide paper was placed across a clean portion of pavement slab, and the roller was pulled forward until the tires were on the paper. Then using pressurized cans, paint was sprayed completely around the contact periphery of each tire, being sure to cover the tire and the paper at all places. When the roller was moved ahead, the four contact areas were outlined on the paper as shown in Figure 3. Later, these were measured as follows:

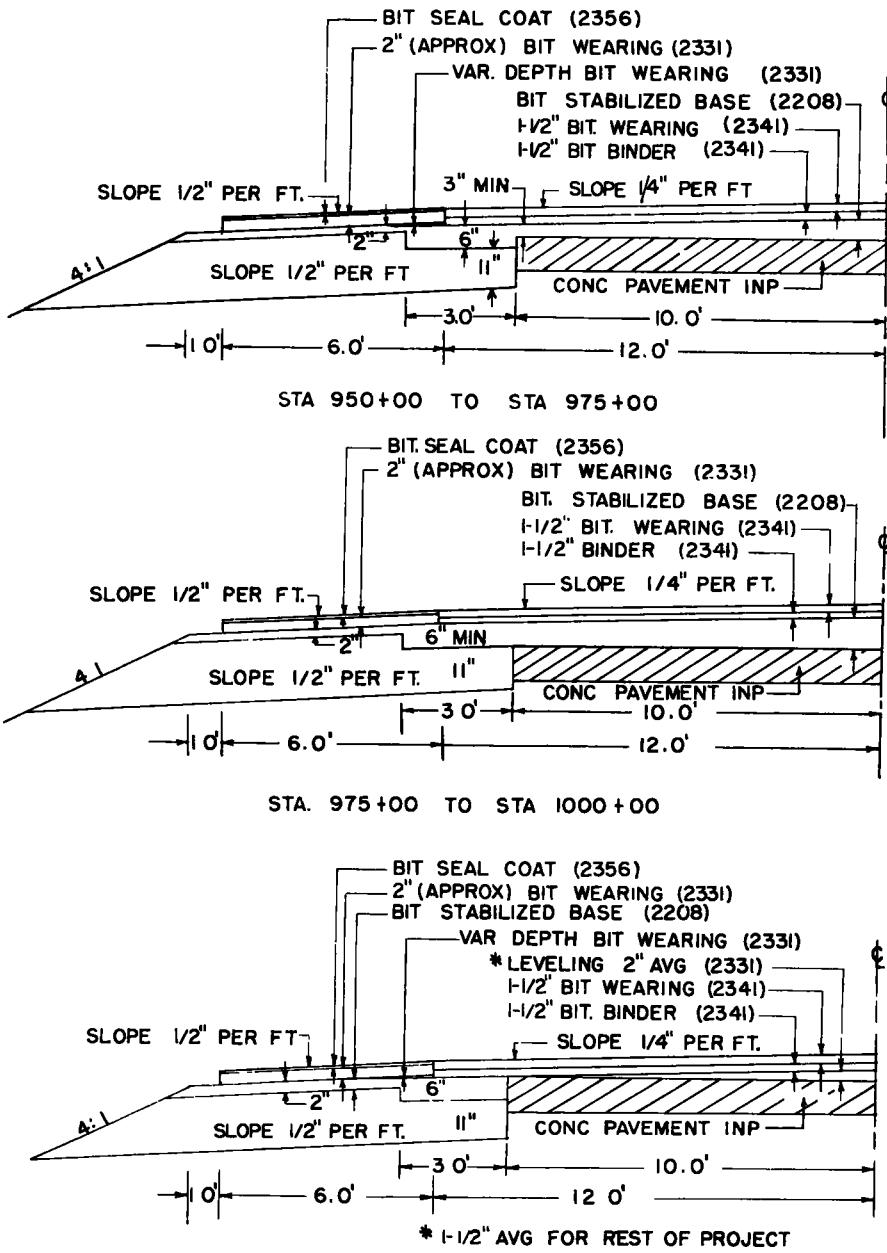
Figure 4. Typical sections.

The typical resurfacing section for the project consisted of a 1 $\frac{1}{2}$ -in. leveling course, a 1 $\frac{1}{2}$ -in. binder course and a 1 $\frac{1}{2}$ -in. wearing course over the old concrete pavement. This section was varied over the rolled experimental portion of the project to provide for a 2-in. leveling course, a 3-in. bituminous base and a 6-in. bituminous base as alternates to the 1 $\frac{1}{2}$ -in. leveling course on the standard section. These features plus the widening designs are shown in detail in Figure 4.

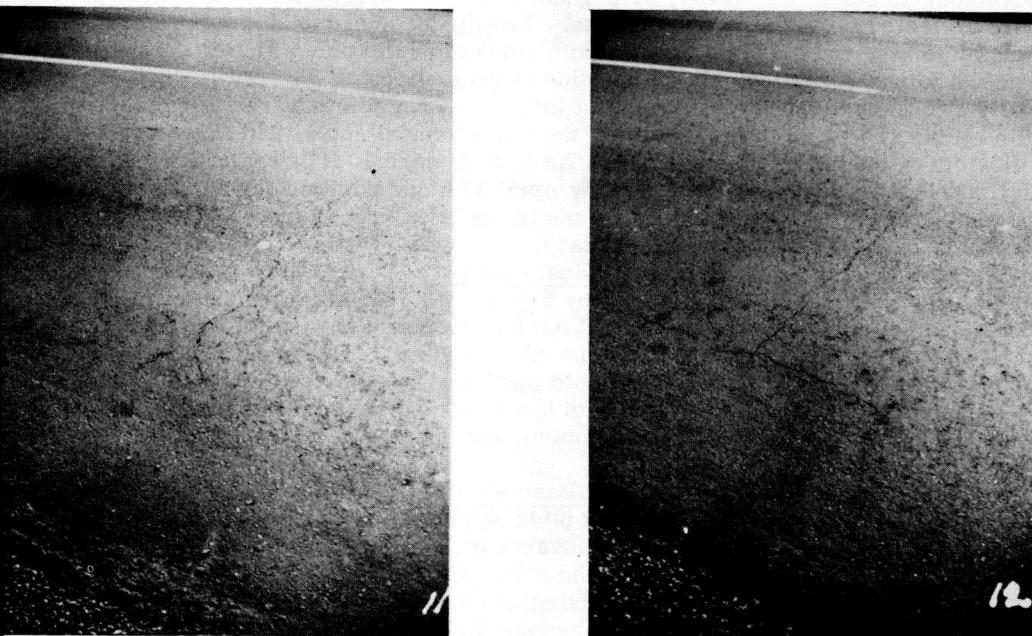
Figure 5. Typical transverse and widening cracks, Sta. 120 to 130.

er 200 ft of longitudinal cracking on centerline. Widening cracks along the edge of the old slab extended up to 5 ft from many of the transverse cracks. Figure 5 shows typical examples of this cracking.
