# Use of the Kelsh Plotter in Geo-Engineering and Allied Investigations in Kansas

ALVIS H. STALLARD and GLENN ANSCHUTZ, Respectively,  
Geologist I and Engineer of Photogrammetry, State Highway Commission of Kansas,  
Topeka

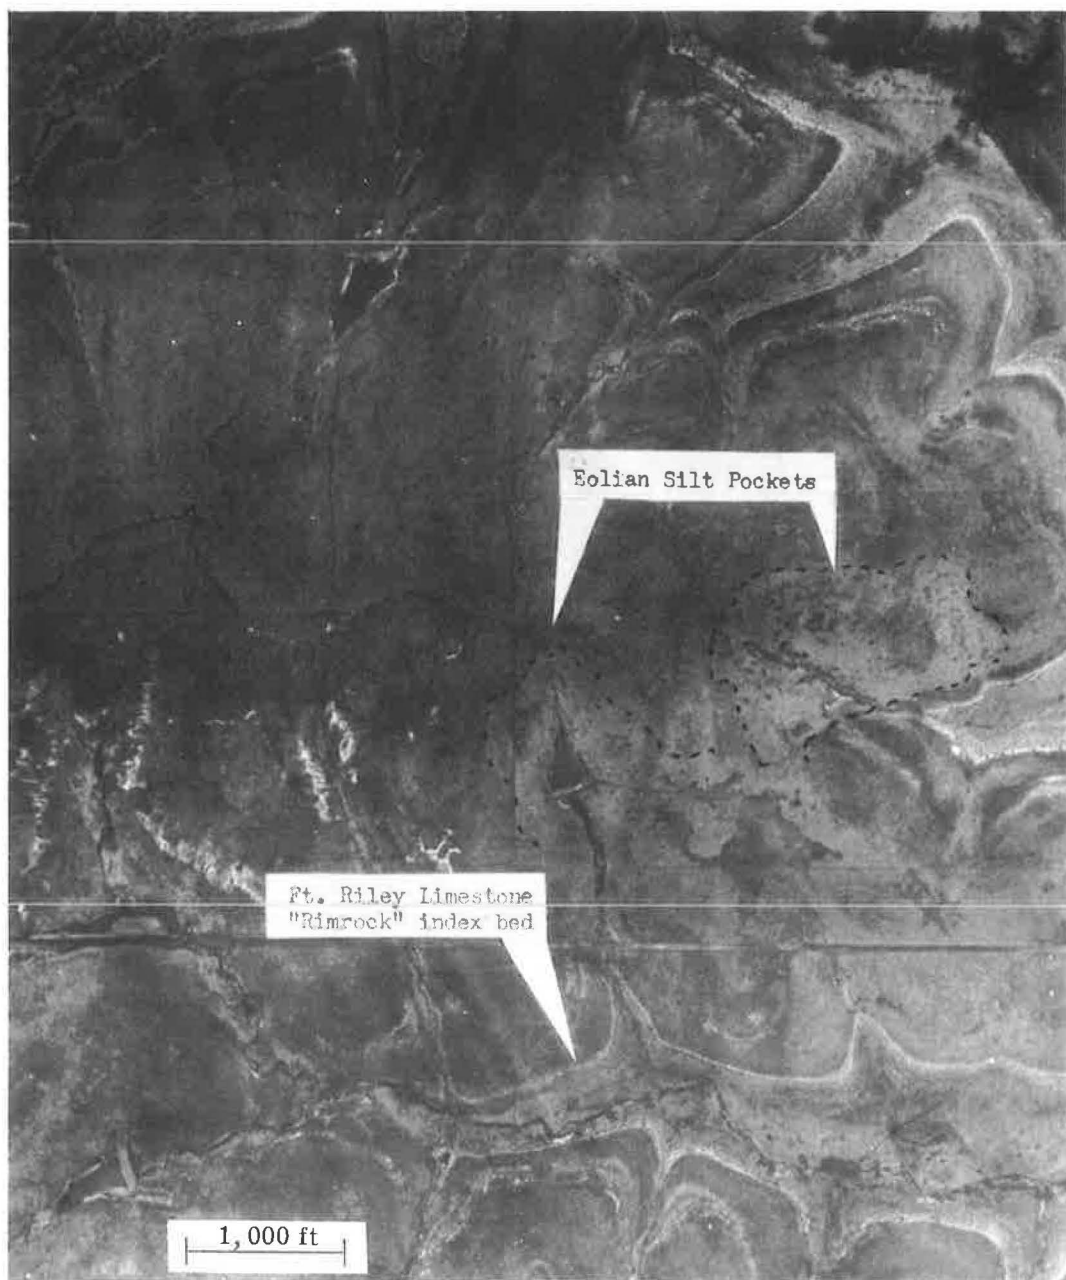
Figure 4. Ft. Riley limestone "rimrock" index bed in Geary County, Kans.; eolian silt pockets detected by gully characteristics and tone variation (scale: 1:12,000).

The Ft. Riley rimrock is a very extensive bed geographically in eastern Kansas. The rimrock occurs in the lower portion of the Ft. Riley limestone member, Barnes-ton limestone, Chase group, Wolfcampian series, Permian system. The main factor that identifies this bed on aerial photographs is its massive characteristics which make it stand out from the overlying and underlying thin bedded and relatively soft limestone. Figure 4 shows the rimrock in Geary County, Kans.

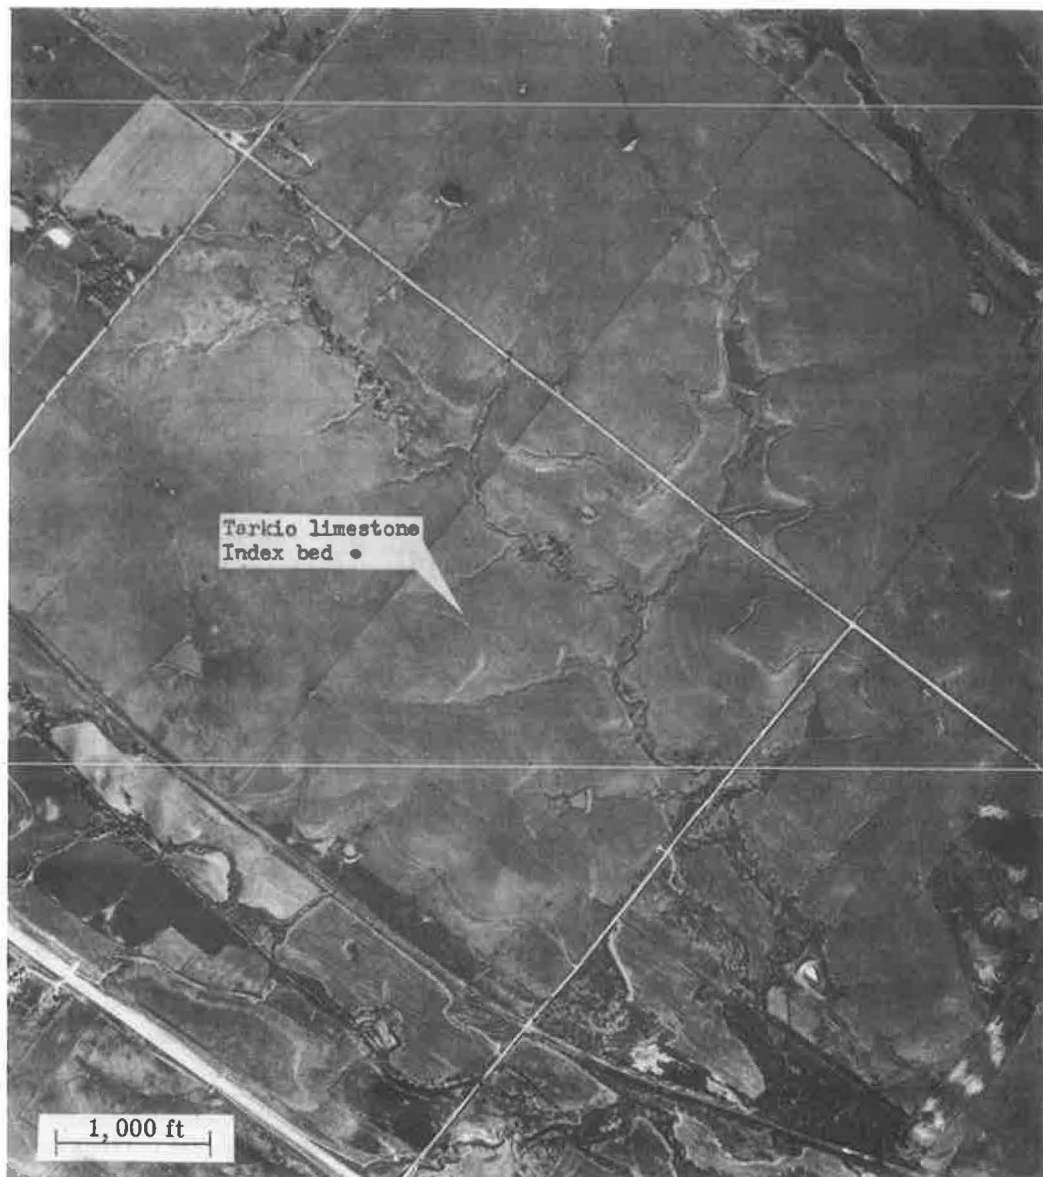
Figure 6. Tarkio limestone index bed in Jackson County, Kans. (scale: 1:12,000).

expression which can be easily discerned on aerial photography. Figure 6 shows the limestone in Jackson County, Kans.

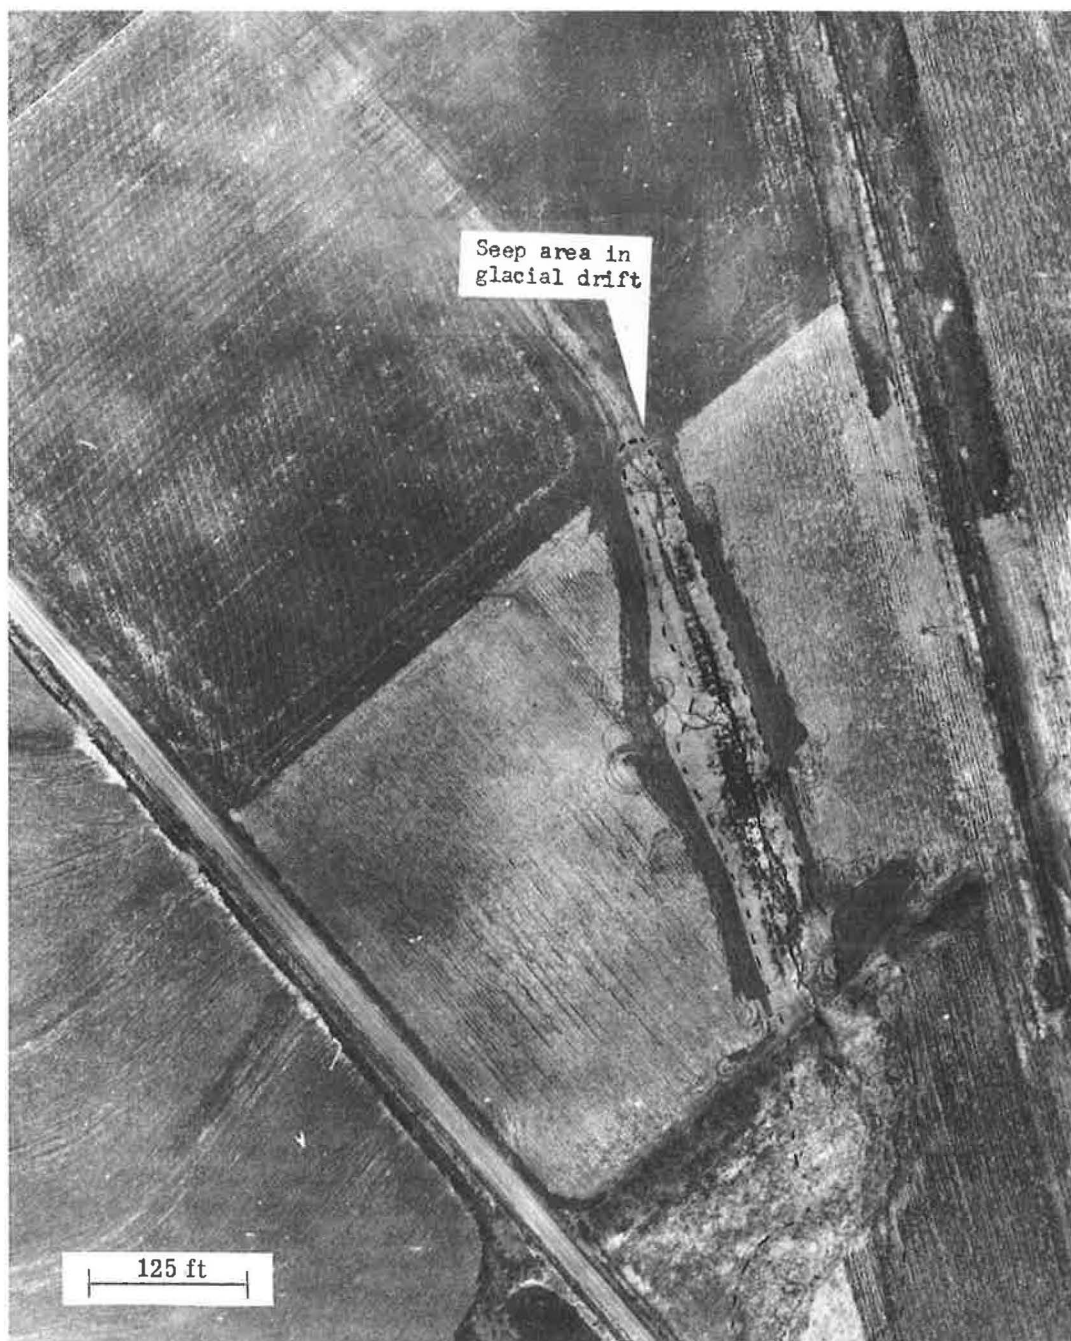
Figure 15. Seep area in glacial drift in Brown County, Kans.; an indication of sand and gravel deposit that may require special attention during field investigation (scale: 1:1,500).

Profiles were plotted for both alignments with measurements taken from the Kelsh plotter. Elevations were taken on selected geological formations. The thickness of the various geological formations were taken from a previous project that was worked in the area. A great deal of interpretation was required to ascertain the bedrock-glacial drift contact. Figure 14 shows bedrock capped with glacial drift along one of the proposed alignments. The geology of each alignment was plotted on the respective profiles. Seep areas were noted and stationed to the centerline. Figure 15 shows a seep area in glacial drift which traverses the proposed centerline.
